DETAILED BUILDING SURVEY

INCORPORATING A VISUAL / STRUCTURAL ASSESSMENT OF THE PROPERTY

SAMPLE SURVEY

Tayross Associates Limited

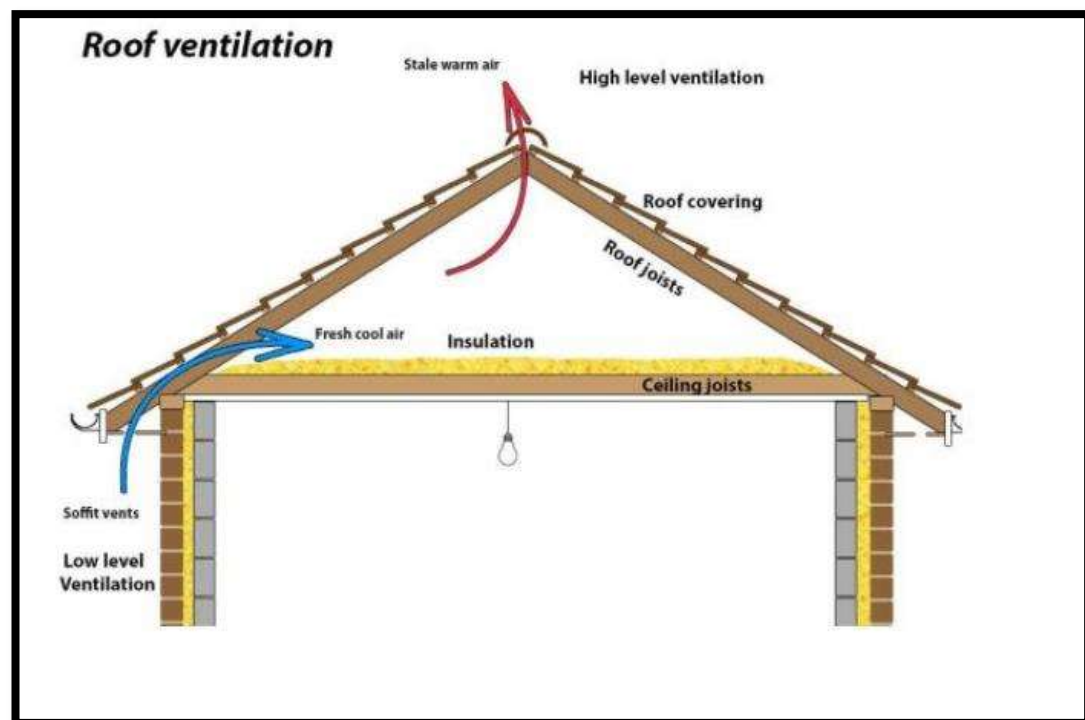
Coverings and Roof Space Ventilation Diagram A

● P09 - We noted that there is no soffit ventilation to the habitable roof space which is a building regulation requirement. It is a bone of contention whether soffit ventilation is required or not- some schools of thought have it; that if you use a breathable under slate membrane and ventilate the roof at ridge level which this property appears to have, that there is no requirement for soffit ventilation, however, NHBC(National house builders council) made it clear that soffit ventilation is required. This can be relatively easily installed retrospectively, so I'm not so over concerned and I have inserted cost at the end of the report for this. there are no indications at the property that this has caused any problems to date.

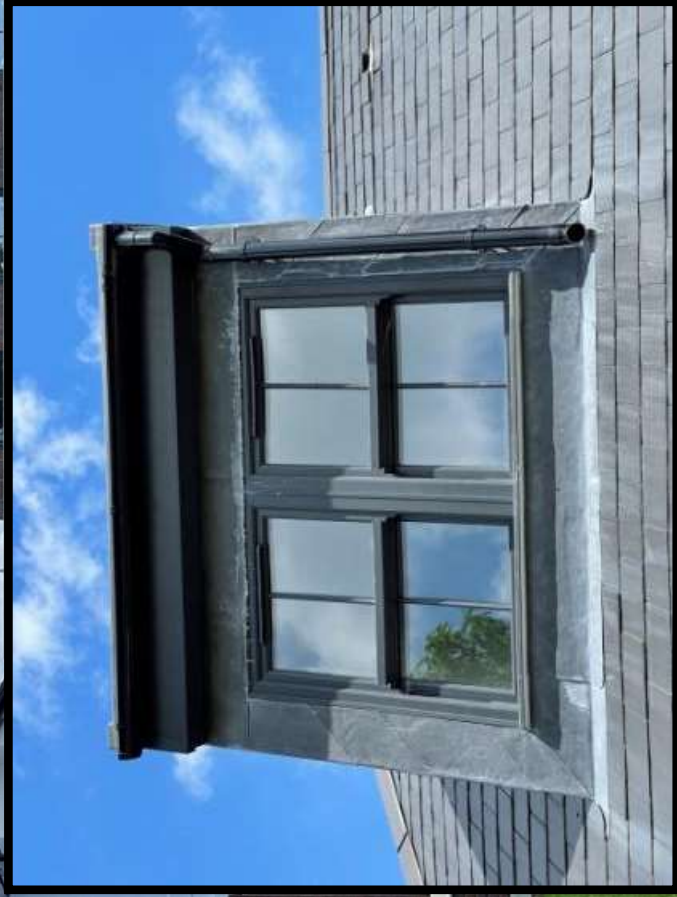
Roof rear elevation

Three large lead clad dormers at the rear with sliding sash windows at the front plastic fascias and plastic rainwater goods. These all appeared in good condition. I did note that none of the lead appears to have been clipped/cleated down this can be a long-term issue if high winds should cause the lead to lift. There are no indications of this presently. Slate roof at the rear appears in reasonable condition again no spaces have been left between the individual slates which give the roof covering an uneven appearance were slates ride on top of each other when they expand and have nowhere to go.

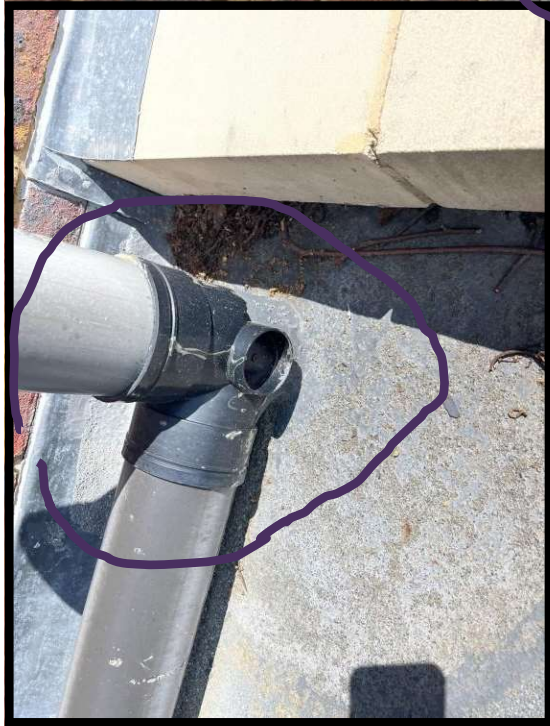
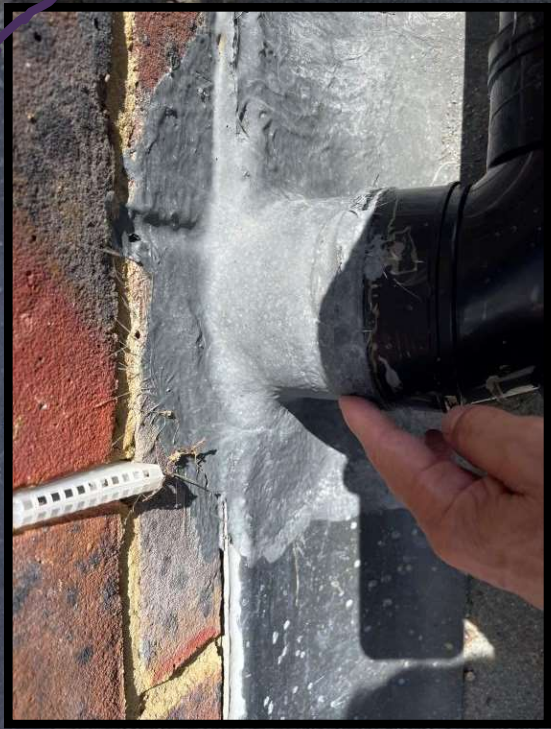
Rear flat roof.

This consists of a GRP roof which has added grit particles on top, I presume this gives some extra protection to the roof and also makes the roof less treacherous during frosty weather.

There is a large glazed lantern light on top of the roof – this doesn't have any ventilation which will make the areas underneath quite hot in summer and possibly cold draughts in winter. We noted that there is an issue with the coping stones, one of these is loose on the corner refer to photograph. This will need re-pointing.

Connection weathering details are prone to failure in the long term, as the grp resin patches used will not stick long-term. It would be better to have a lead flashing detail, which is more robust. This looks like these applications were done only recently. We did not look any damp below this area.

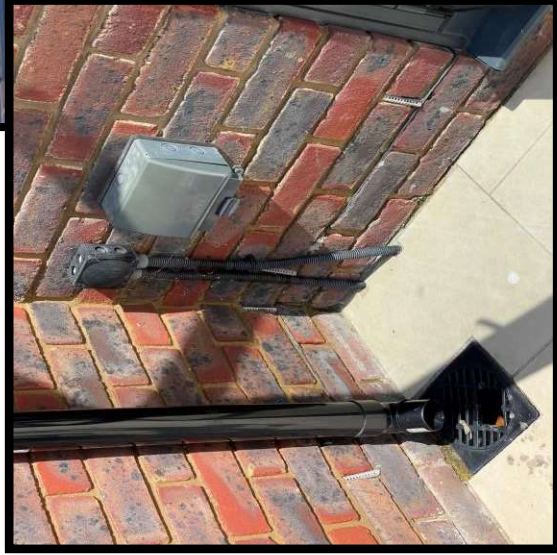
Rainwater fittings

We noted that the rainwater pipe for the porch roof discharges onto the paved area at the front of the property.

Further downpipe on the left-hand side for the main roof this appears in good condition and discharges to the front left-hand corner there is also rainwater pipe to the back left-hand corner.

We noted that the garage of the neighbour's property downpipe drains onto your property. Also a foot trap here.

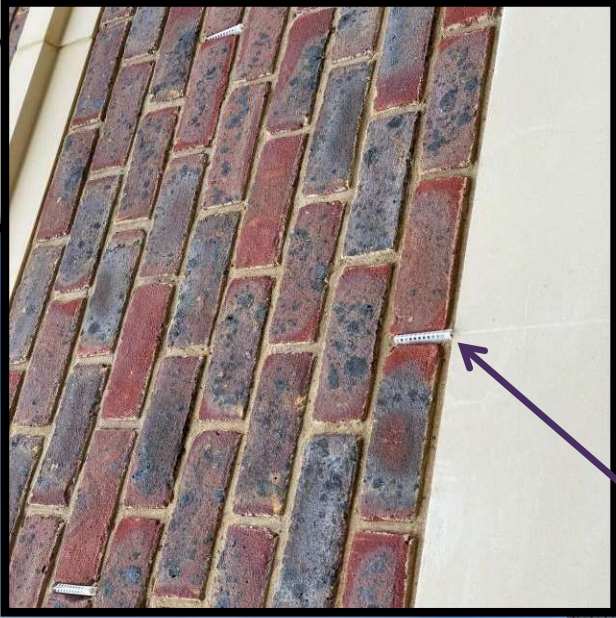
No soffit ventilation fitted around the roof.

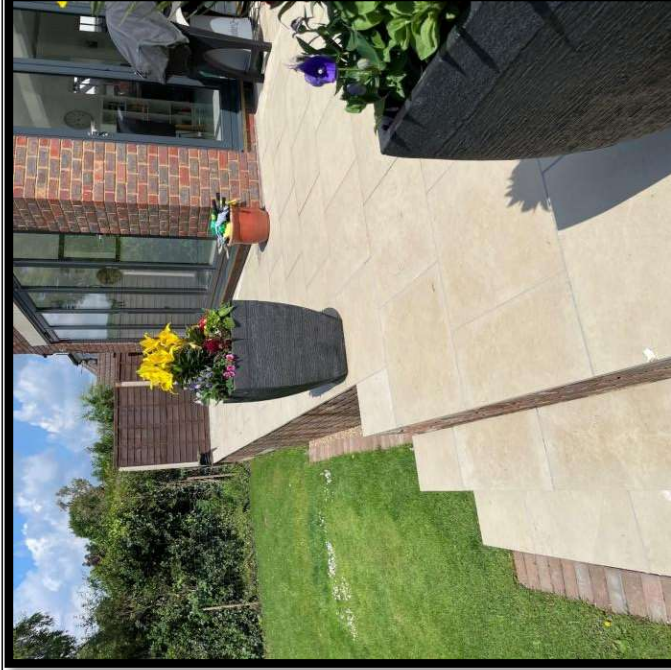
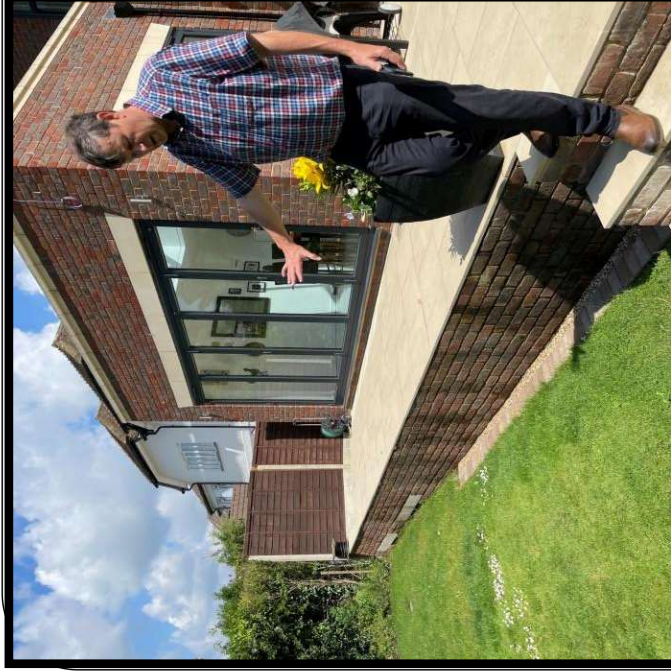
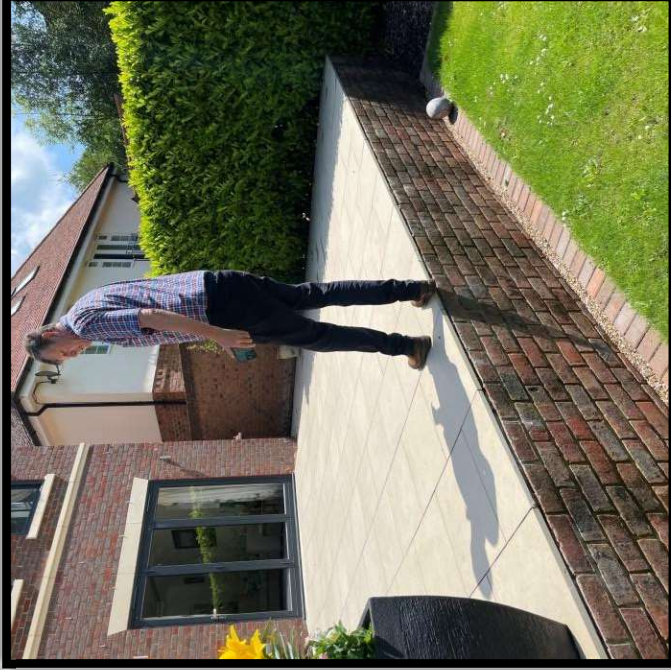
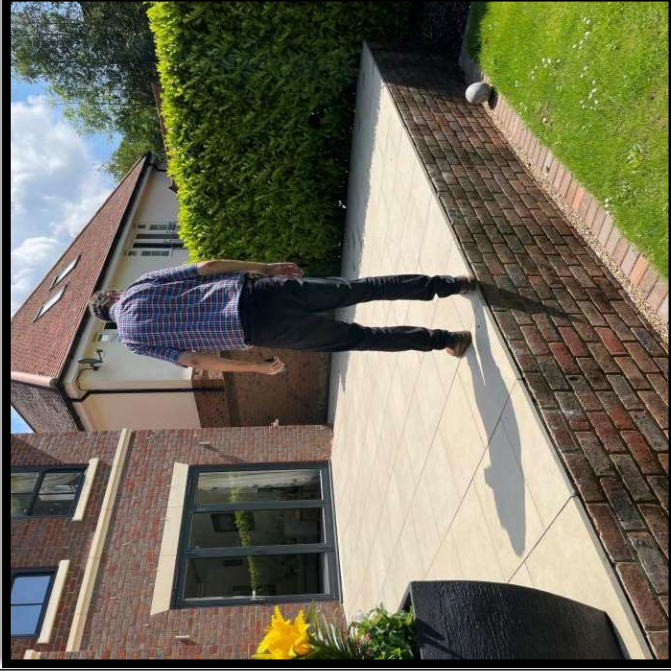
Rear garden patio

The patio at the rear is quite extensive. We noted on the left-hand side of the patio when viewing it from the garden that quite a bit of the pointing is missing between the slabs. Otherwise, the patio appears in reasonable condition.

Also noted that there are unprotected **fall hazards** on the patio and the stairs leading down to the garden which require protective railings/handrail. To prevent trip hazards.

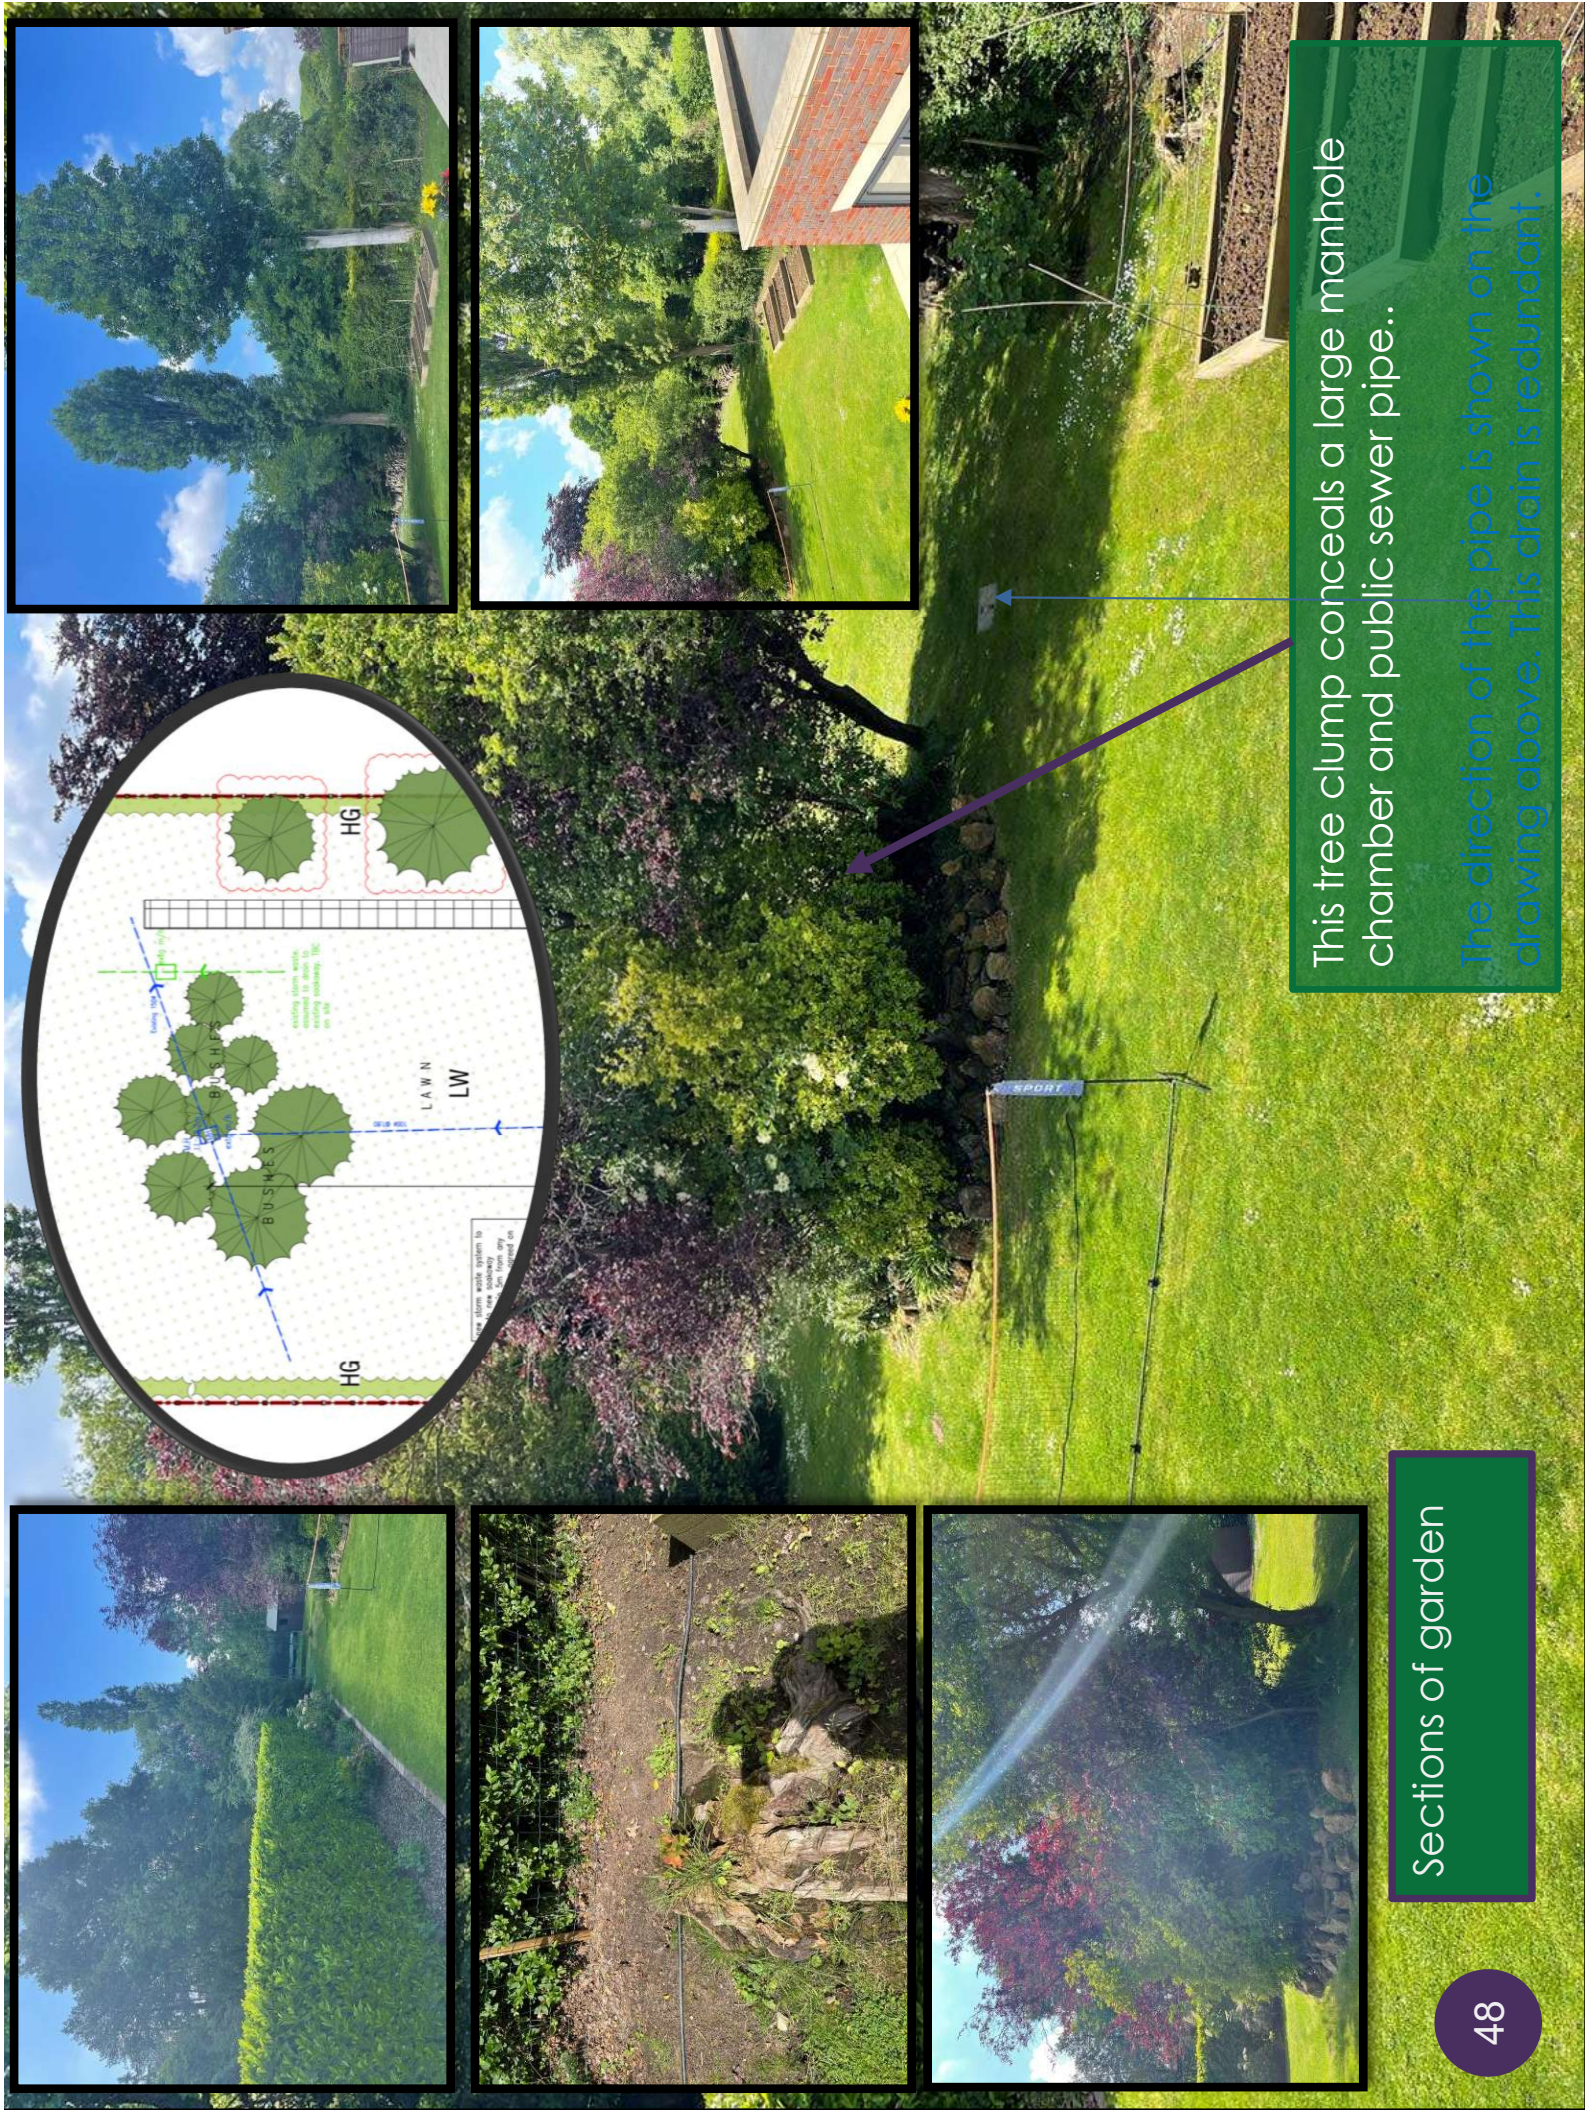
Garden

There is a large substantial garden to the rear. There is a central feature to the garden with the copper beach tree, we noted that there is a very large manhole chamber cover which looks like a public drain.

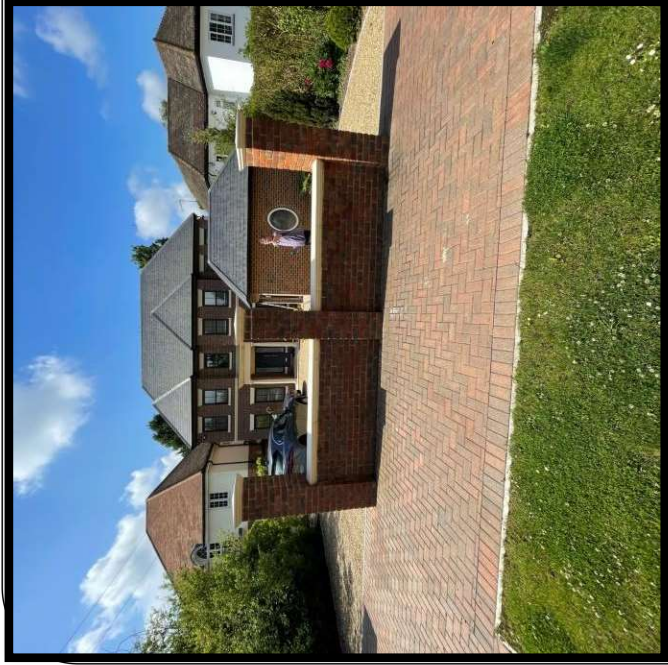
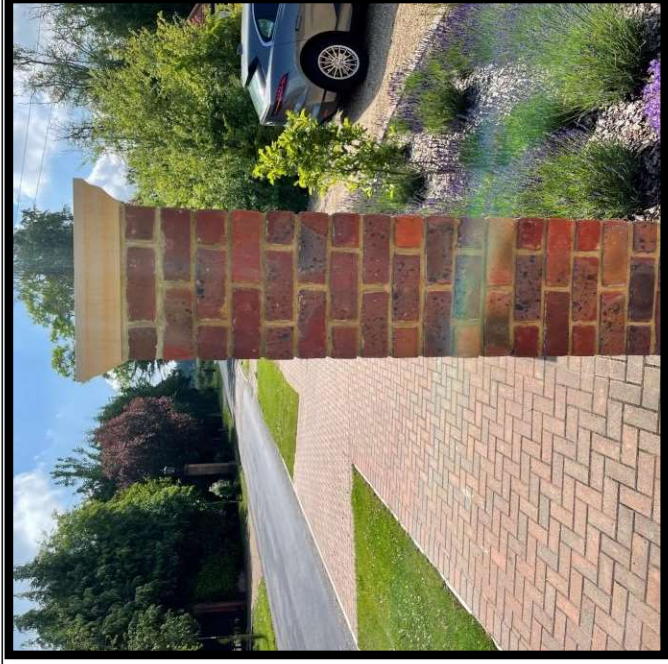
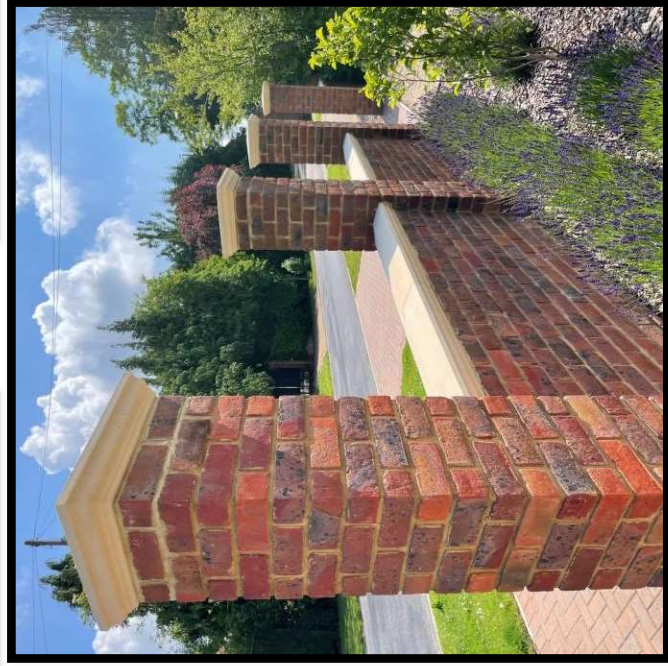
Right-hand side boundary at the front of property

This continuous up to where the neighbour's property and outbuilding where the guttering over-sails the boundary. This continuous all the way up to the back of the garage where then you have a large hedge; it's not exactly clear where the boundary is here. I would say it's the face of the neighbour's garage wall.

The gutter appears to oversail the boundary in this location. Owner is aware of this.

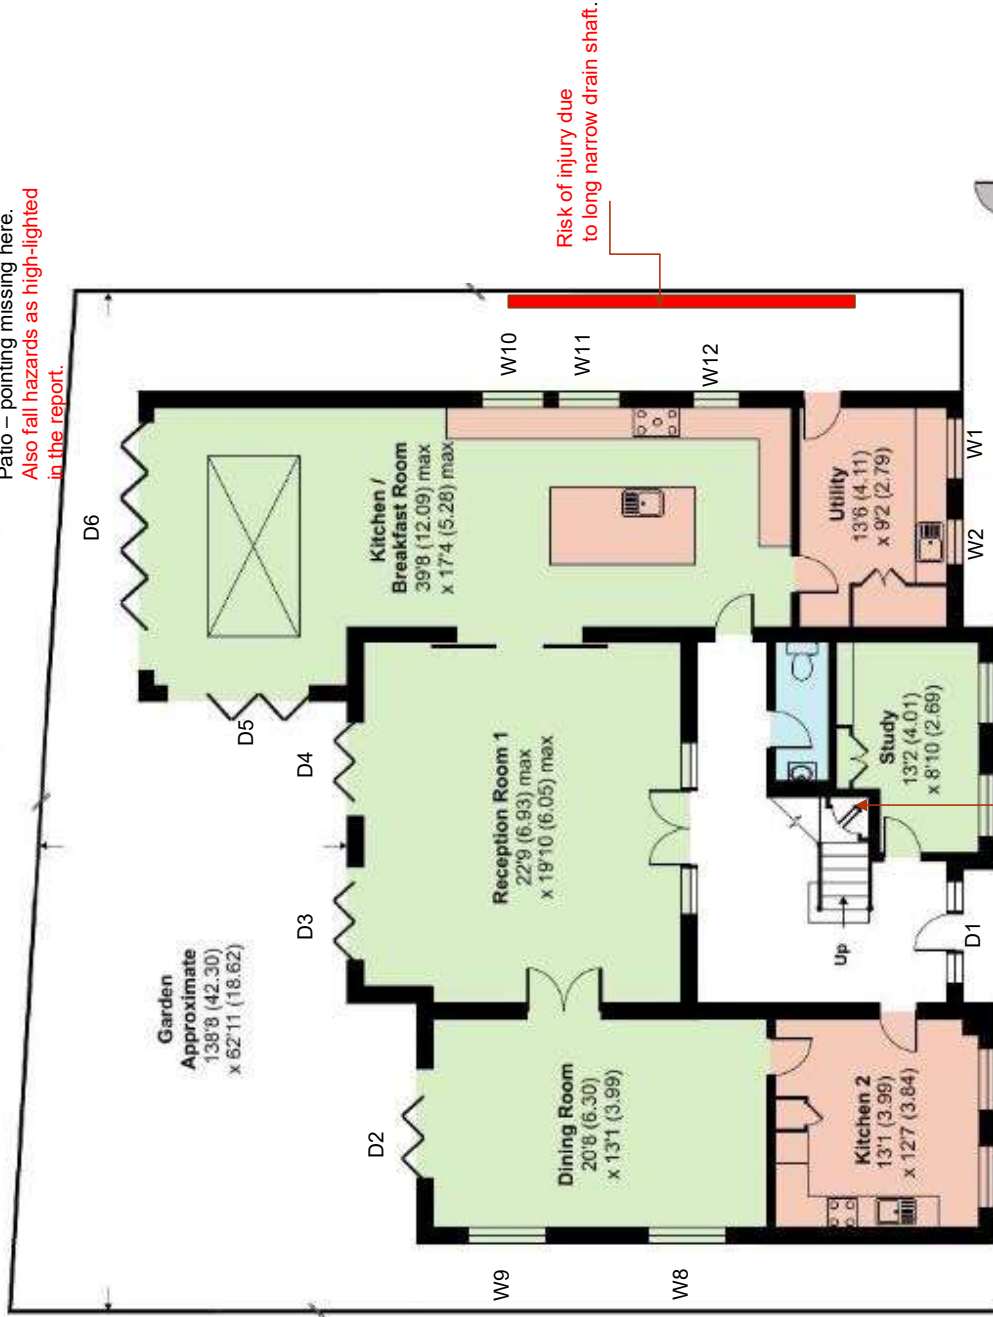
Patio – pointing missing here.
Also fall hazards as high-lighted
in the report.
