SAMPLE REPORT

DETAILED BUILDING SURVEY

INCORPORATING A VISUAL / STRUCTURAL ASSESSMENT OF THE PROPERTY

SECOND FLOOR PLAN:
77 Cadogan Terrace, London, E9 5HP

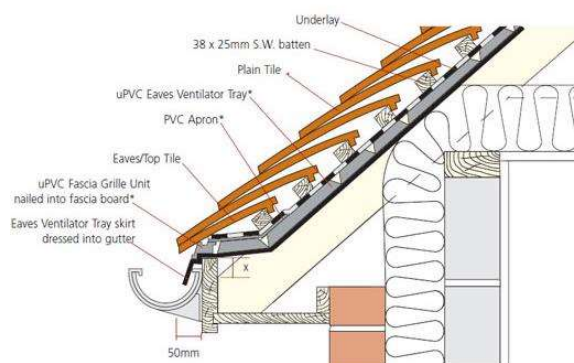
At the rear rainwater pipe and gutters are made of plastic. Gutters are fixed to fascias and downpipes fixed to walls using brackets. They appear to be in reasonably good order no signs of any overflowing or leaking gutters.

No repairs currently necessary, normal maintenance required.

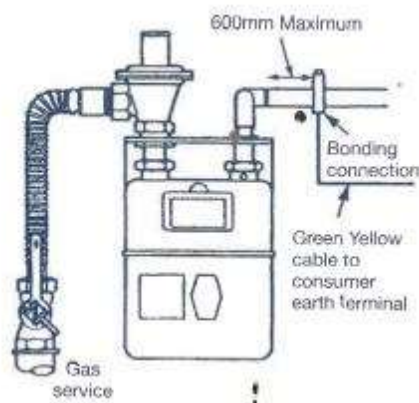
●P46-shows the location of the gas meter. The property is connected to the mains gas supply and the meter is in the lower ground floor cupboard under the external front stairs. The gas meter does not appear to be electrically earth bonded. The service is provided to the kitchen and bathroom.

It appears that the gas installation pipework fitted at your property may not have Electrical Equipotential bonding correctly fitted.

I am required under Section 18(2) of the Gas Safety (Installation and Use) Regulations 1998 to advise you that the Electrical Installation should be checked by a competent electrical contractor.

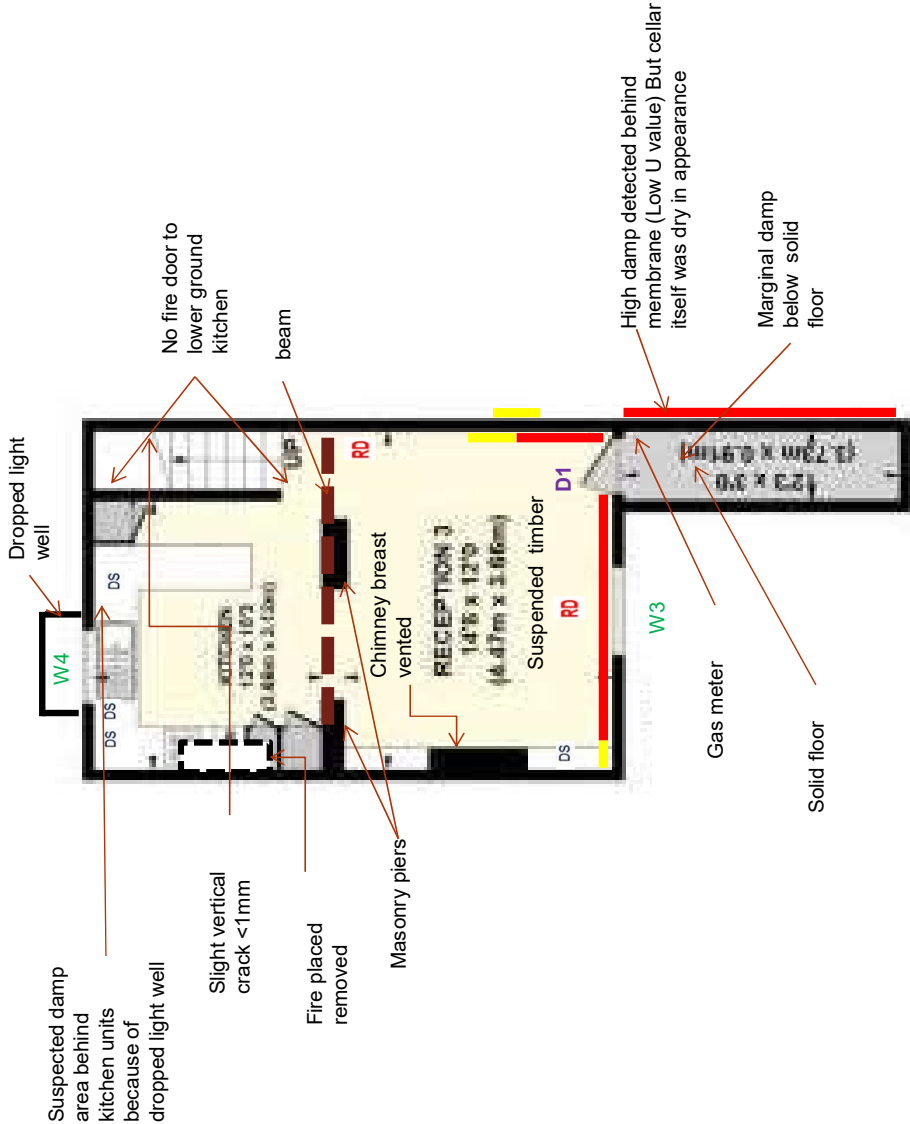
LOWER GROUND FLOOR PLAN:

We noted areas at the front and rear of the property where the ground level is higher than the DPC level. Further investigation we found damp in the lower ground floor can refer to sketch plan attached and further information in the damp section below
