DETAILED BUILDING SURVEY

INCORPORATING A VISUAL / STRUCTURAL ASSESSMENT OF THE PROPERTY

SAMPLE SURVEY

Tayross Associates Limited

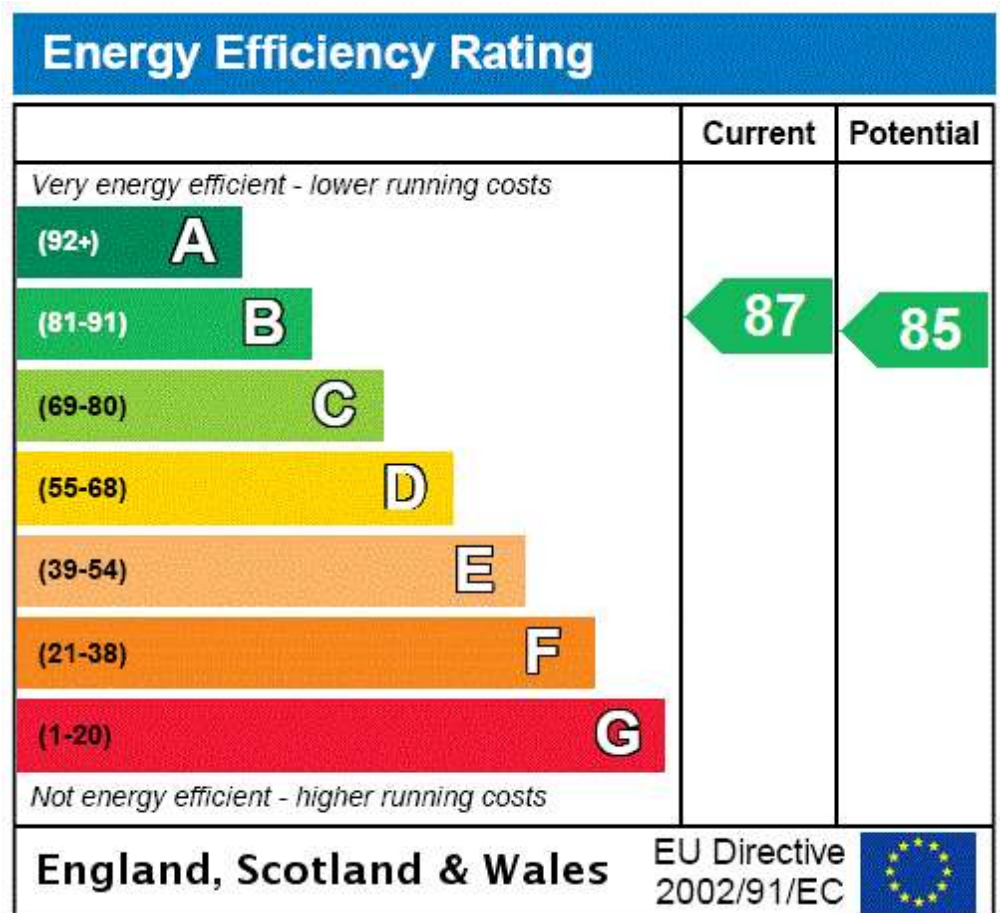
EPC (Energy Performance Certificate):

The EPC for this property (see attached) is in band B87 which is reasonably good.

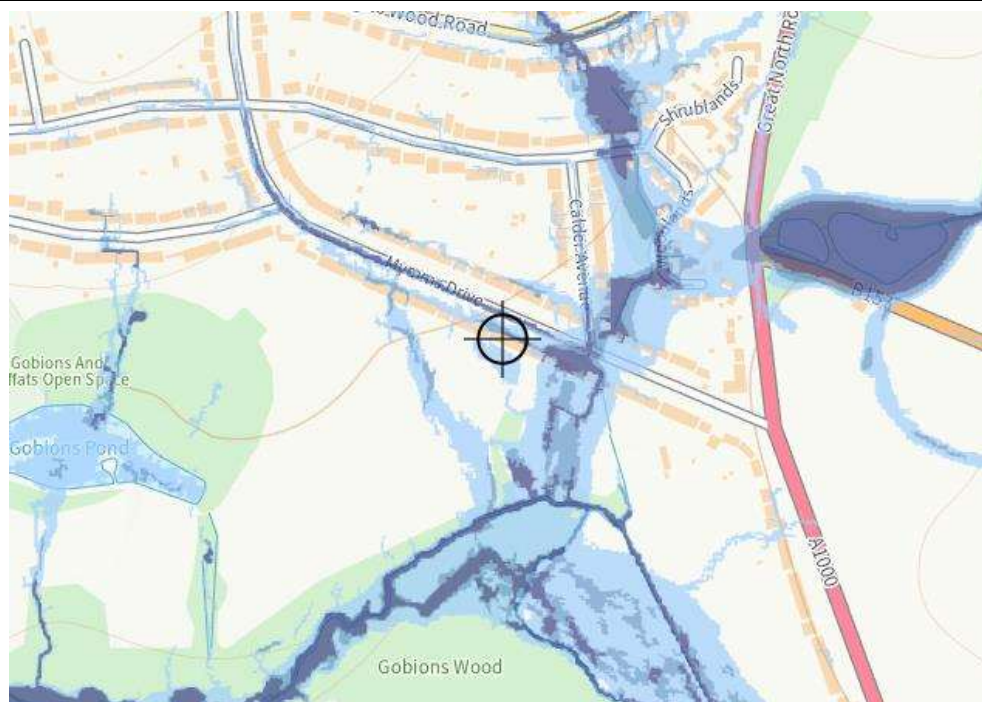
Surface Water;

According to the map below- the property is very close to areas that are at risk from surface water flooding, but not currently within an area at risk.

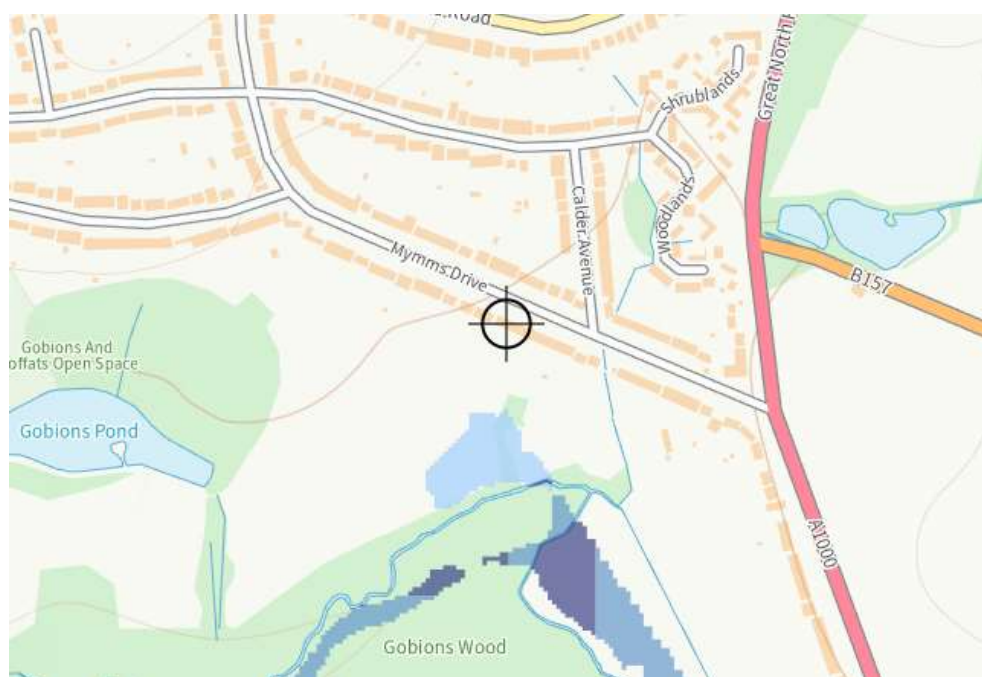
River and the sea;

The property **does not appear to fall within a flood zone** (see map above).

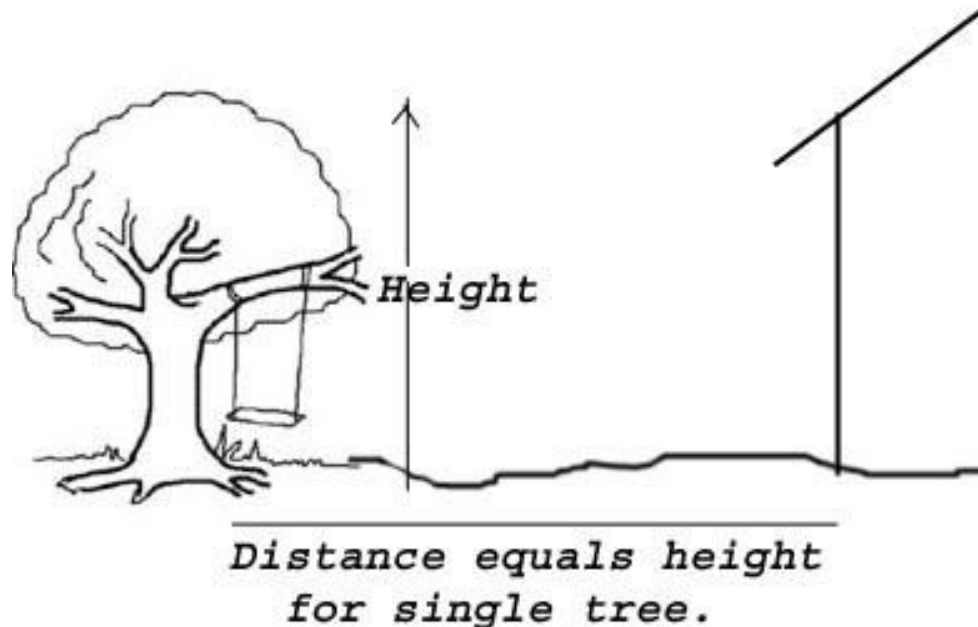
The diagram below is a rule of thumb for safe distance of trees to property without putting the foundations at risk. There are a lot of trees around the property, and I would consult with a tree arborist specialist to come up with a tree management plan.

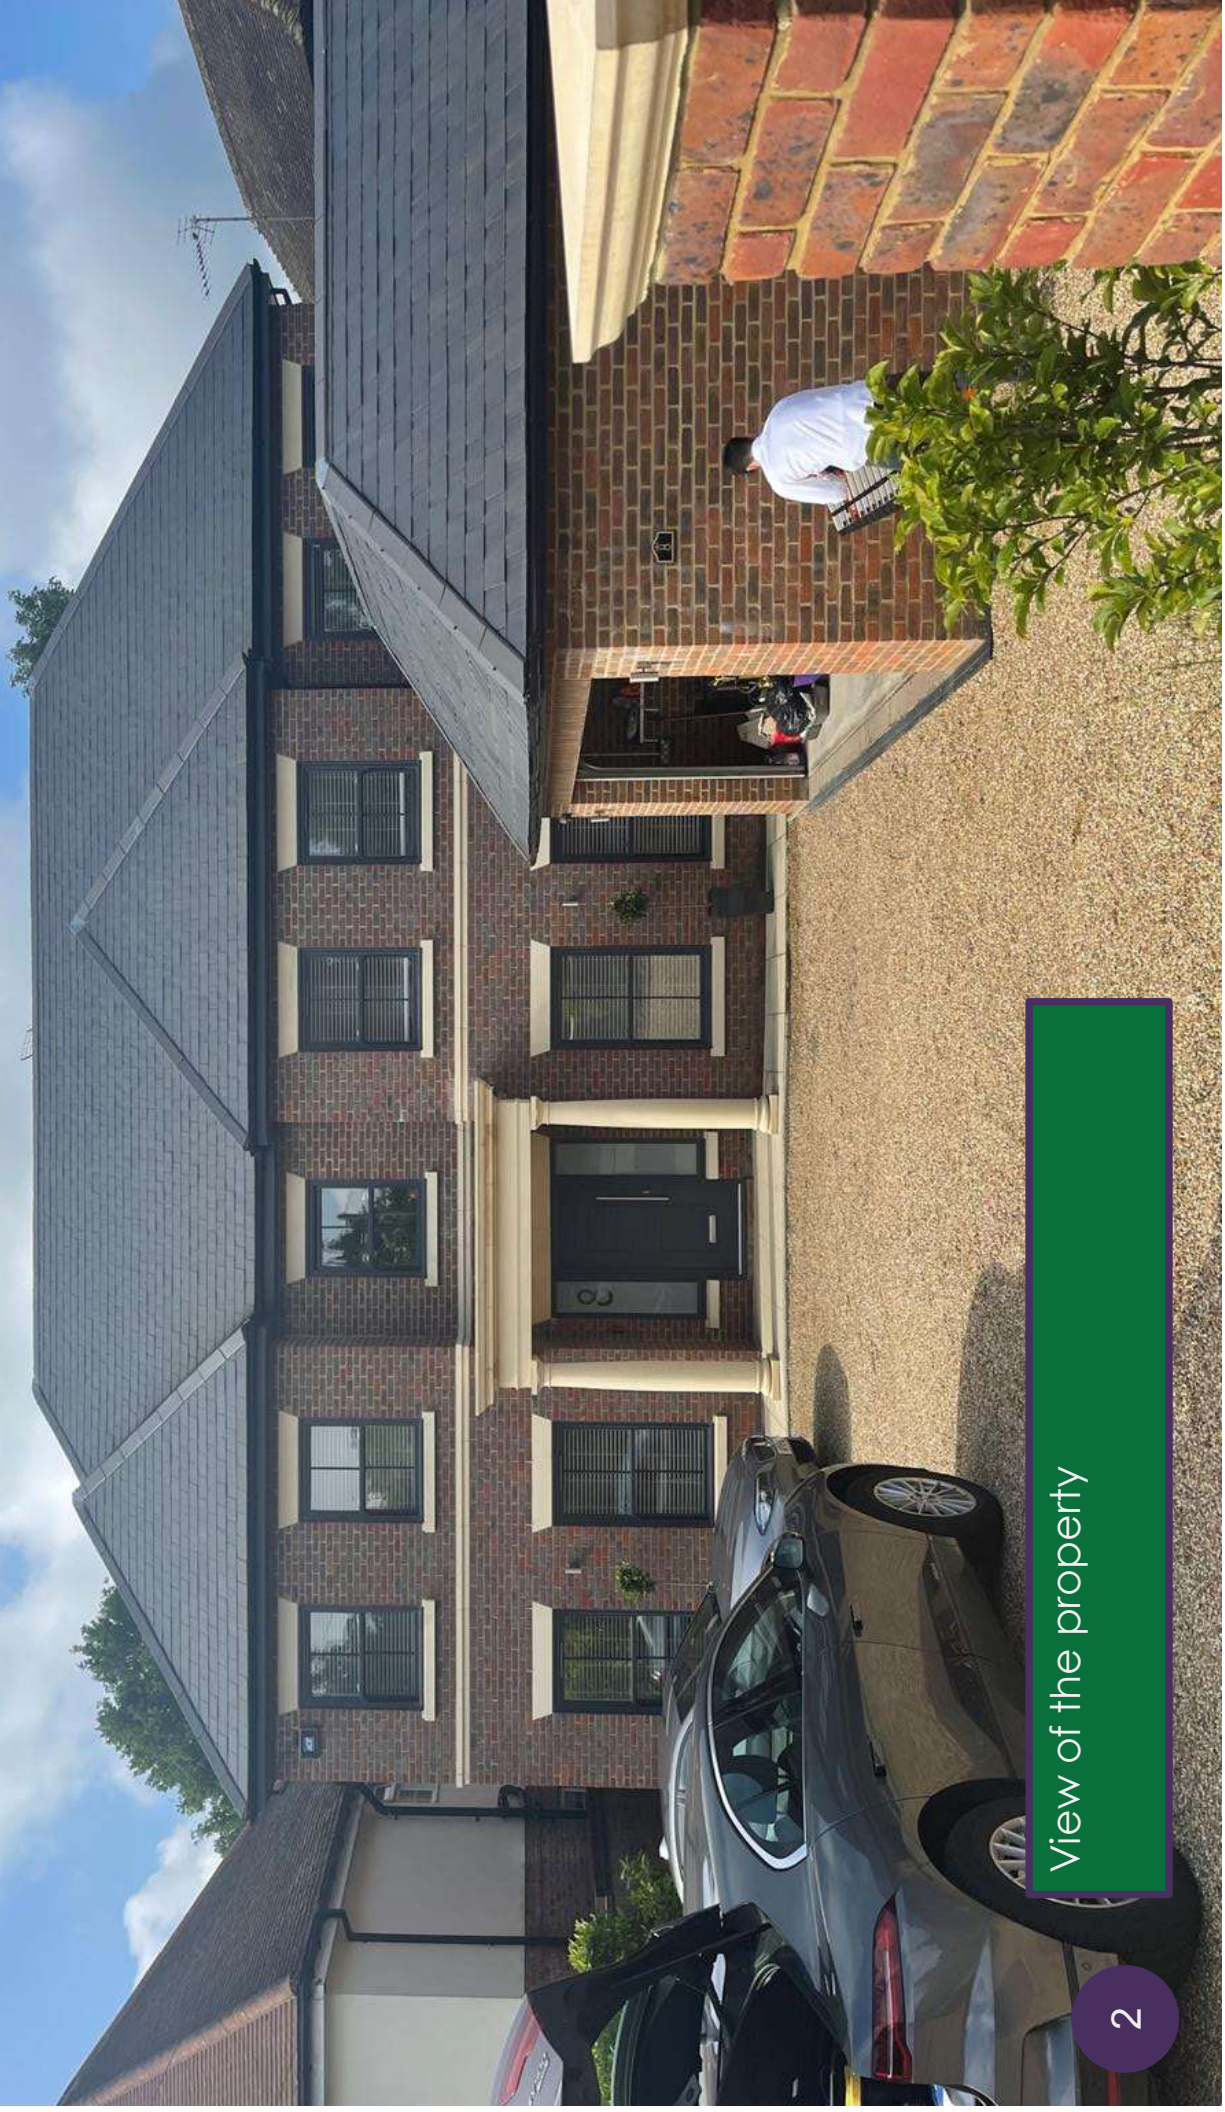
View of the property

Detached three storey
property built in October
2019

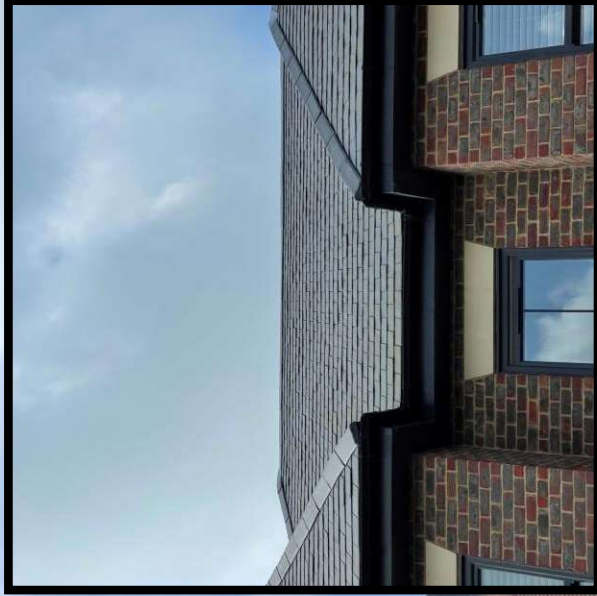
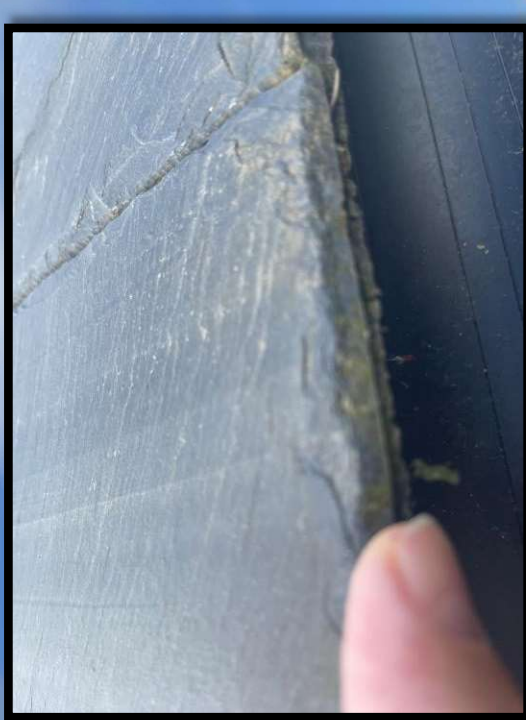
● P02-03 - The covering to the main roof and garage consists of natural riven slates. It appears to me that the slates have not been graded i.e. this is when the slates are measured in thickness heavier slates at the bottom lighter slates a top and this gives a more even appearance. I noted that some of the slates are riding on top of each other this occurs when insufficient gaps are left between the slates i.e. normally should be around 3 mm minimum. This is to allow for an expansion and contraction during hot and cold weathers respectfully. This can in some instances cause the tiles/slates to snap. I did not note any that have but I did note that a few of the slates are riding on top of each other which gives that uneven appearance or exacerbates it.

The covering to the main roof and garage consists of natural riven slates. It appears to me that the slates have not been graded i.e. this is when the slates are measured in thickness heavier slates at the bottom lighter slates a top and this gives a more even appearance. I noted that some of the slates are riding on top of each other this occurs when insufficient gaps are left between the slates i.e. normally should be around 3 mm minimum. This is to allow for an expansion and contraction during hot and cold weathers respectfully. This can in some instances cause the tiles/slates to snap I did not note any that have but I did know that a few of the slates are riding on top of each other which gives that uneven appearance or exacerbates it.

As stated above slate covering have not been graded pre-fixing and gaps have not been left between the individual slates-this can cause slates to crack during very hot and cold weather. There are no indications on my inspection that any previous slates have cracked or been replaced normally one would be able to spot this.

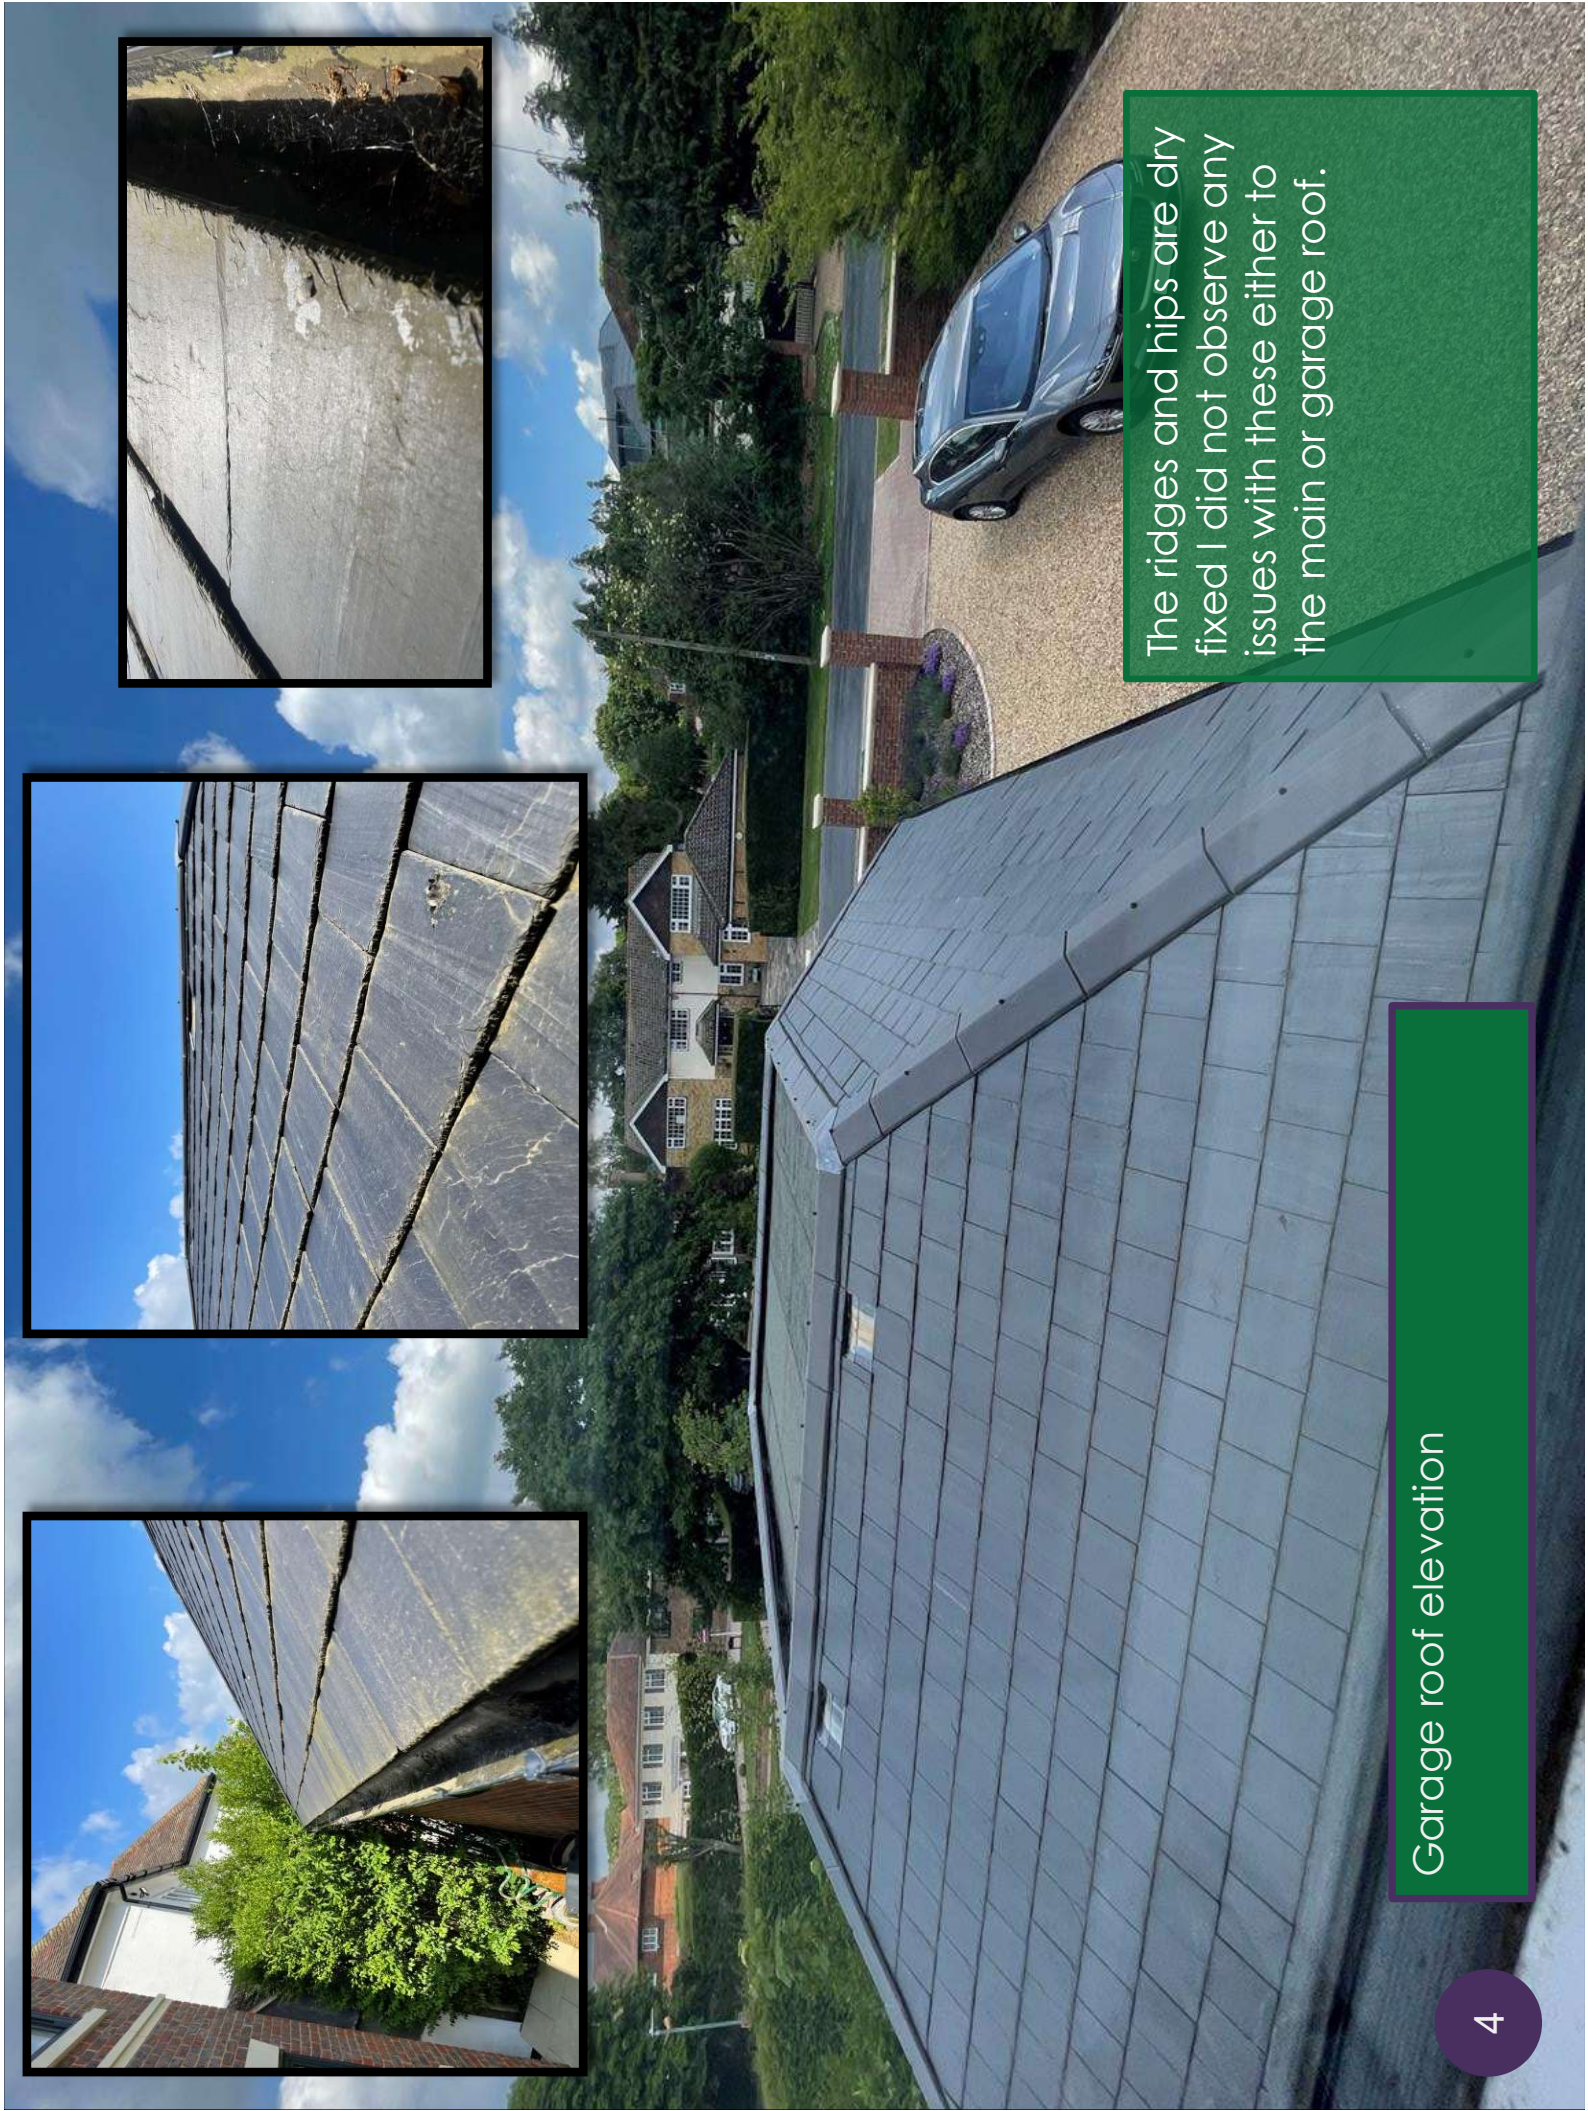
Roof front elevation

The ridges and hips are dry fixed I did not observe any issues with these either to the main or garage roof.

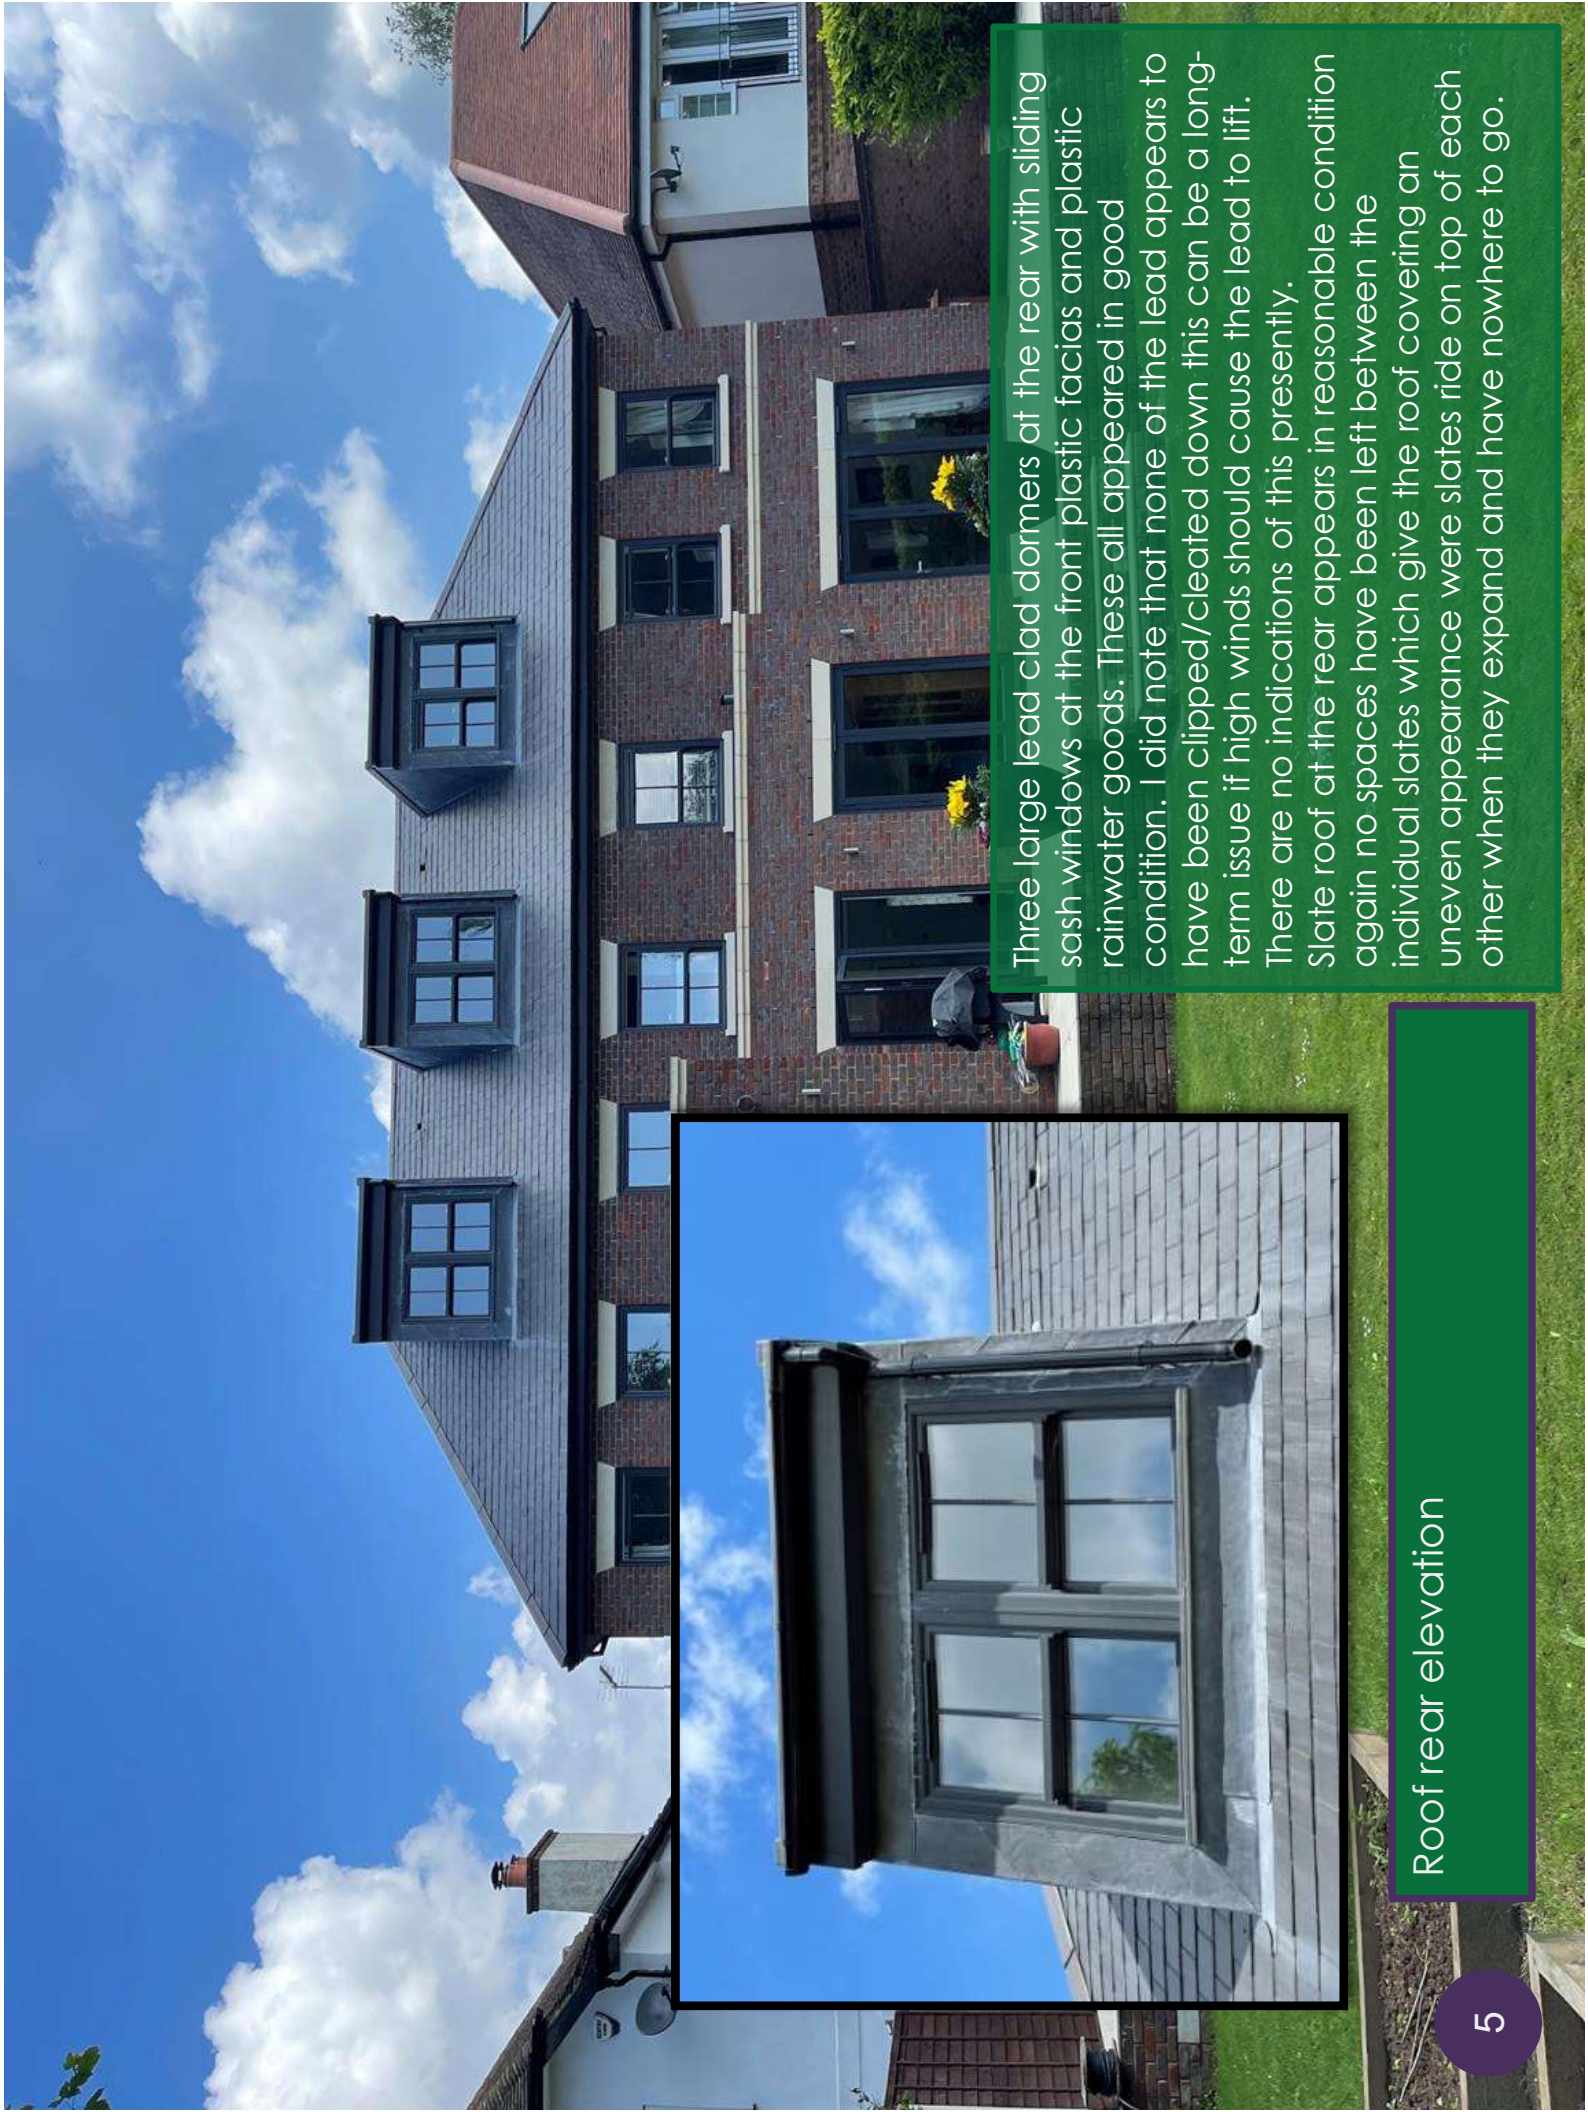
Garage roof elevation

● P03 - Three large lead clad dormers at the rear with sliding sash windows at the front plastic facias and plastic rainwater goods. These all appeared in good condition. I did note that none of the lead appears to have been clipped/cleated down this can be a long-term issue if high winds should cause the lead to lift. There are no indications of this presently.

● P03 - Slate roof at the rear appears in reasonable condition again no spaces have been left between the individual slates which give the roof covering an uneven appearance were slates ride on top of each other when they expand and have nowhere to go.

Three large lead clad dormers at the rear with sliding sash windows at the front plastic fascias and plastic rainwater goods. These all appeared in good condition. I did note that none of the lead appears to have been clipped/cleated down this can be a long-term issue if high winds should cause the lead to lift. There are no indications of this presently. Slate roof at the rear appears in reasonable condition again no spaces have been left between the individual slates which give the roof covering an uneven appearance were slates ride on top of each other when they expand and have nowhere to go.

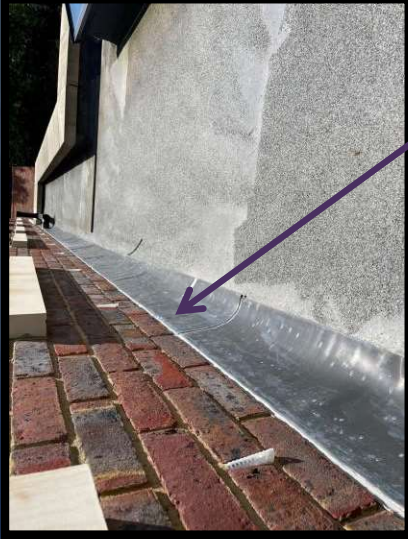
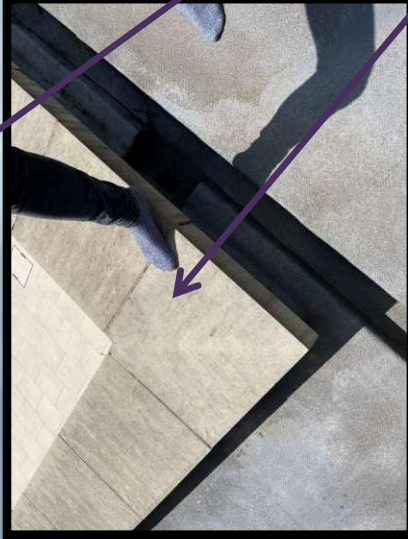
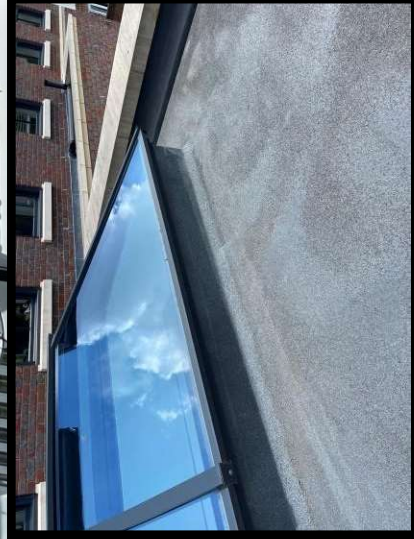
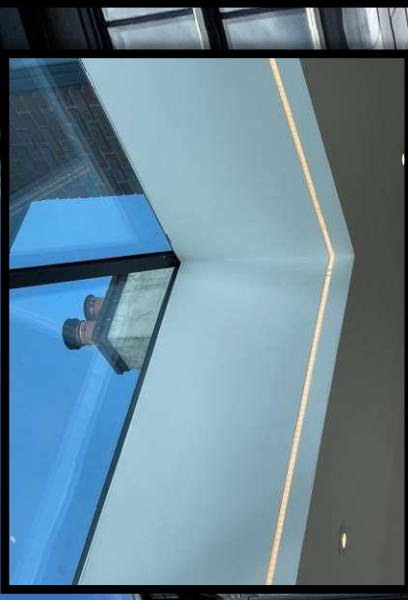
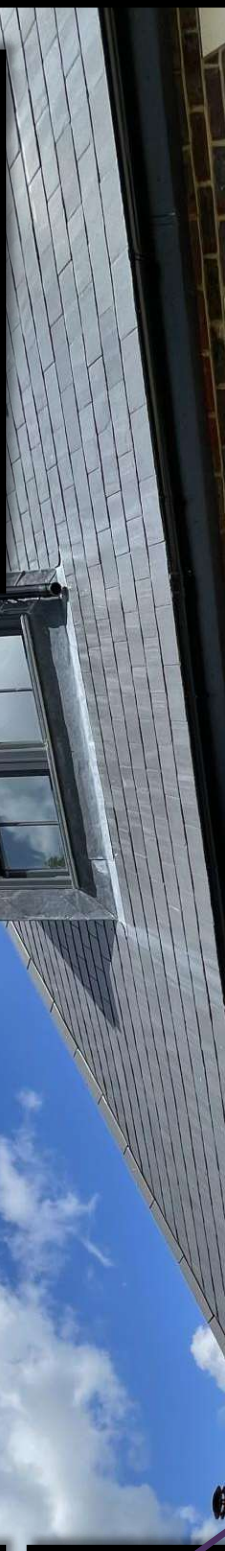
Roof rear elevation

● P06 - We noted that there is an issue with the coping stones, one of these is loose on the corner refer to photograph. This will need re-pointing.

This consists of a GRP roof which has added grit particles on top, I presume this gives some extra protection to the roof and also makes the roof less treacherous during frosty weather.

There is a large glazed lantern light on top of the roof – this doesn't have any ventilation which will make the areas underneath quite hot in summer and possibly cold draughts in winter. We noted that there is an issue with the coping stones, one of these is loose on the corner refer to photograph. This will need re-pointing.

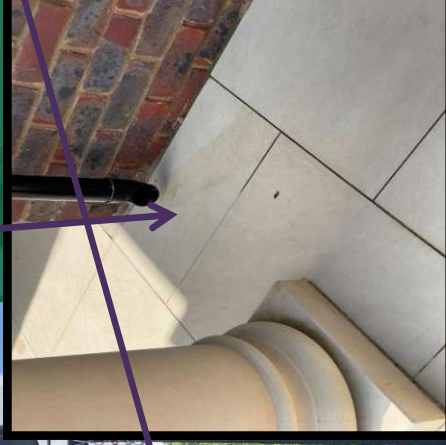
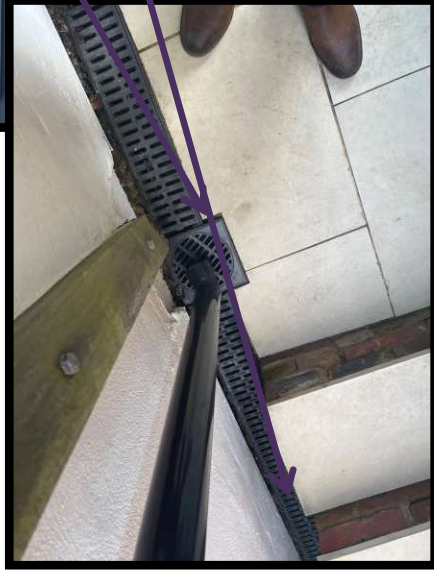
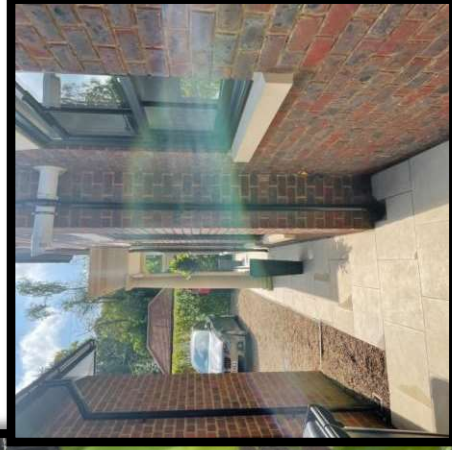
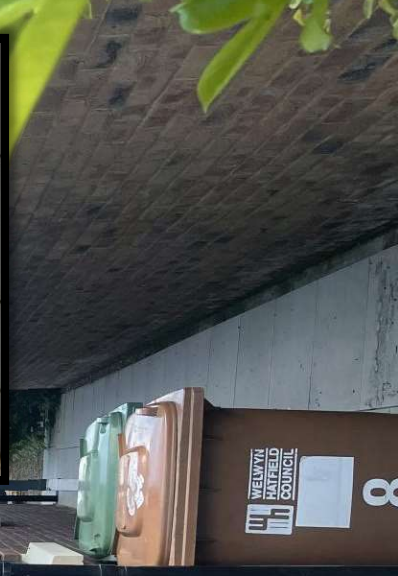
Rainwater fittings

P08 - We noted that the rainwater pipe for the porch roof discharges onto the paved area at the front of the property. This has caused staining to the paving.

● P08 - We noted that the garage of the neighbour's property downpipe drains onto your property-Side passageway on the right-hand side when viewed from the road. I spoke to the seller about this and he said it has always been like that and there are no current disputes with the neighbour-he stated that he had added a drainage channel to take the rainwater. We did note that there is a large narrow drop beside this garage which could be a foot/leg/fall trap and could be hazardous during icy slippery weather. I would advise closing this gap down to prevent risk of injury.

Further downpipe on the left-hand side for the main roof this appears in good condition and discharges to the front left-hand corner there is also rainwater pipe to the back left-hand corner.

We noted that the garage of the neighbour's property downpipe drains onto your property. Also a foot trap here.

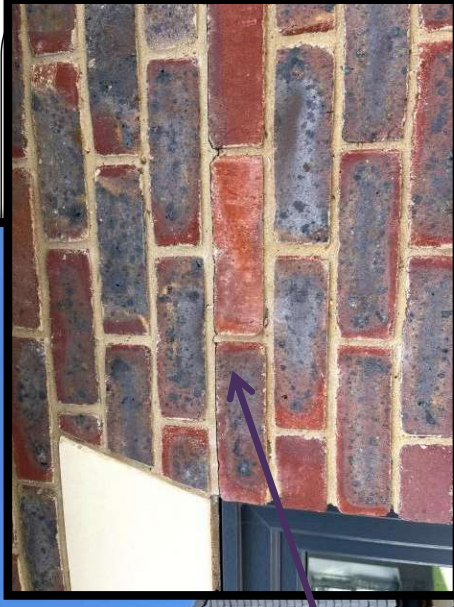
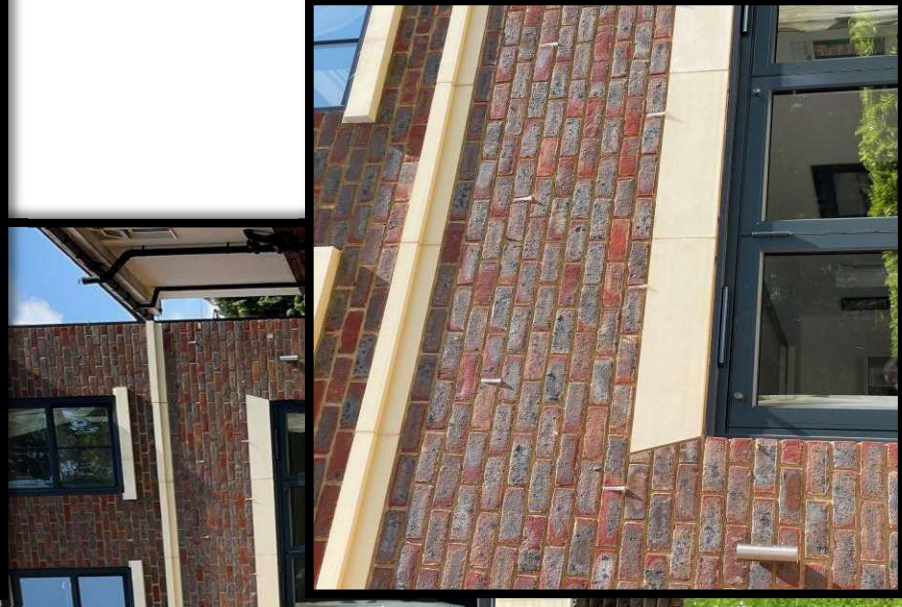
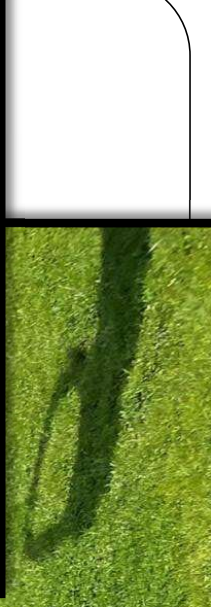
External walls rear elevation

I did note that quite a lot of the weep holes have been removed.

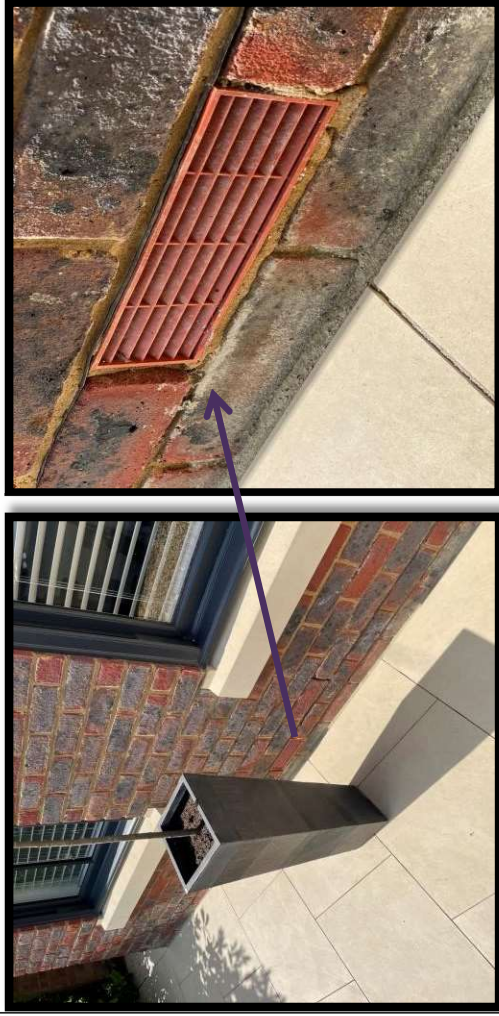
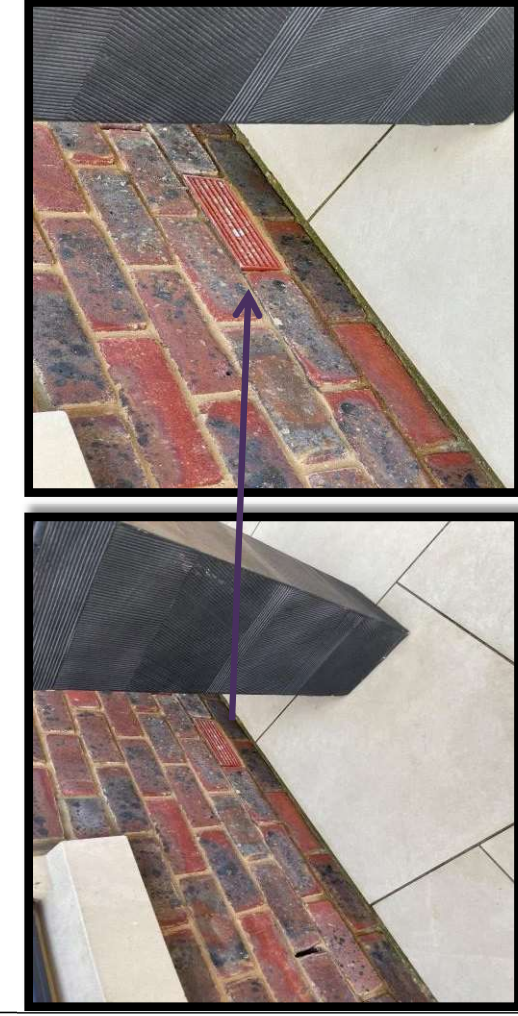
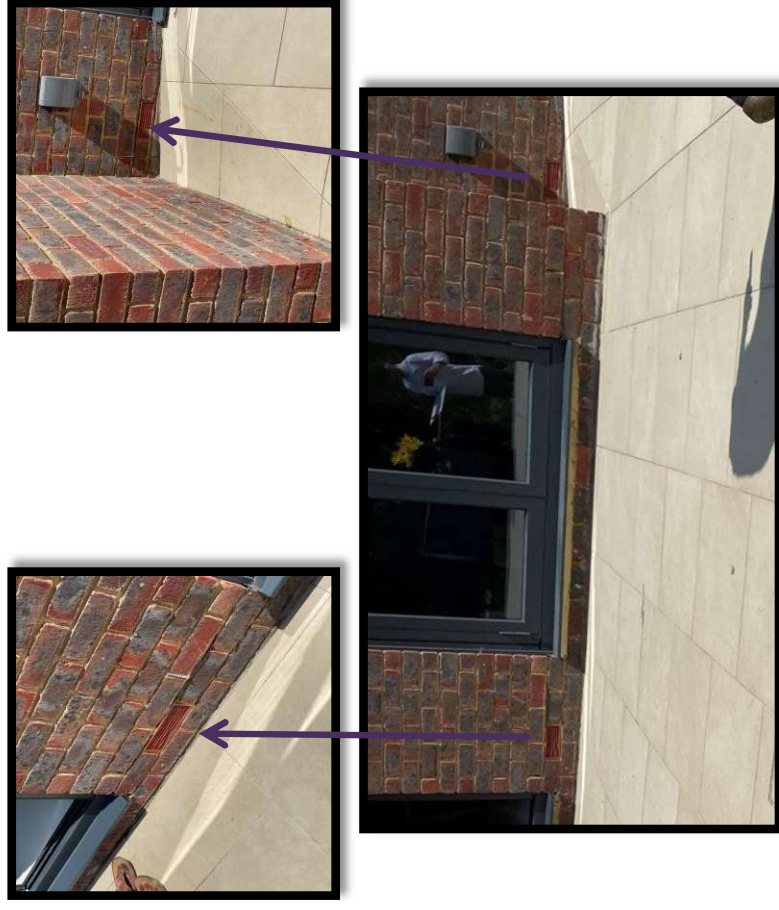
Air bricks located around the property

Position of vent bricks.

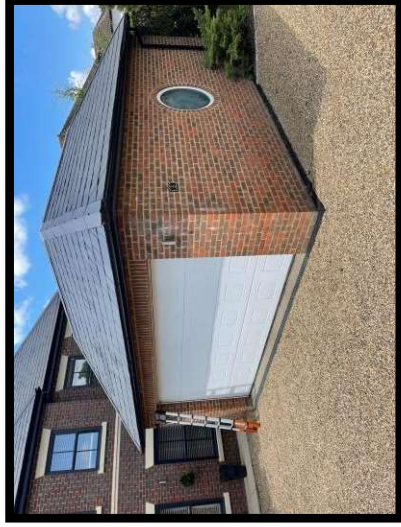
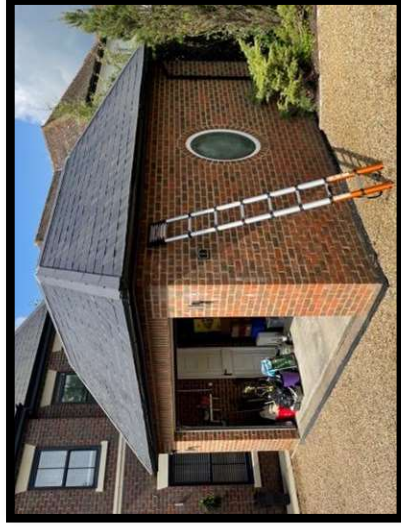
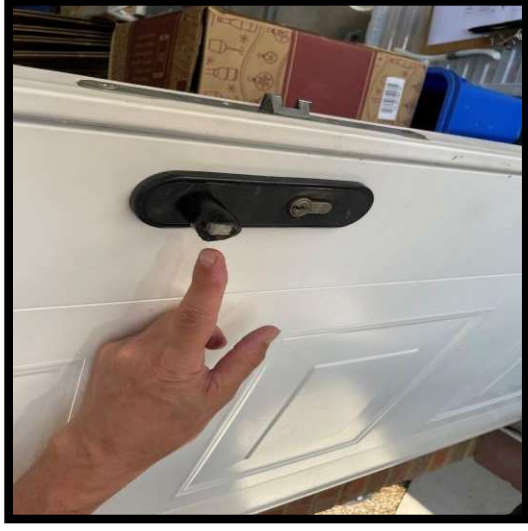
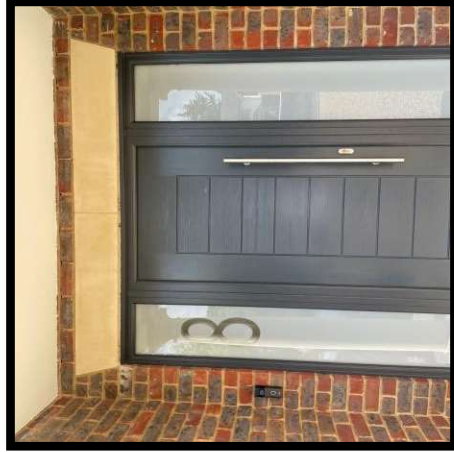
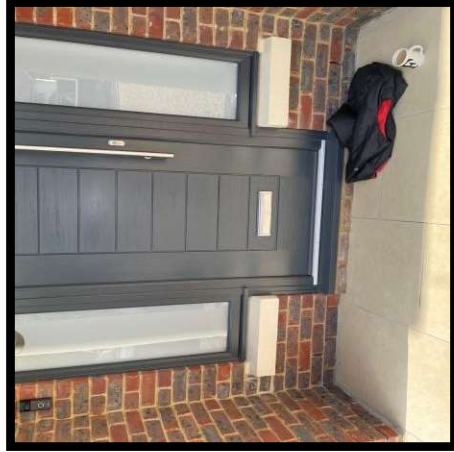
Front door and garage doors

Front door consists of a UPVC composite material with frosted double glazed units either side. Door appears in good condition. We noted that the metal door into the side of the garage the external handle here has snapped and broken.

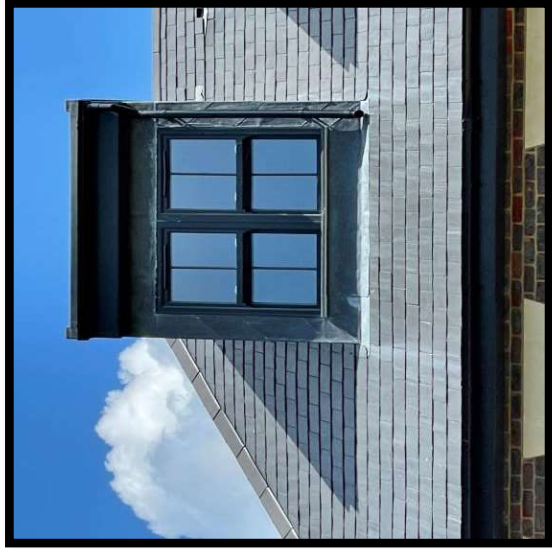
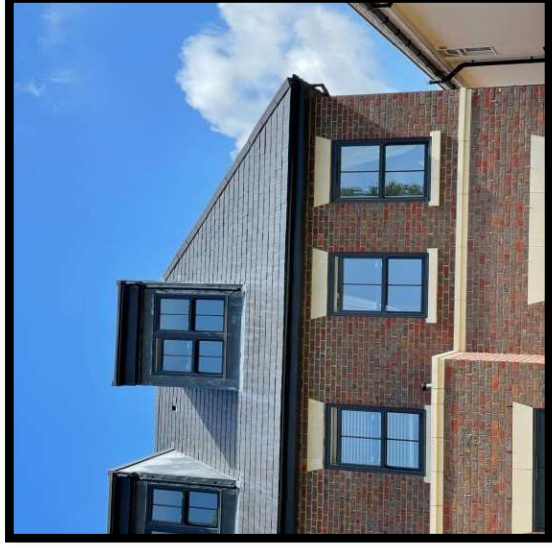
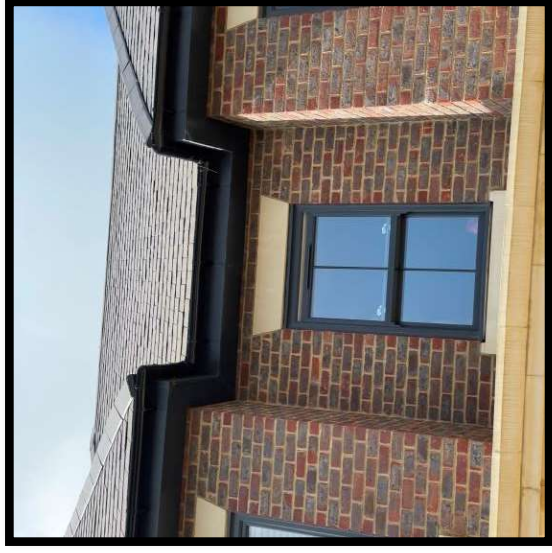
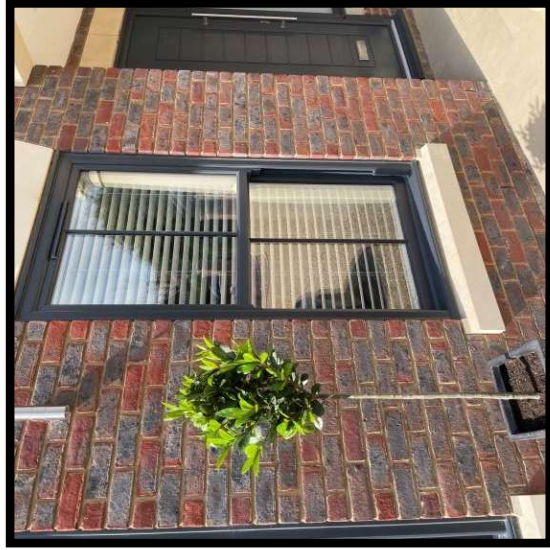
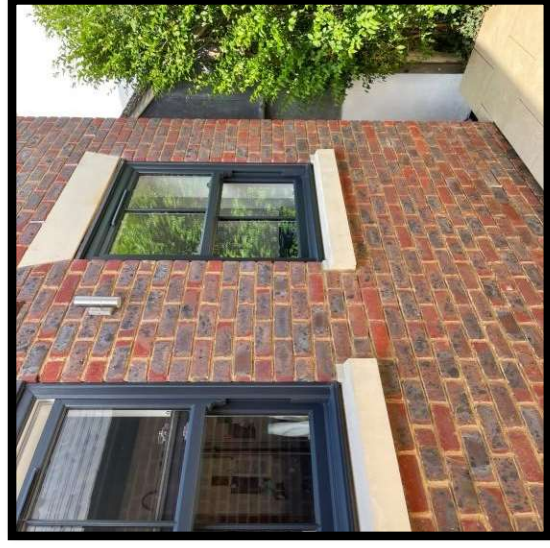
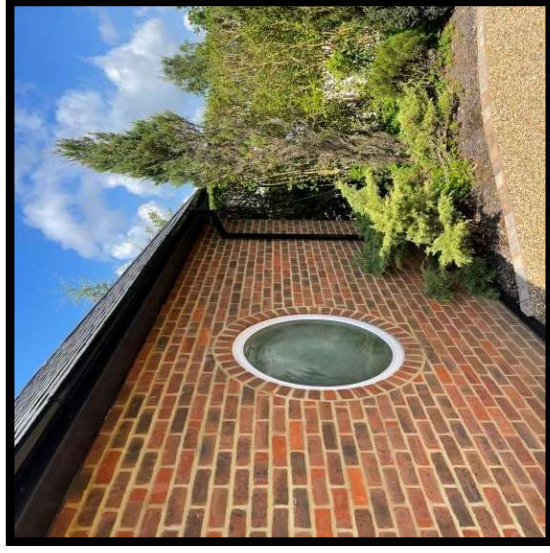
Windows viewed around the property

Windows at the front of the property consist of sliding sash UPVC dark anthracite grey double glazed units. Windows appear in good condition. Windows are fitted with trickle ventilation.
