DETAILED BUILDING SURVEY

INCORPORATING A VISUAL / STRUCTURAL ASSESSMENT OF THE PROPERTY

SAMPLE SURVEY

Tayross Associates Limited

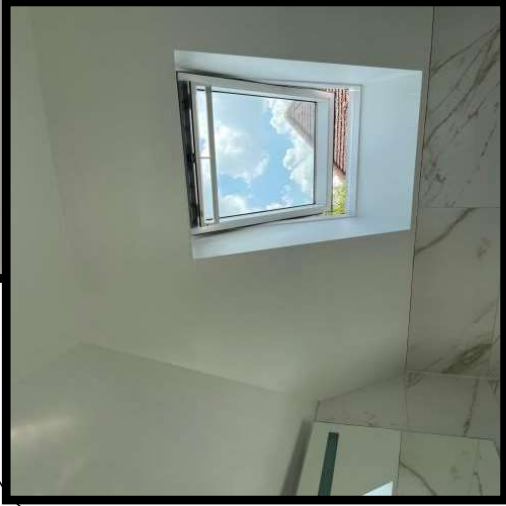
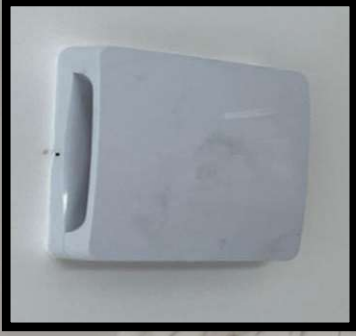
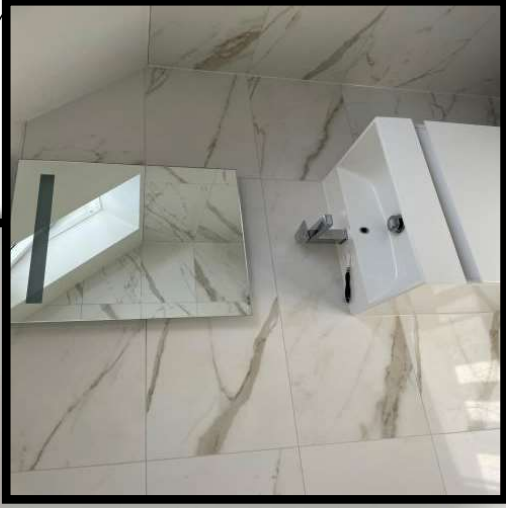
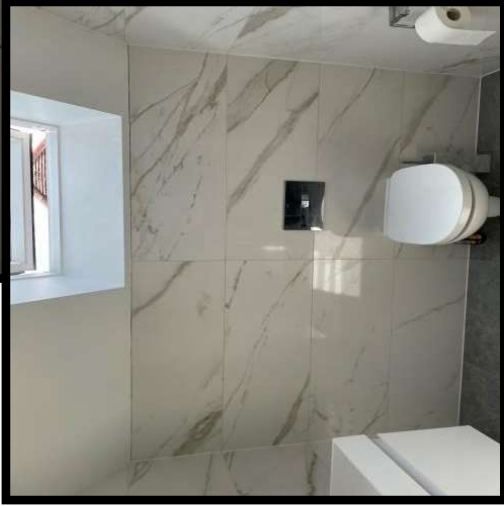
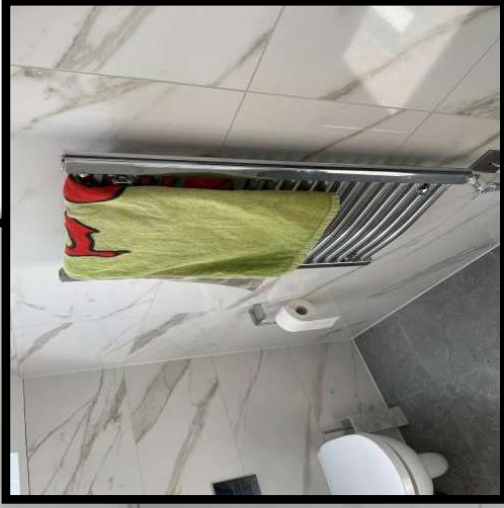
Bathroom 3 En Suite

White painted angled ceiling with down lighters and extractor.
Stone tiles to walls all appeared in good condition.
Large stone tile floors all appeared in good condition.
Low energy down lighters all appear to be working.
The water pressures appeared good to the sanitary ware generally.
Low-level entry shower with clear screen – the screen was very shaky, needs a brace to hold it more firmly.

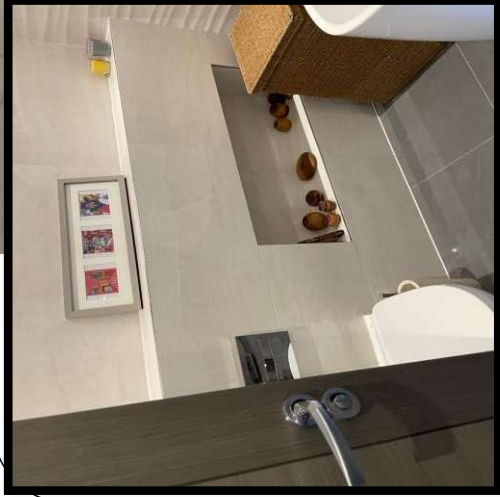
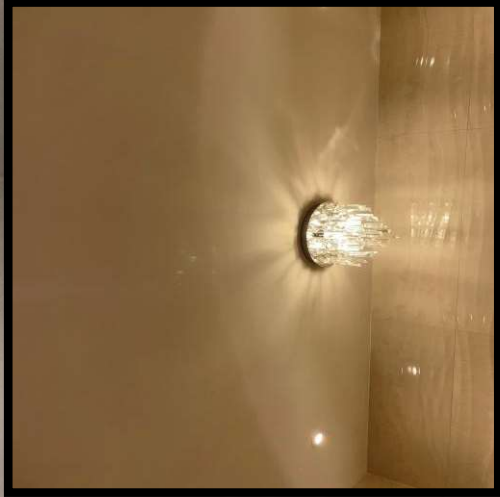
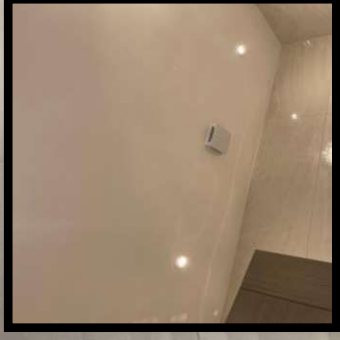
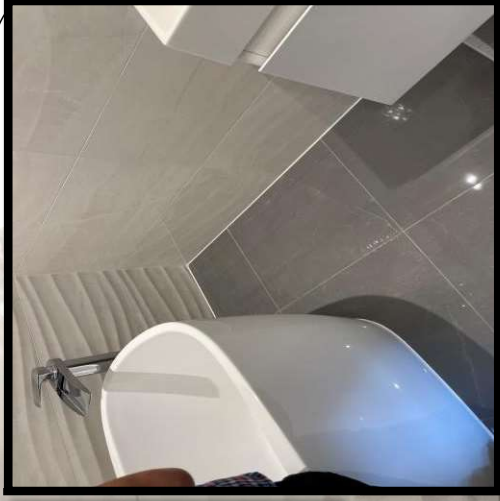
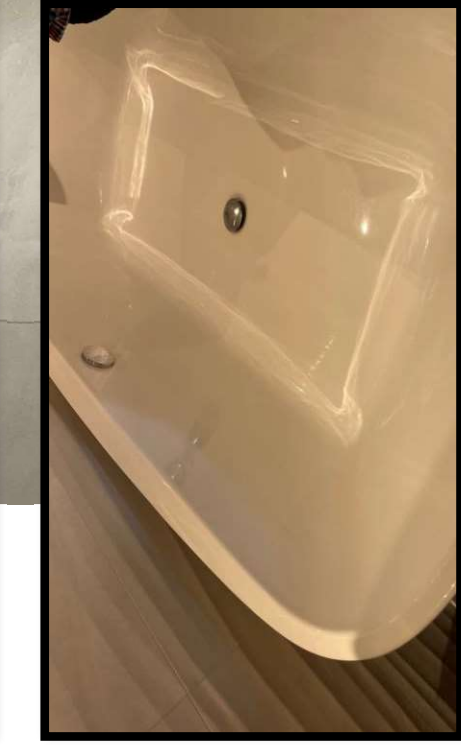
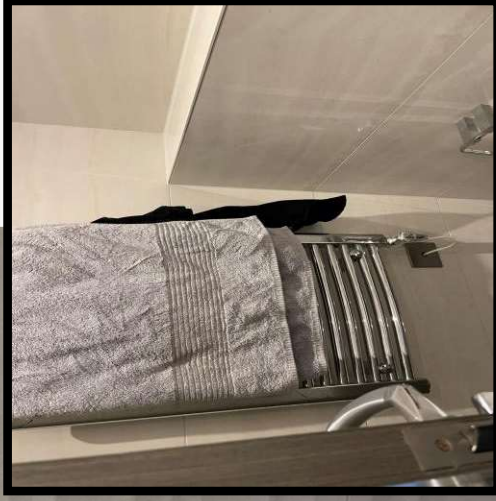
White painted ceilings with down lighters, all in good condition and working order. Full height tiled walls all in good condition. Fully stone tiled floor with level entry shower all in good condition, I see that the shower screen does have a stabiliser unlike bedroom 3 En Suite. All in good condition, there are blinds in the front of the windows; need to enquire if these are included in the scale. Room stat fitted on the wall for the underfloor heating. Lights all operational including central feature light fitting.

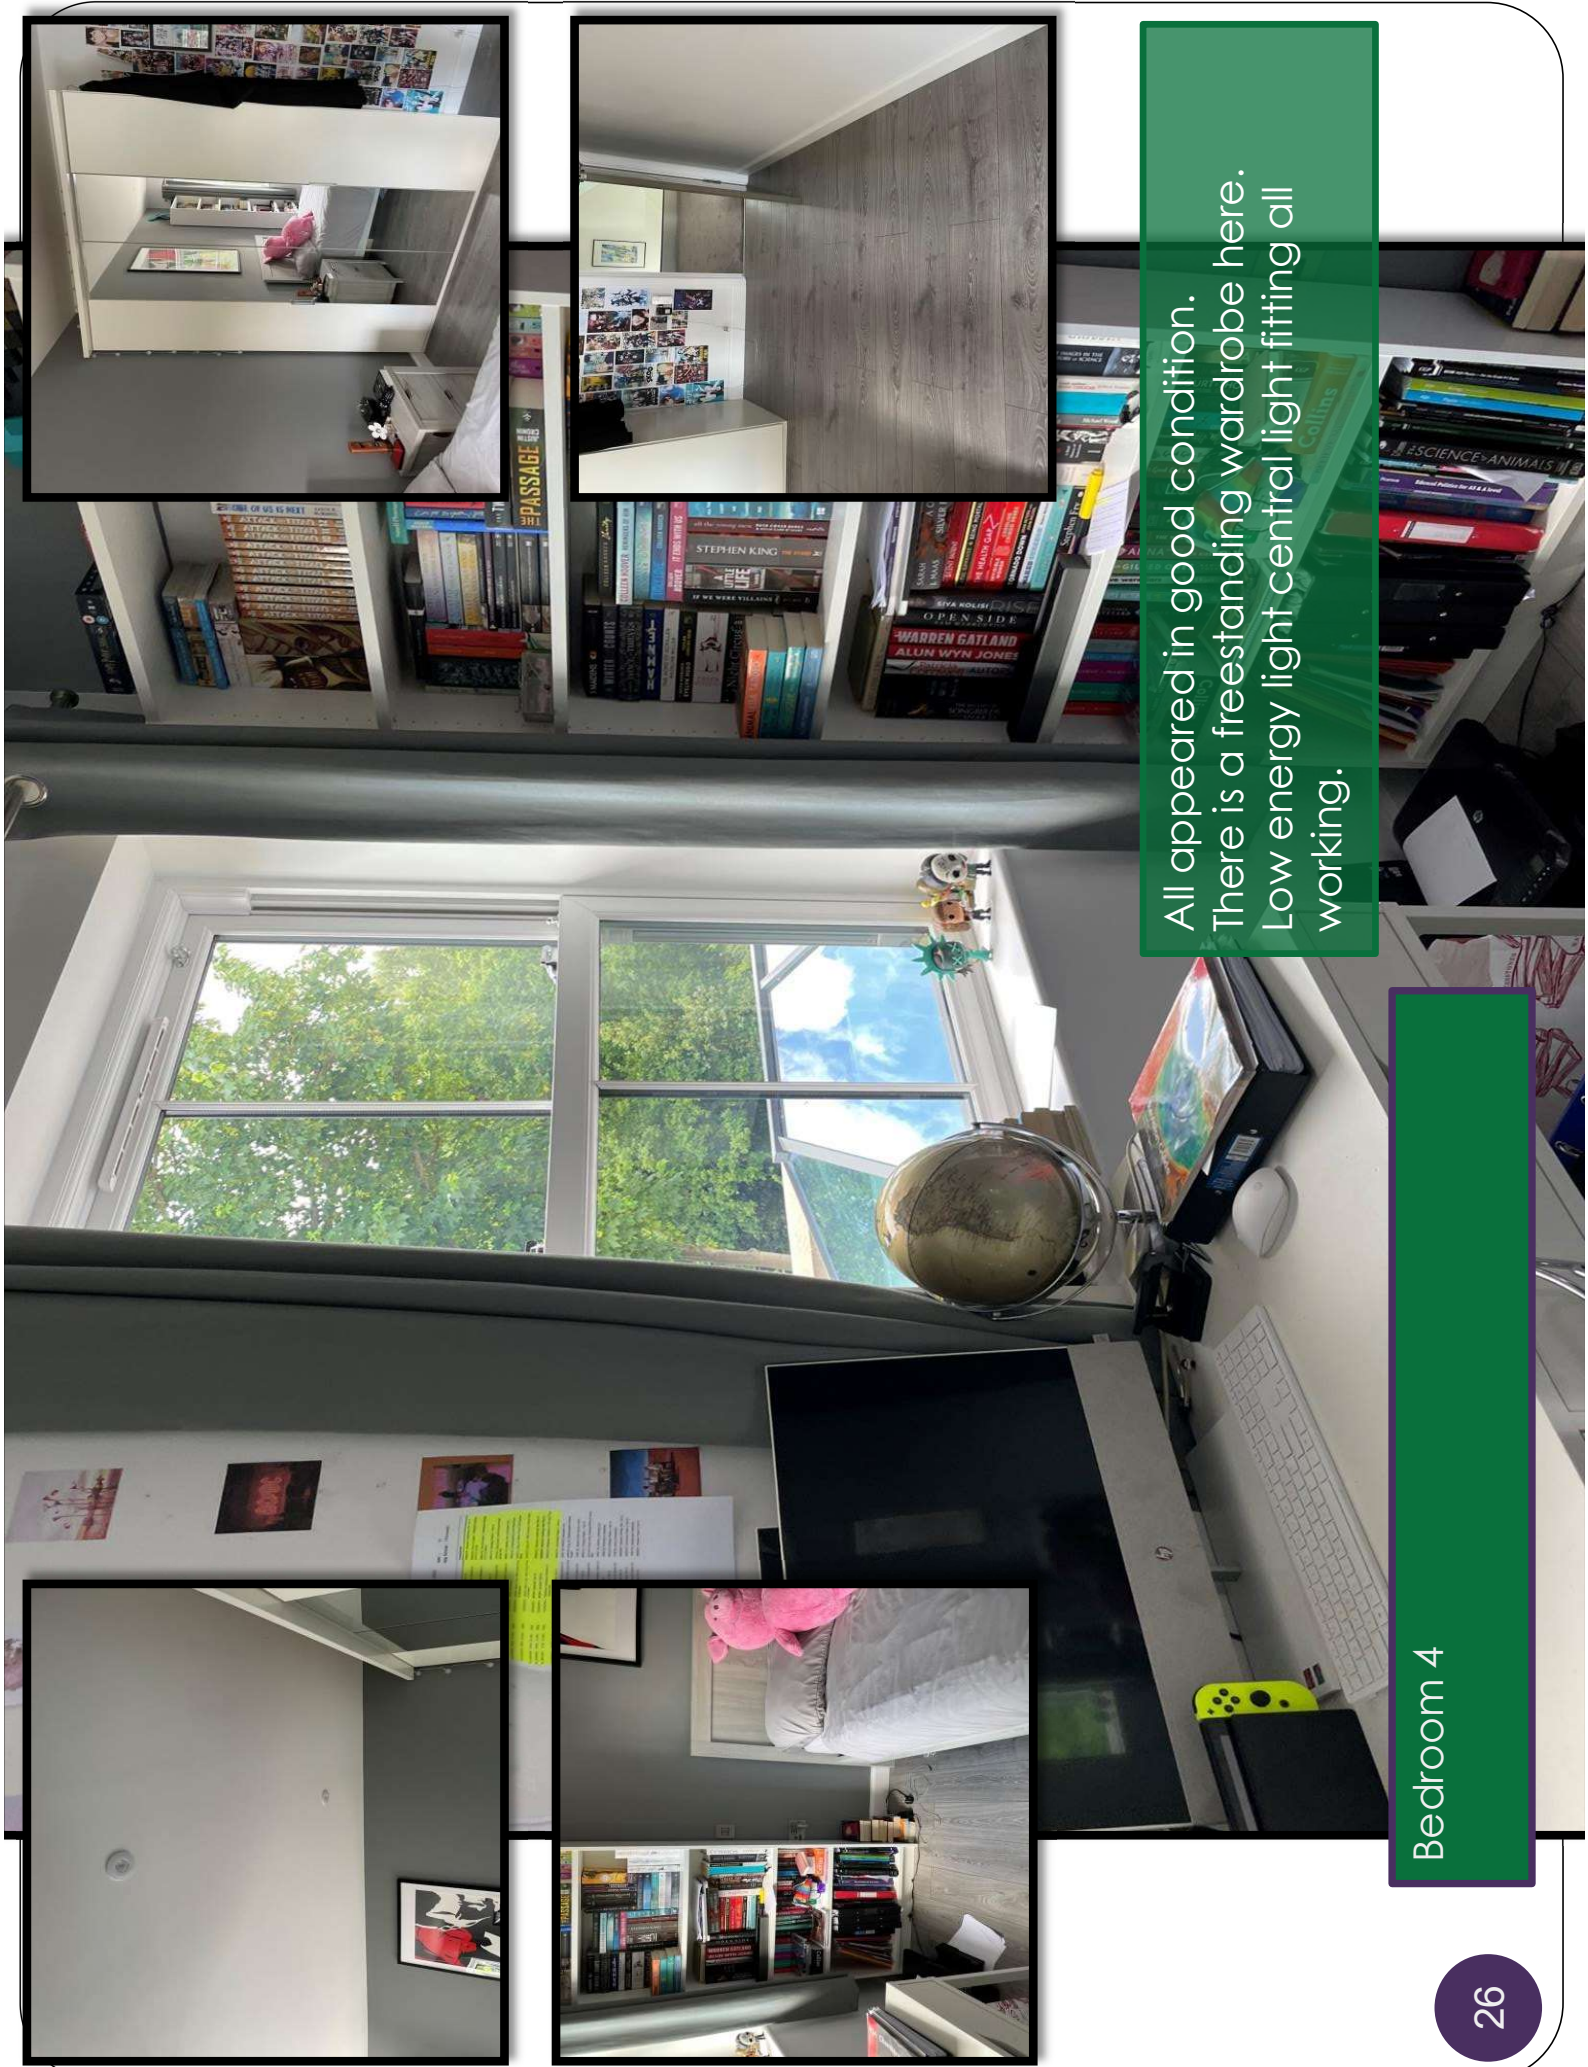
Main bathroom

White painted ceilings with down lighters and extractor and chandelier over bath. All appeared in good condition.

Full height tiled walls, all in good condition.

Fully tiled floors, all in good condition.

Door into bathroom in good condition.

Sanitary ware all appeared in good condition.

Towel radiator appears to be electric, the rubber grommet is missing between the cable and the face.

Sanitary ware appeared in good condition, there is a resin bath with floor standing mixer disappeared firmly fixed to the floor.

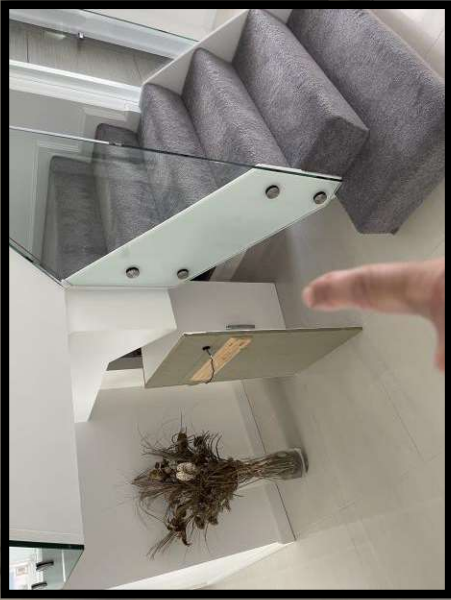
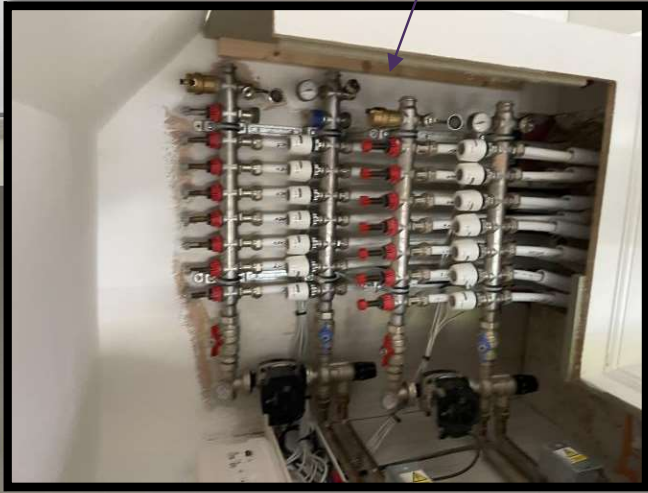
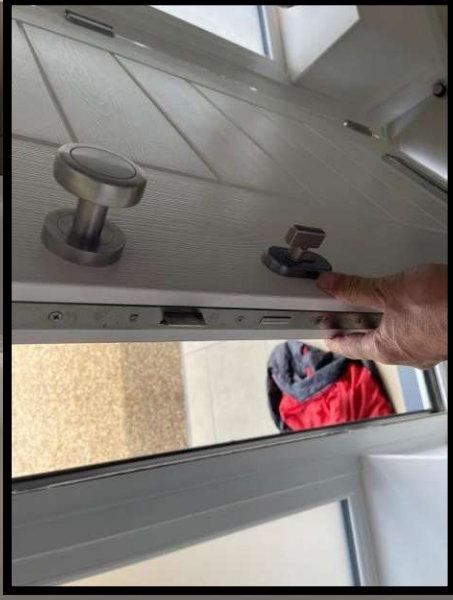
Location of manifold below stairs for the underfloor heating. The upper floor manifold is in the top stair/hallway cupboard at attic level.

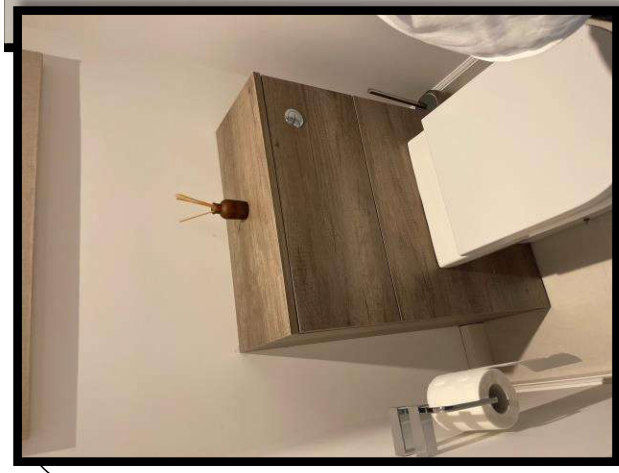
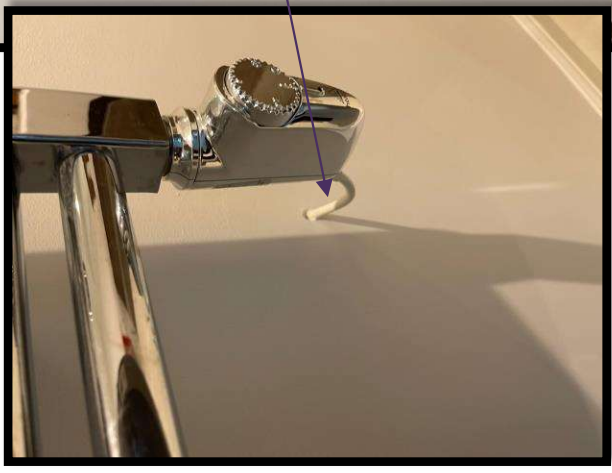
Ground floor WC

White painted ceiling with two down lighters and extractor, all appear to be working in good condition. White painted stud partition walls all in good condition. Porcelain tiled floors all in good condition. In good condition. Wall radiator is electric, appears in good condition, face plate missing – cable just comes out of the wall.

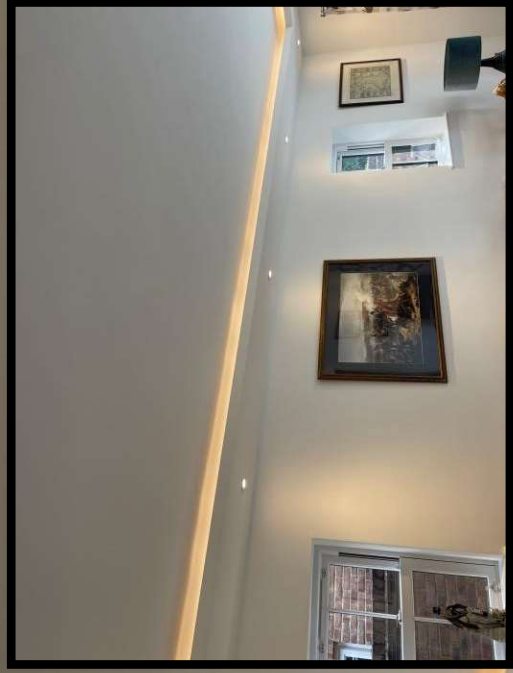
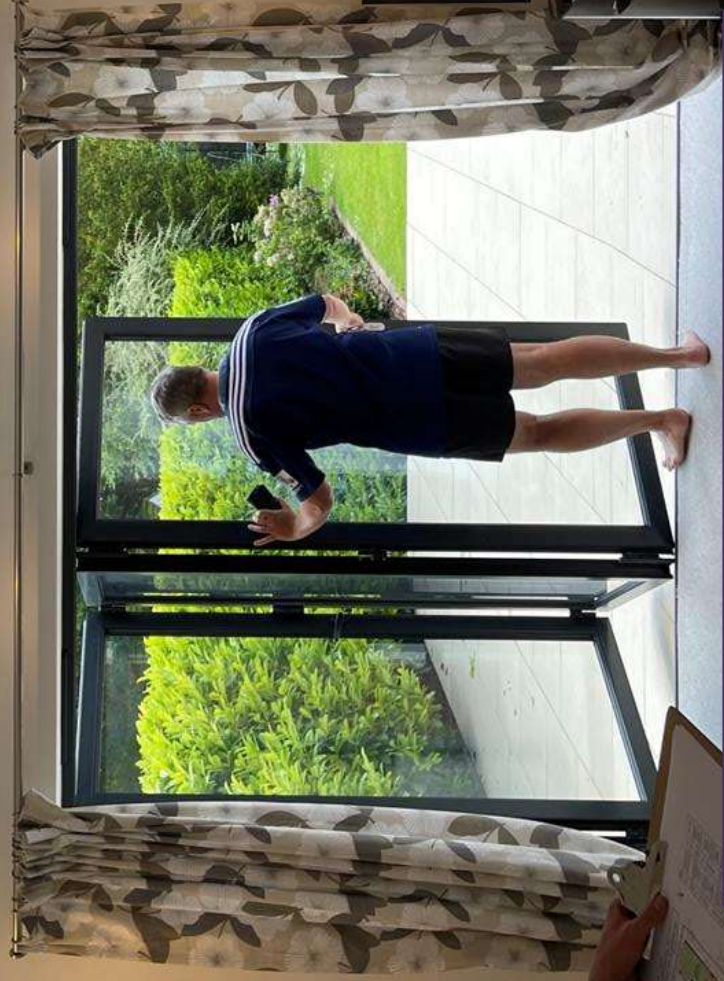
Reception Room

White painted coffered recessed lighted ceiling, all in good condition.
Dry lined wall to perimeter and stud partitions between rooms and solid wall between reception and hallway, all in good condition.
Porcelain tiled floor all appeared in good condition.
Sliding folding door open during inspection, this all appeared in good condition.

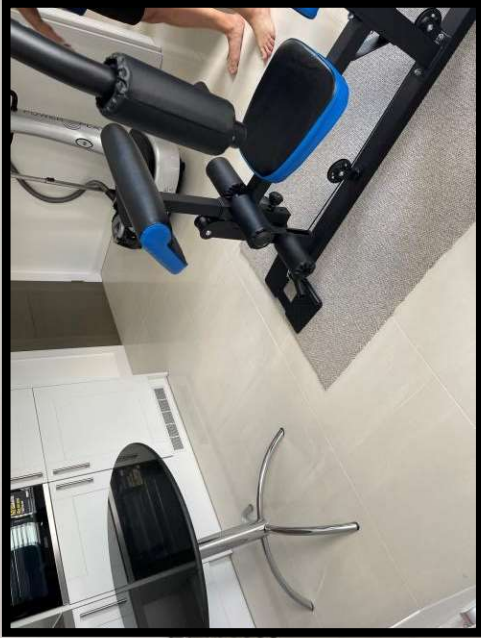
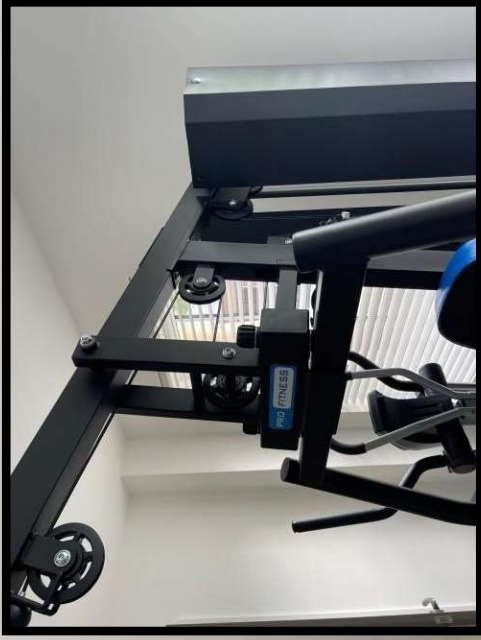
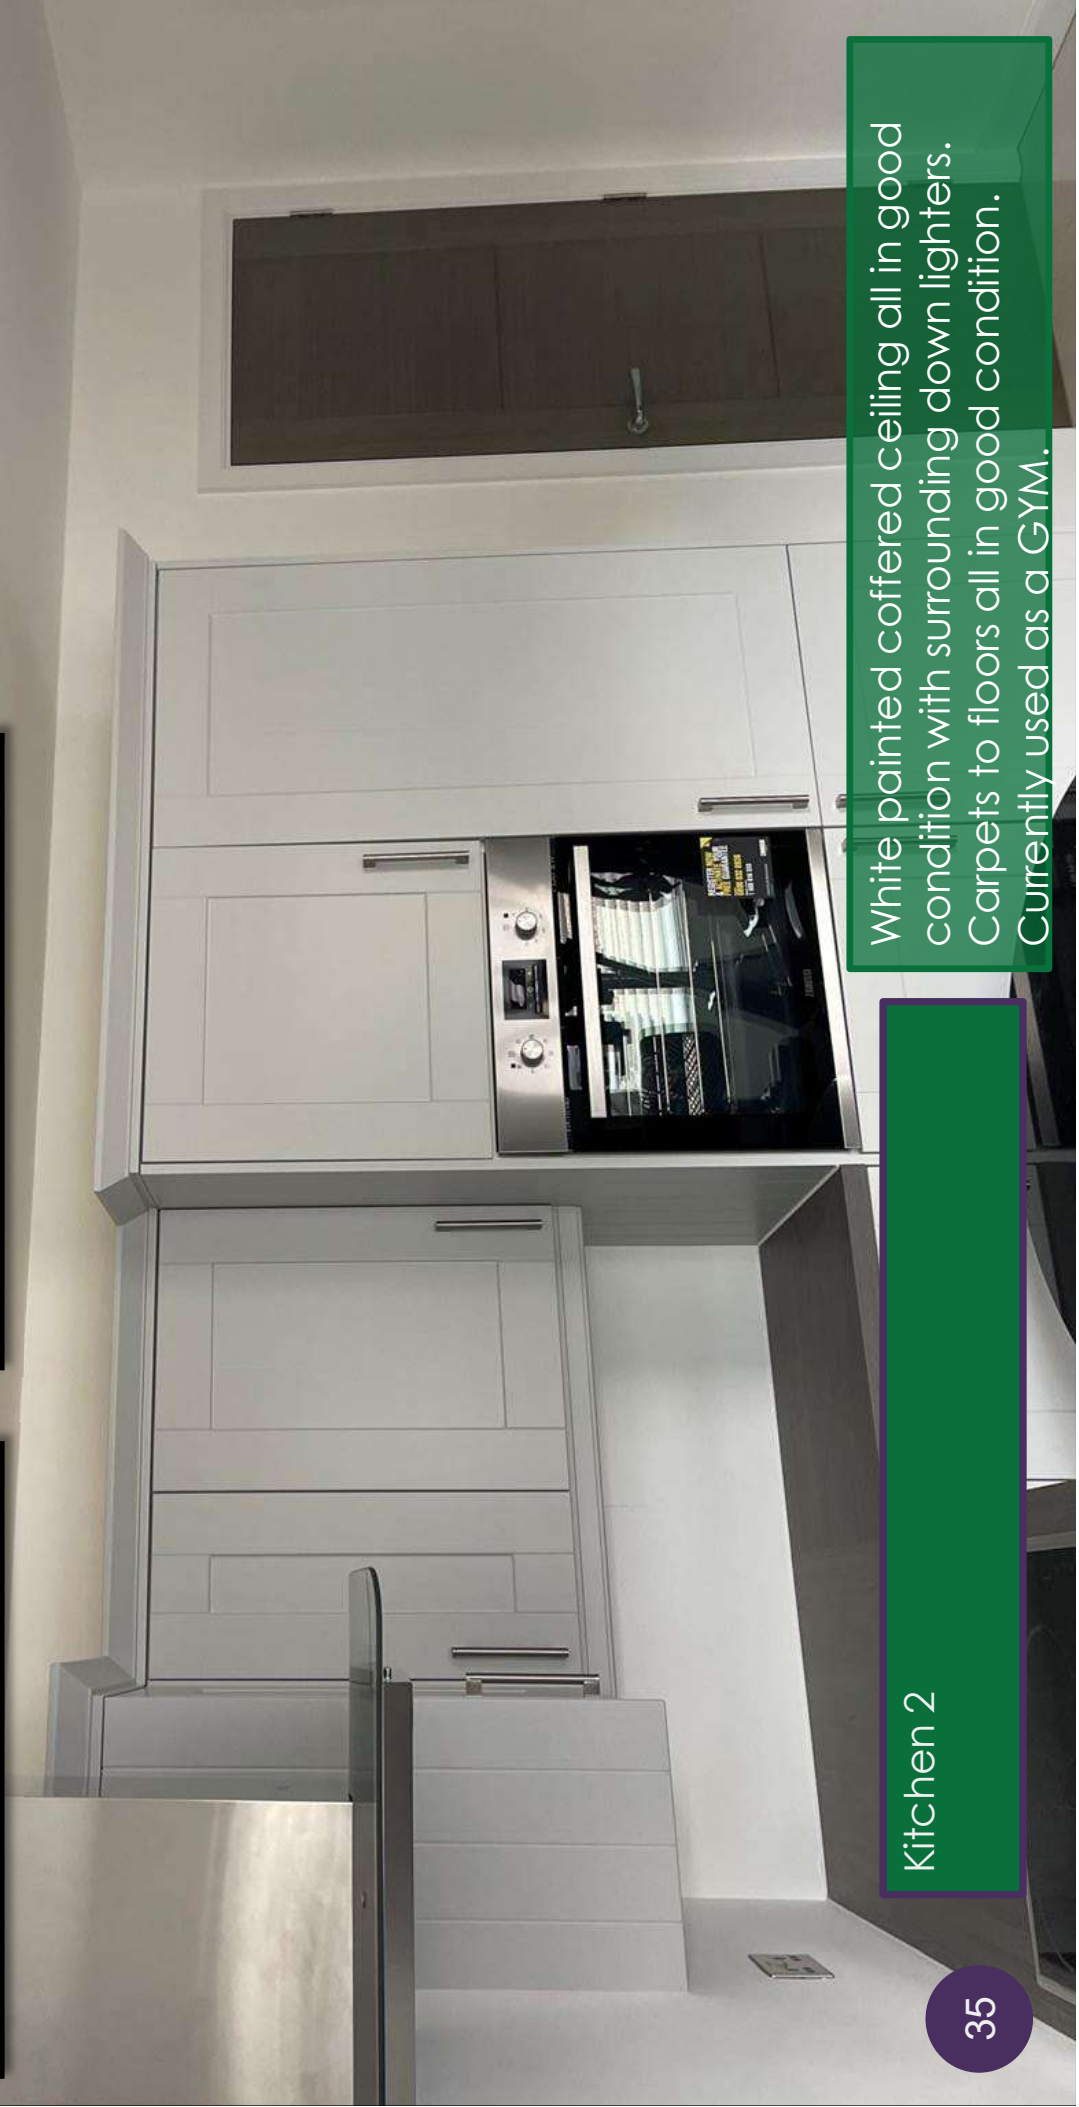
Dining room

White painted coffered ceiling all in good condition with surrounding down lighters. Carpets to floors all in good condition. Currently used as a GYM.

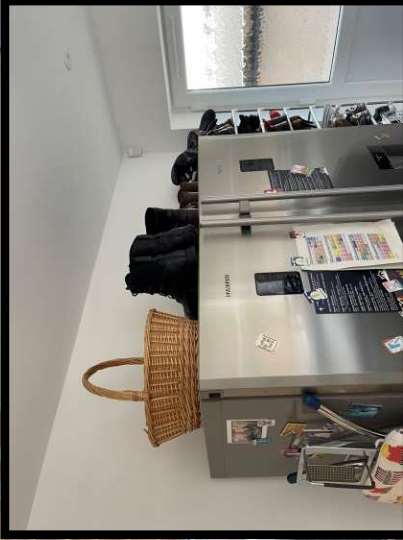
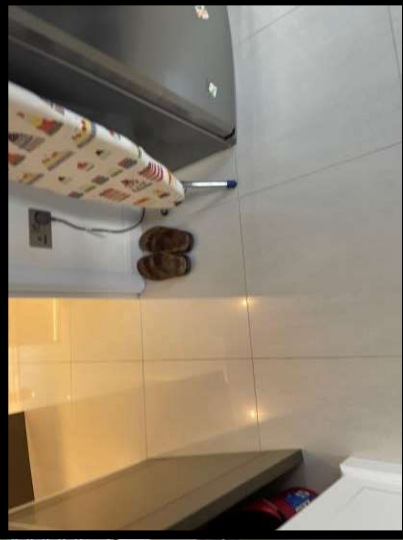
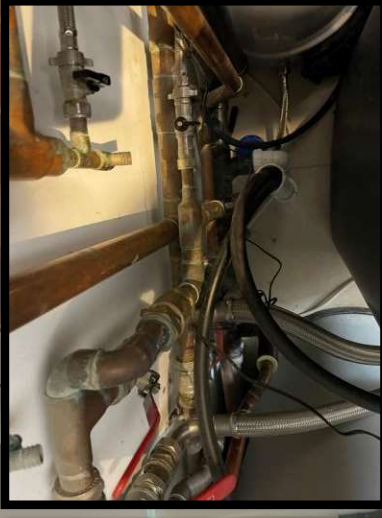
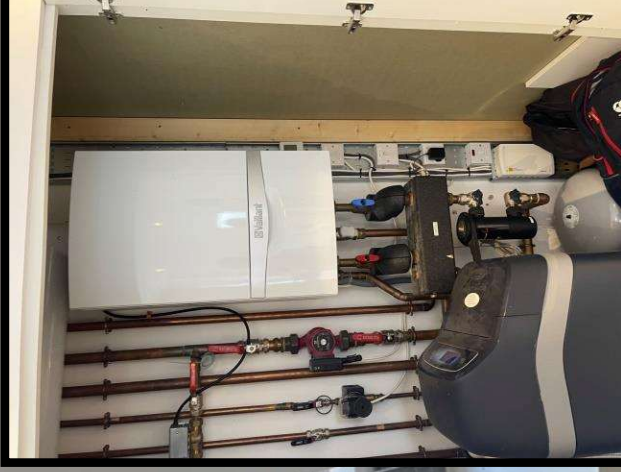
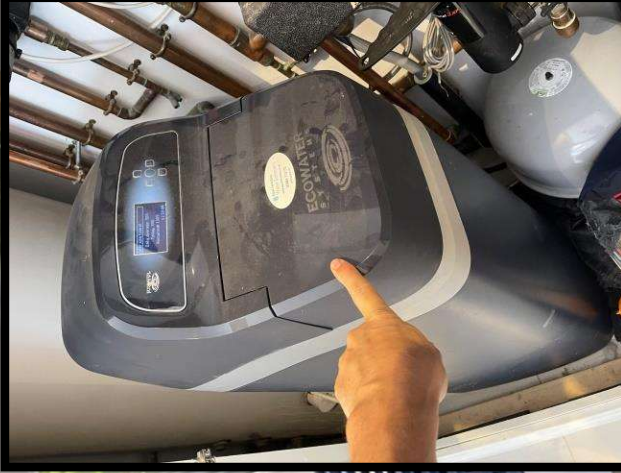
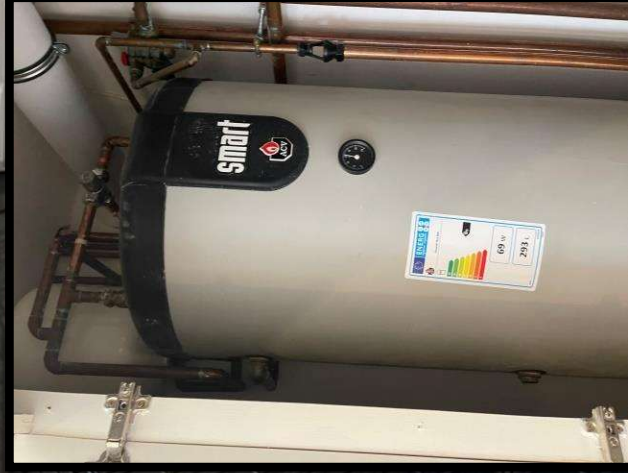
Kitchen/Breakfast Room

No issues apparent.

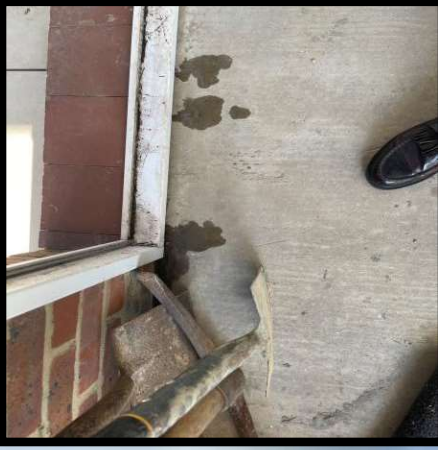
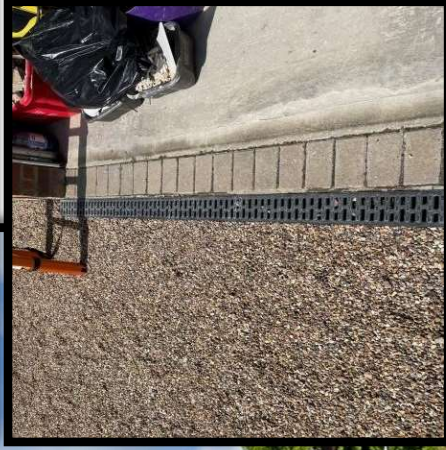
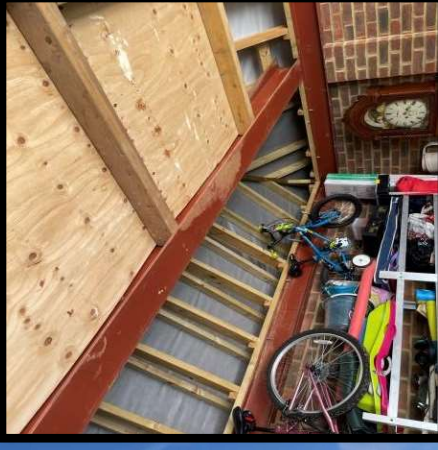
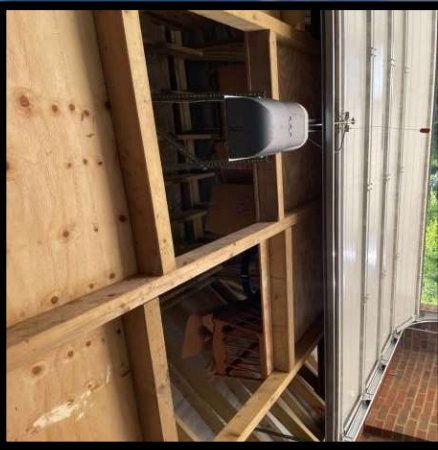
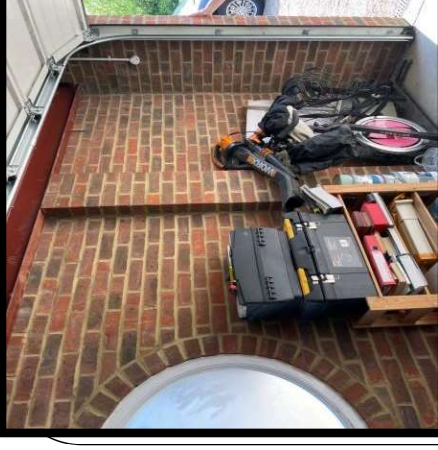
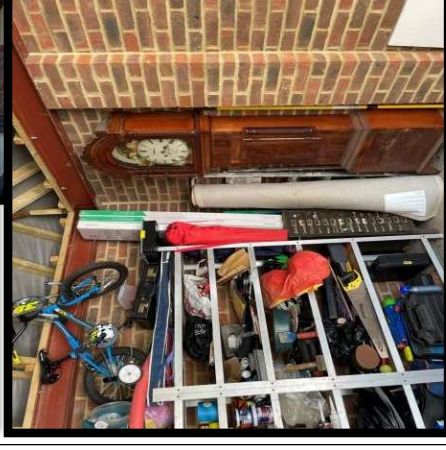
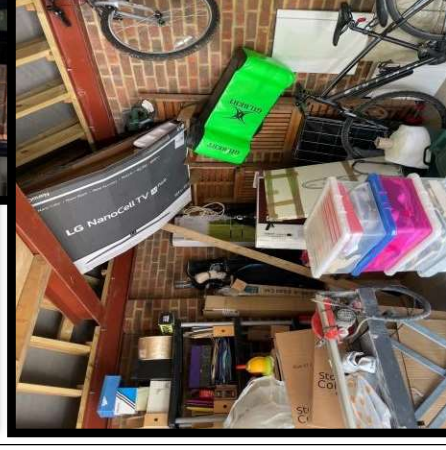
Damp proof check throughout property

We did note in the garage at the DPM (Damp proof membrane) in the floor has not been linked into the brickwork DPC. We also noted that the ground levels at the rear of the garage compromise the level of the DPC. However, we did not note any damp issues within the garage. I would recommend that the two brick courses above the concrete floor slab are sealed with a brick sealer just to keep this area born dry and to avoid issues in the future.

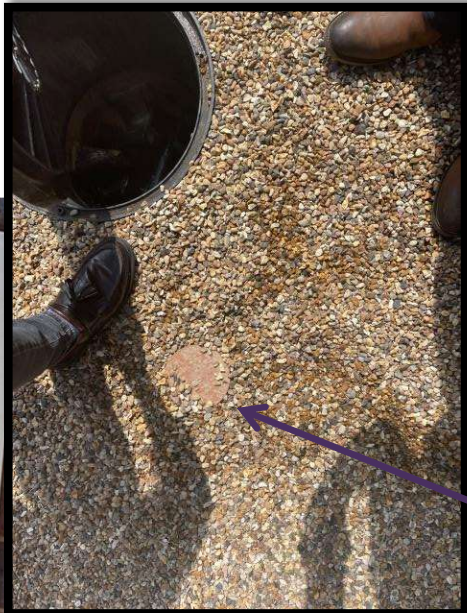
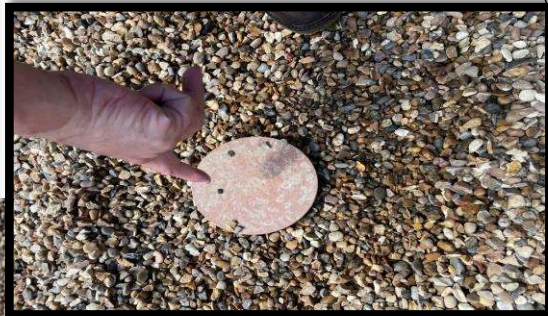
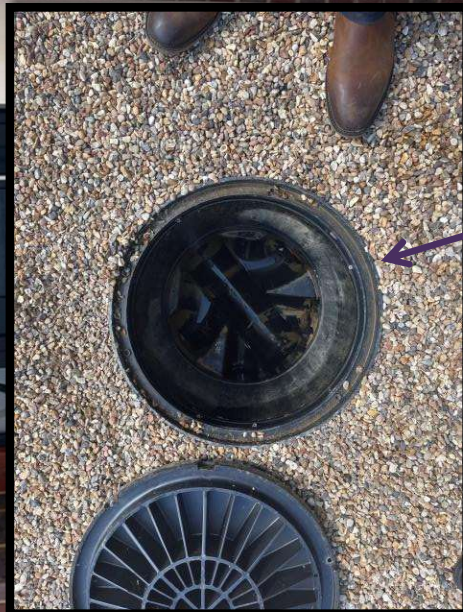
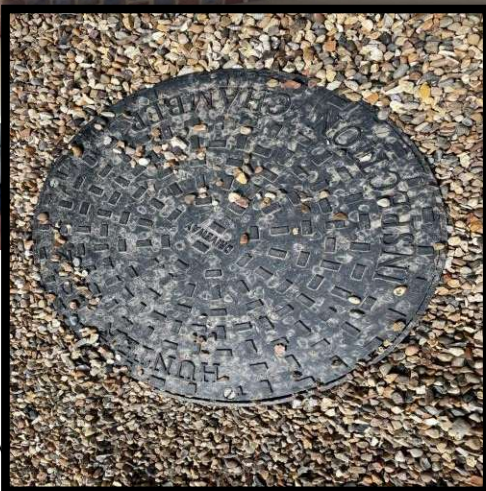
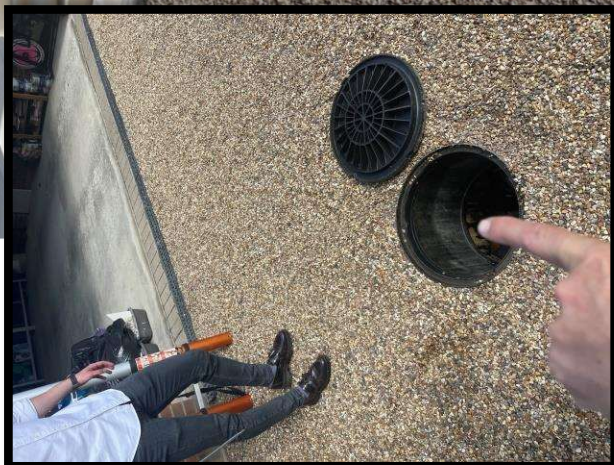
Driveway

I did not observe any issues regarding the driveway.

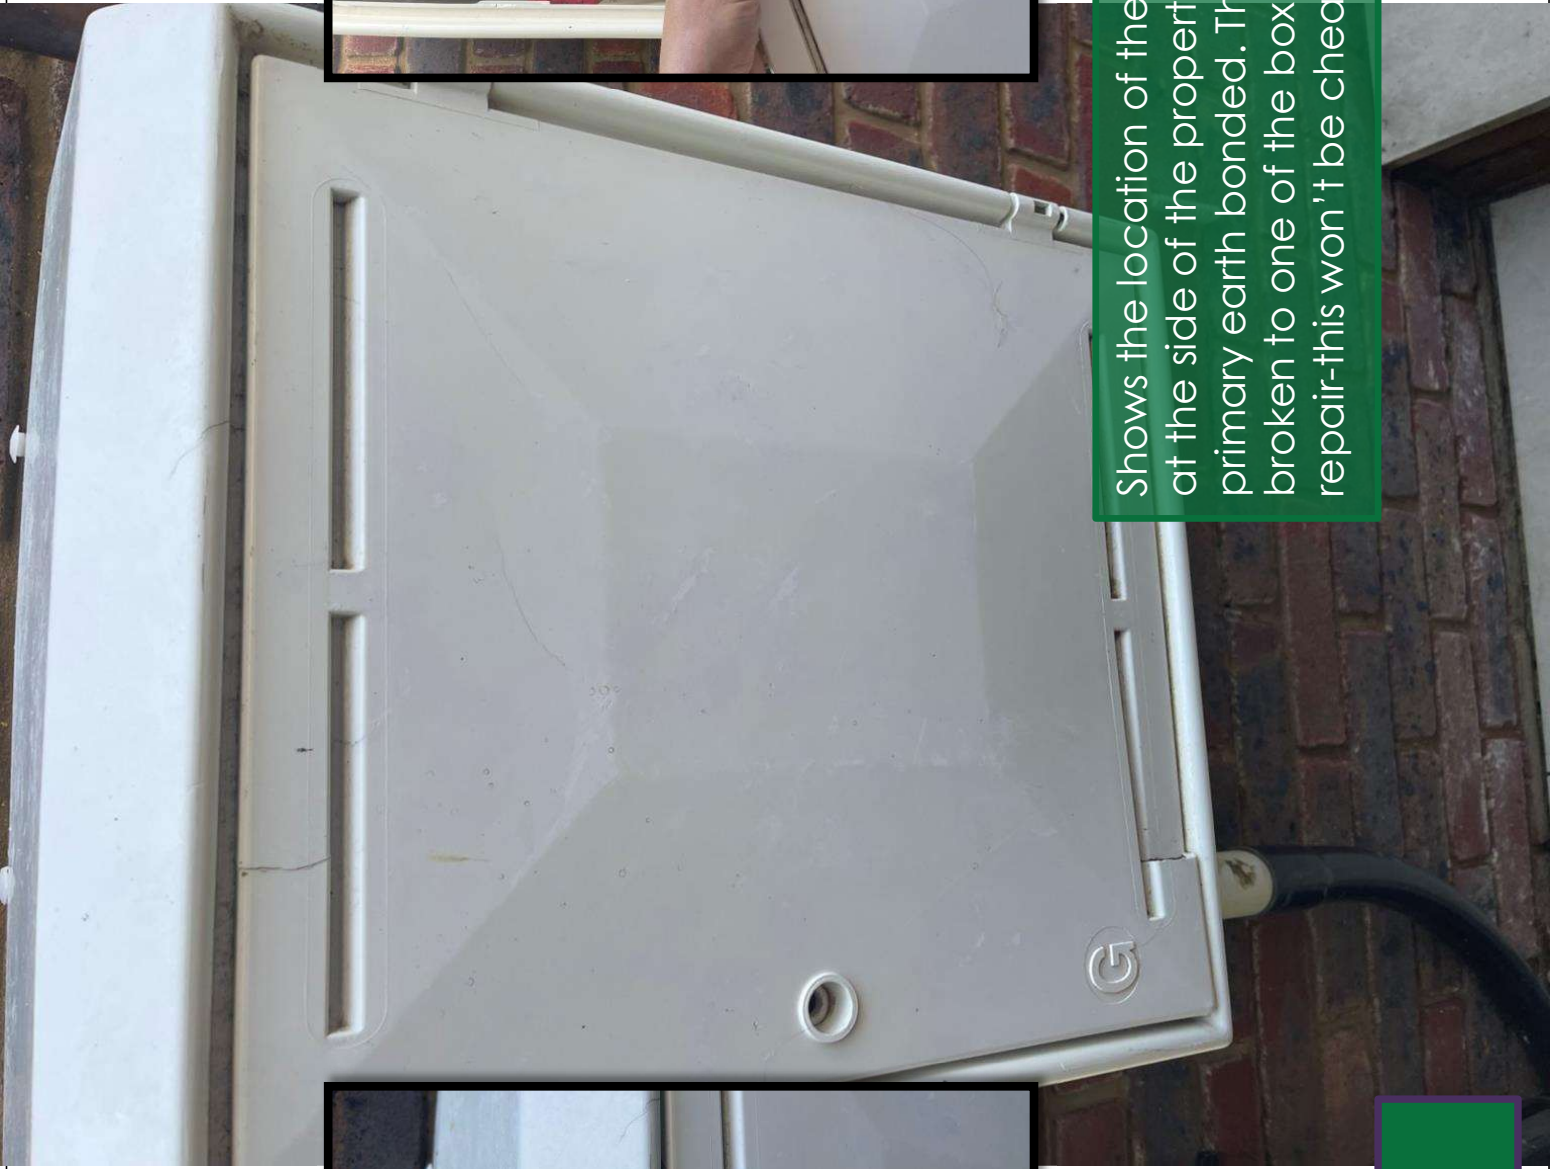
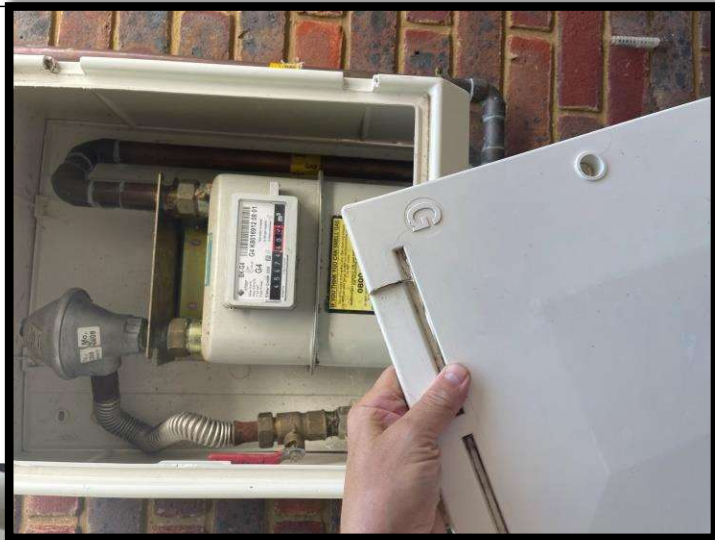
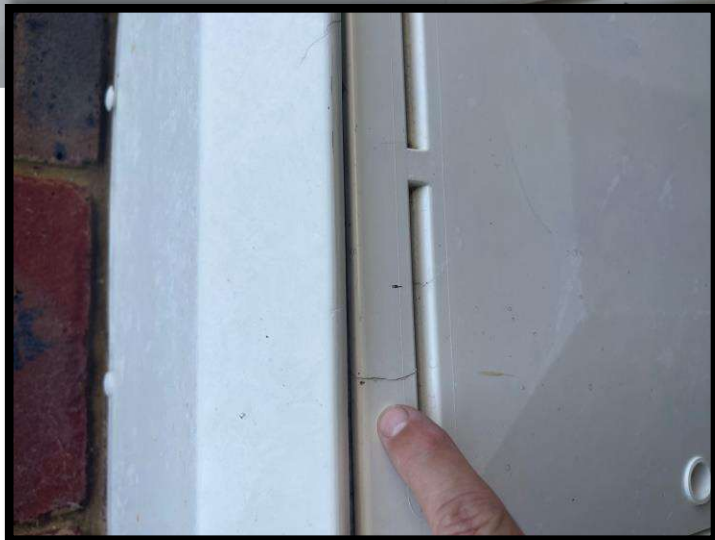
Gas box lid.

Shows the location of the gas meter externally at the side of the property. This appears to be primary earth bonded. The lid is cracked and broken to one of the boxes and requires repair-this won't be cheap

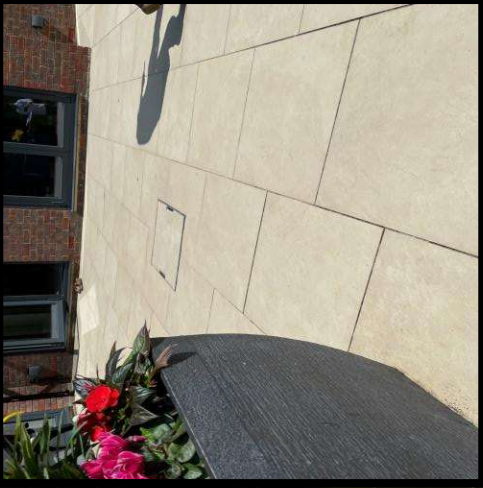
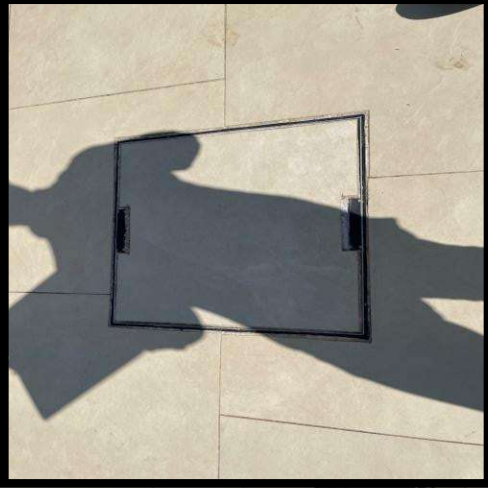
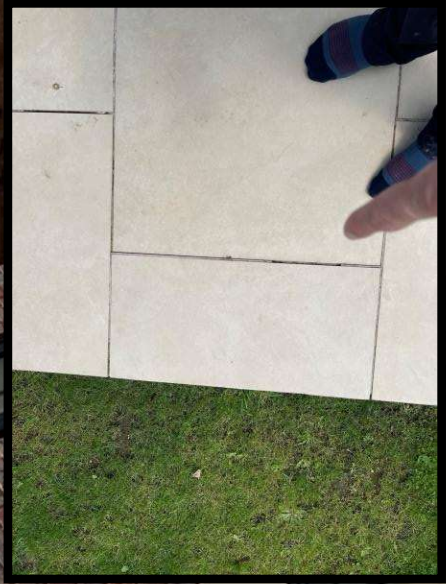
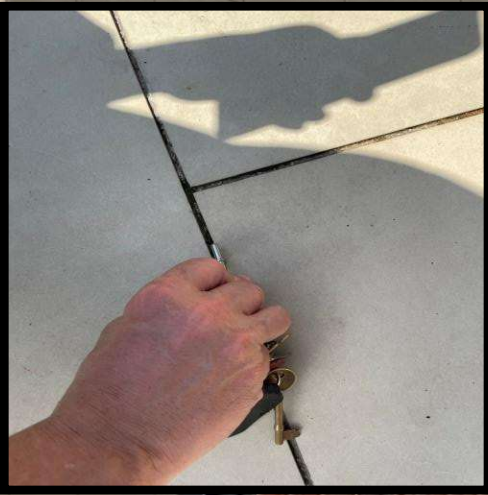
Rear garden patio

The patio at the rear is quite extensive. We noted on the left-hand side of the patio when viewing it from the garden that quite a bit of the pointing is missing between the slabs. Otherwise, the patio appears in reasonable condition.

Also noted that there are unprotected **fall hazards** on the patio and the stairs leading down to the garden which require protective railings/handrail. To prevent trip hazards.
