DETAILED BUILDING SURVEY

INCORPORATING A VISUAL / STRUCTURAL ASSESSMENT OF THE PROPERTY

SAMPLE SURVEY

Tayross Associates Limited

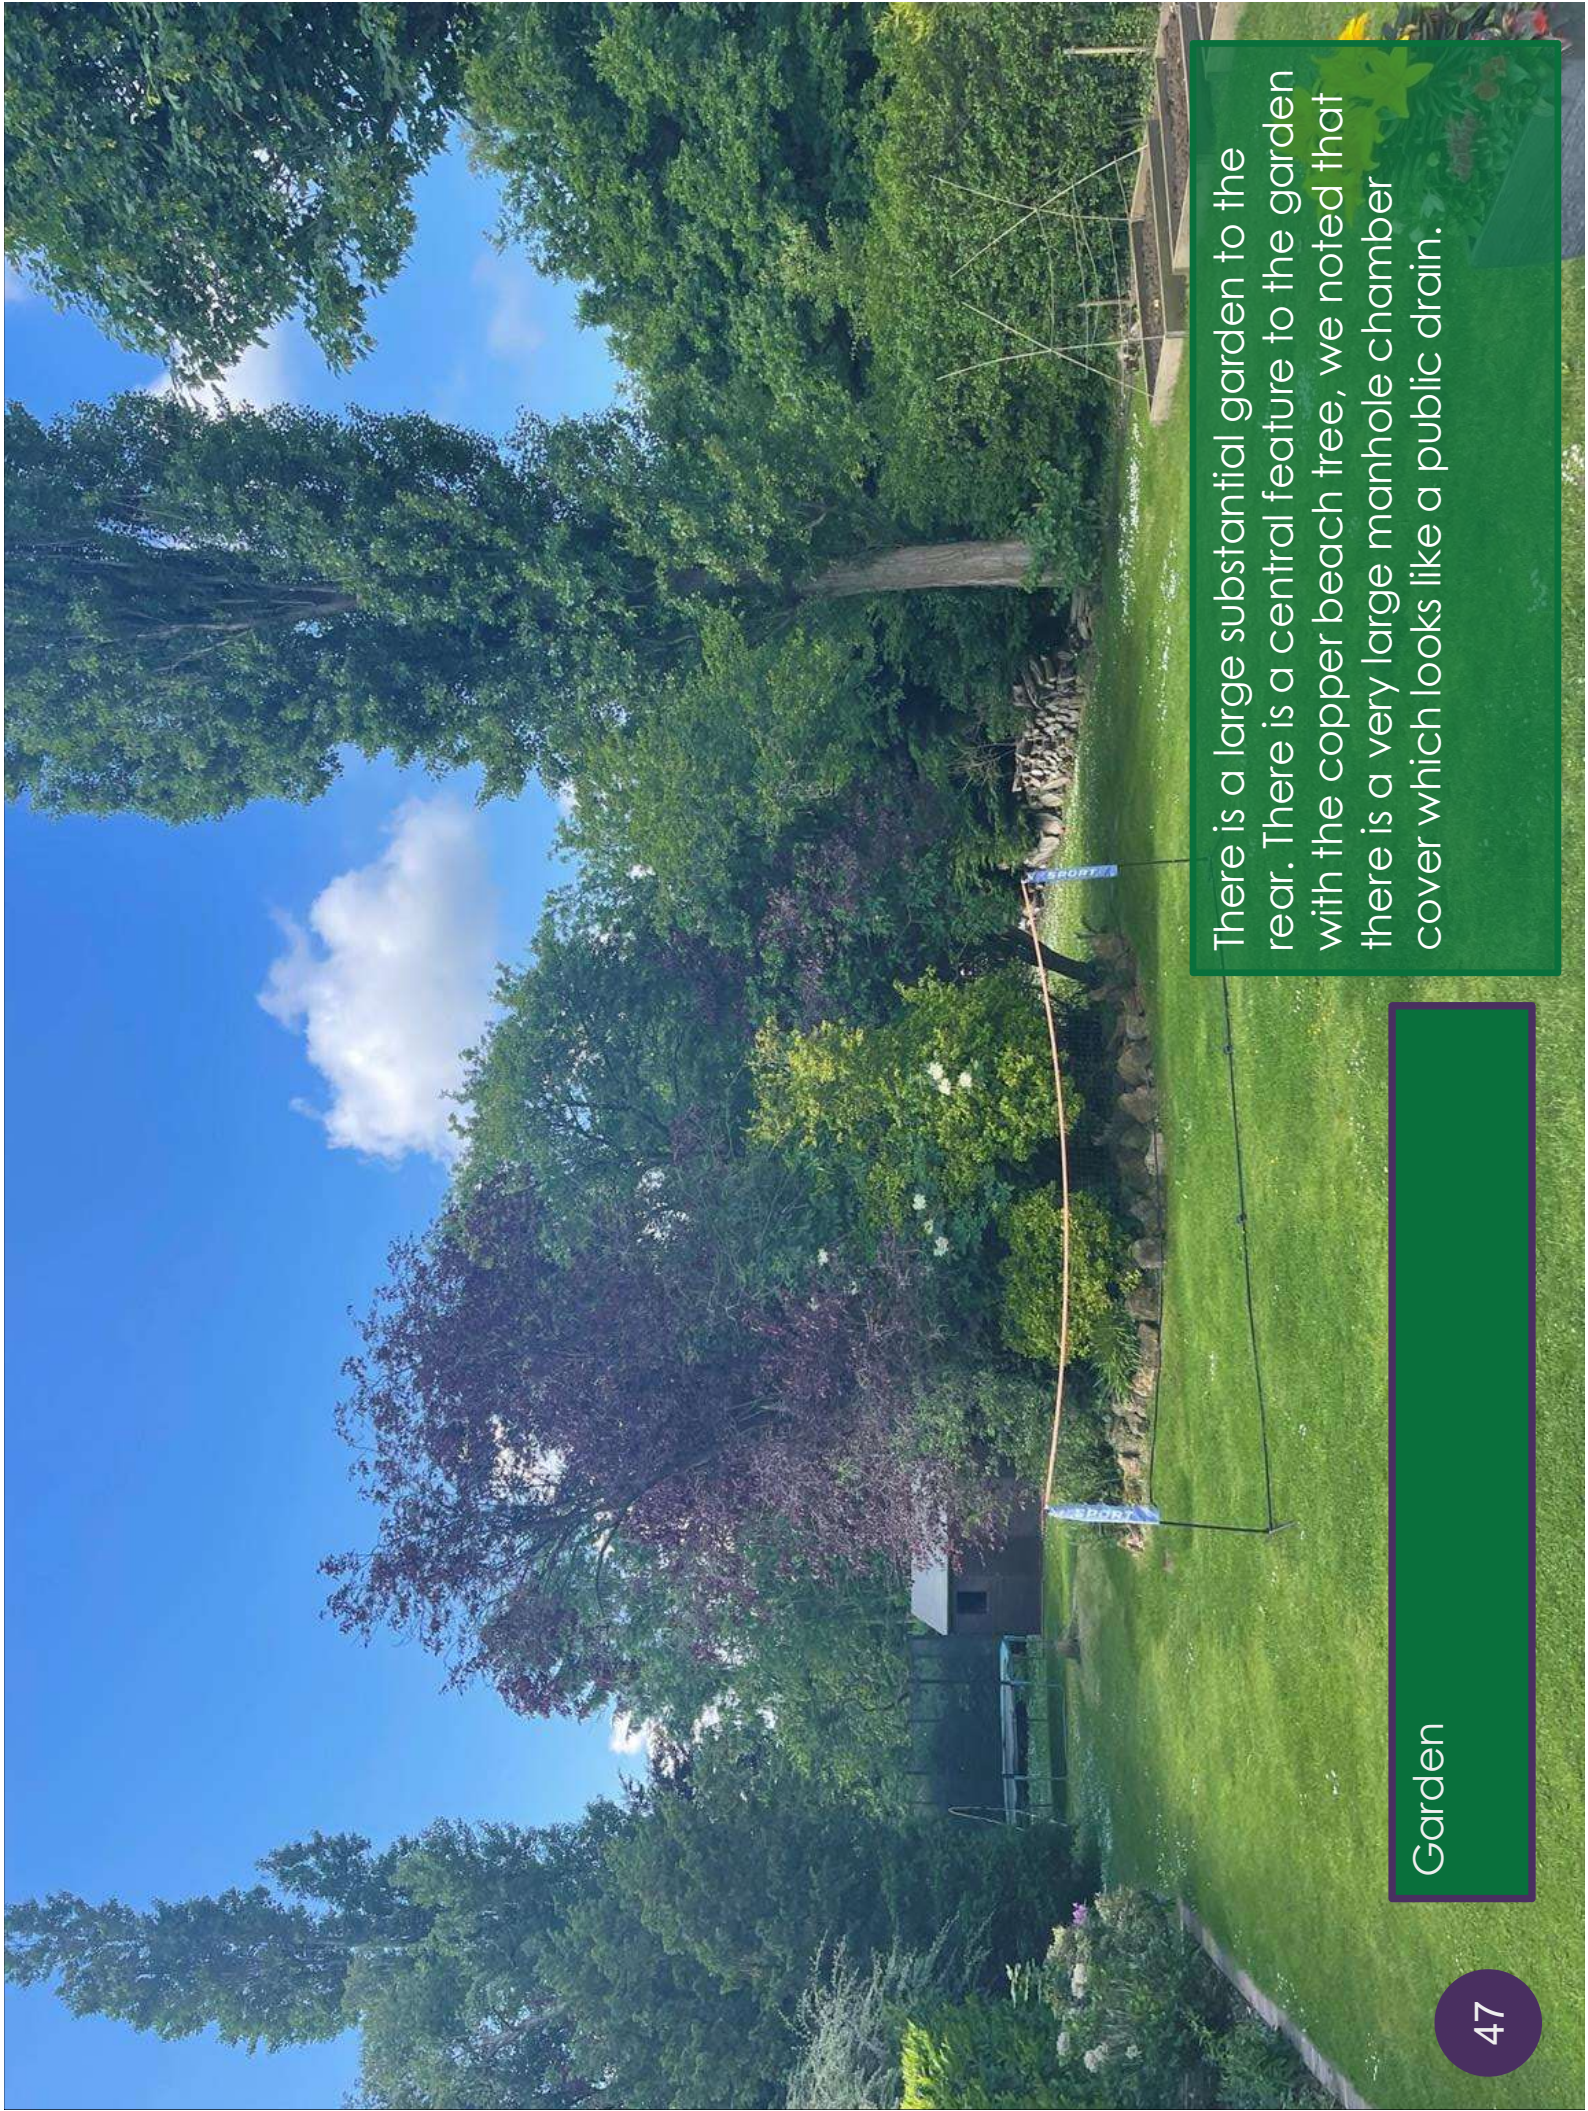
Garden

There is a large substantial garden to the rear. There is a central feature to the garden with the copper beach tree, we noted that there is a very large manhole chamber cover which looks like a public drain.

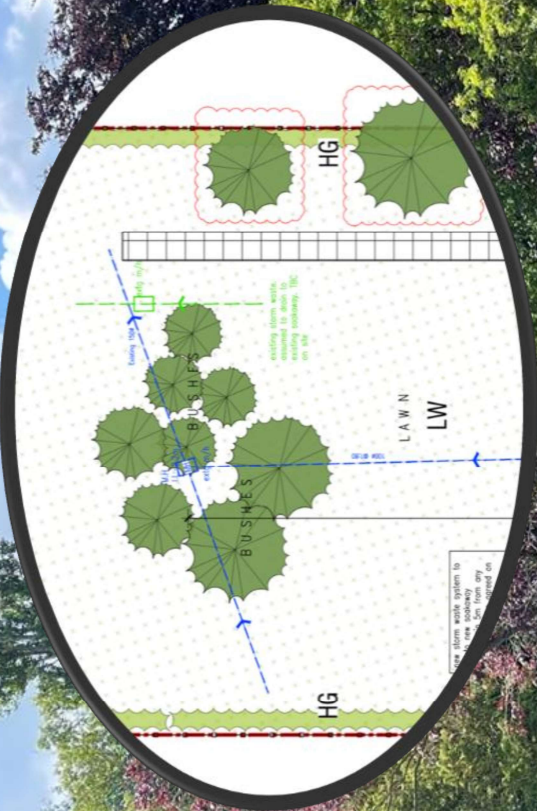
Sections of garden

This tree clump conceals a large manhole chamber and public sewer pipe..

The direction of the pipe is shown on the drawing above. This drain is redundant.

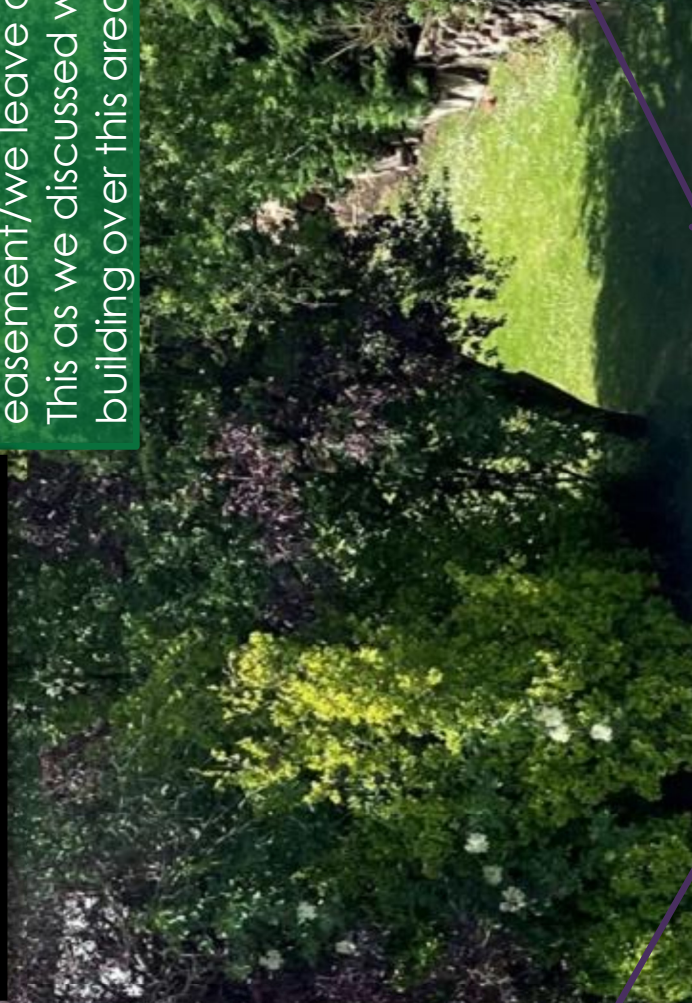
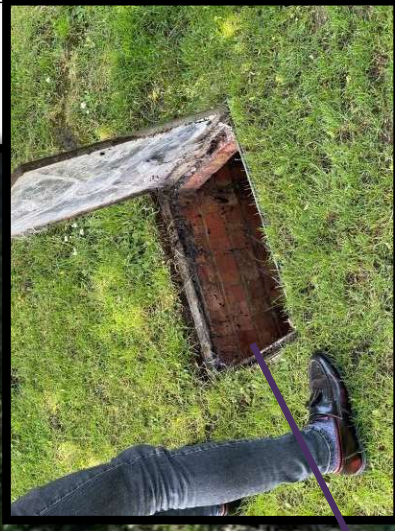
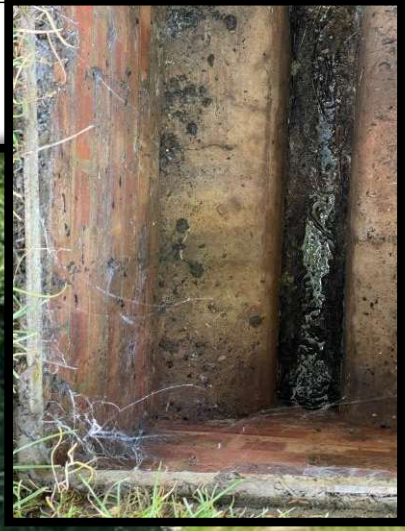
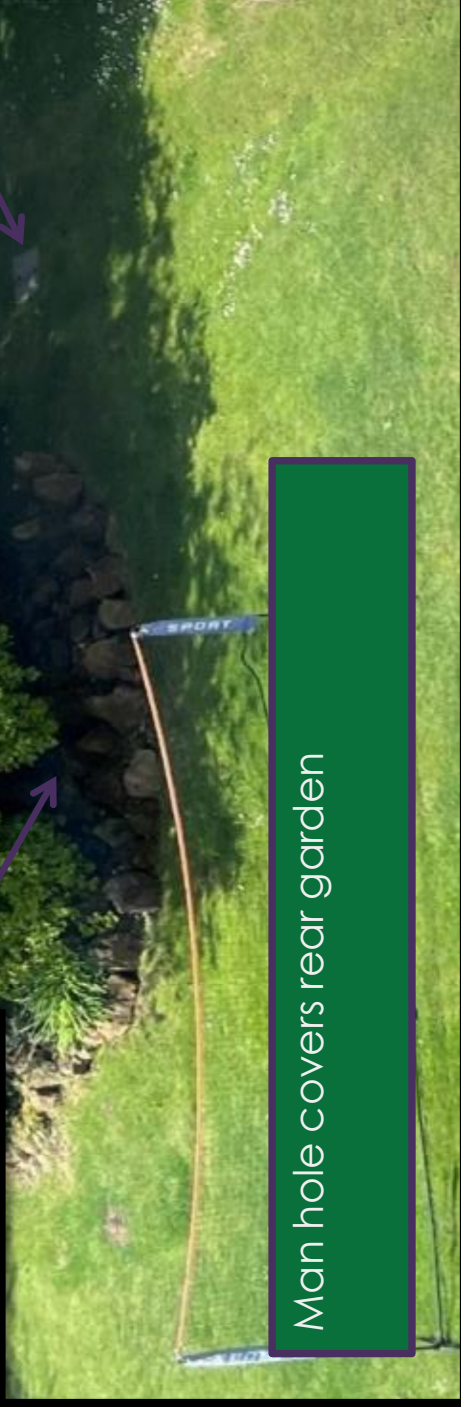
Man hole covers rear garden

We discussed with you that there is a very large public adopted utility drain that runs across the garden at the rear. We have been told by the owner that this pipe takes the drainage from other properties and extends from left to right across the garden through the centre of the large clump of trees in the middle of the garden. It's likely that there is a easement/we leave across the rear garden. This as we discussed would prevent you building over this area.

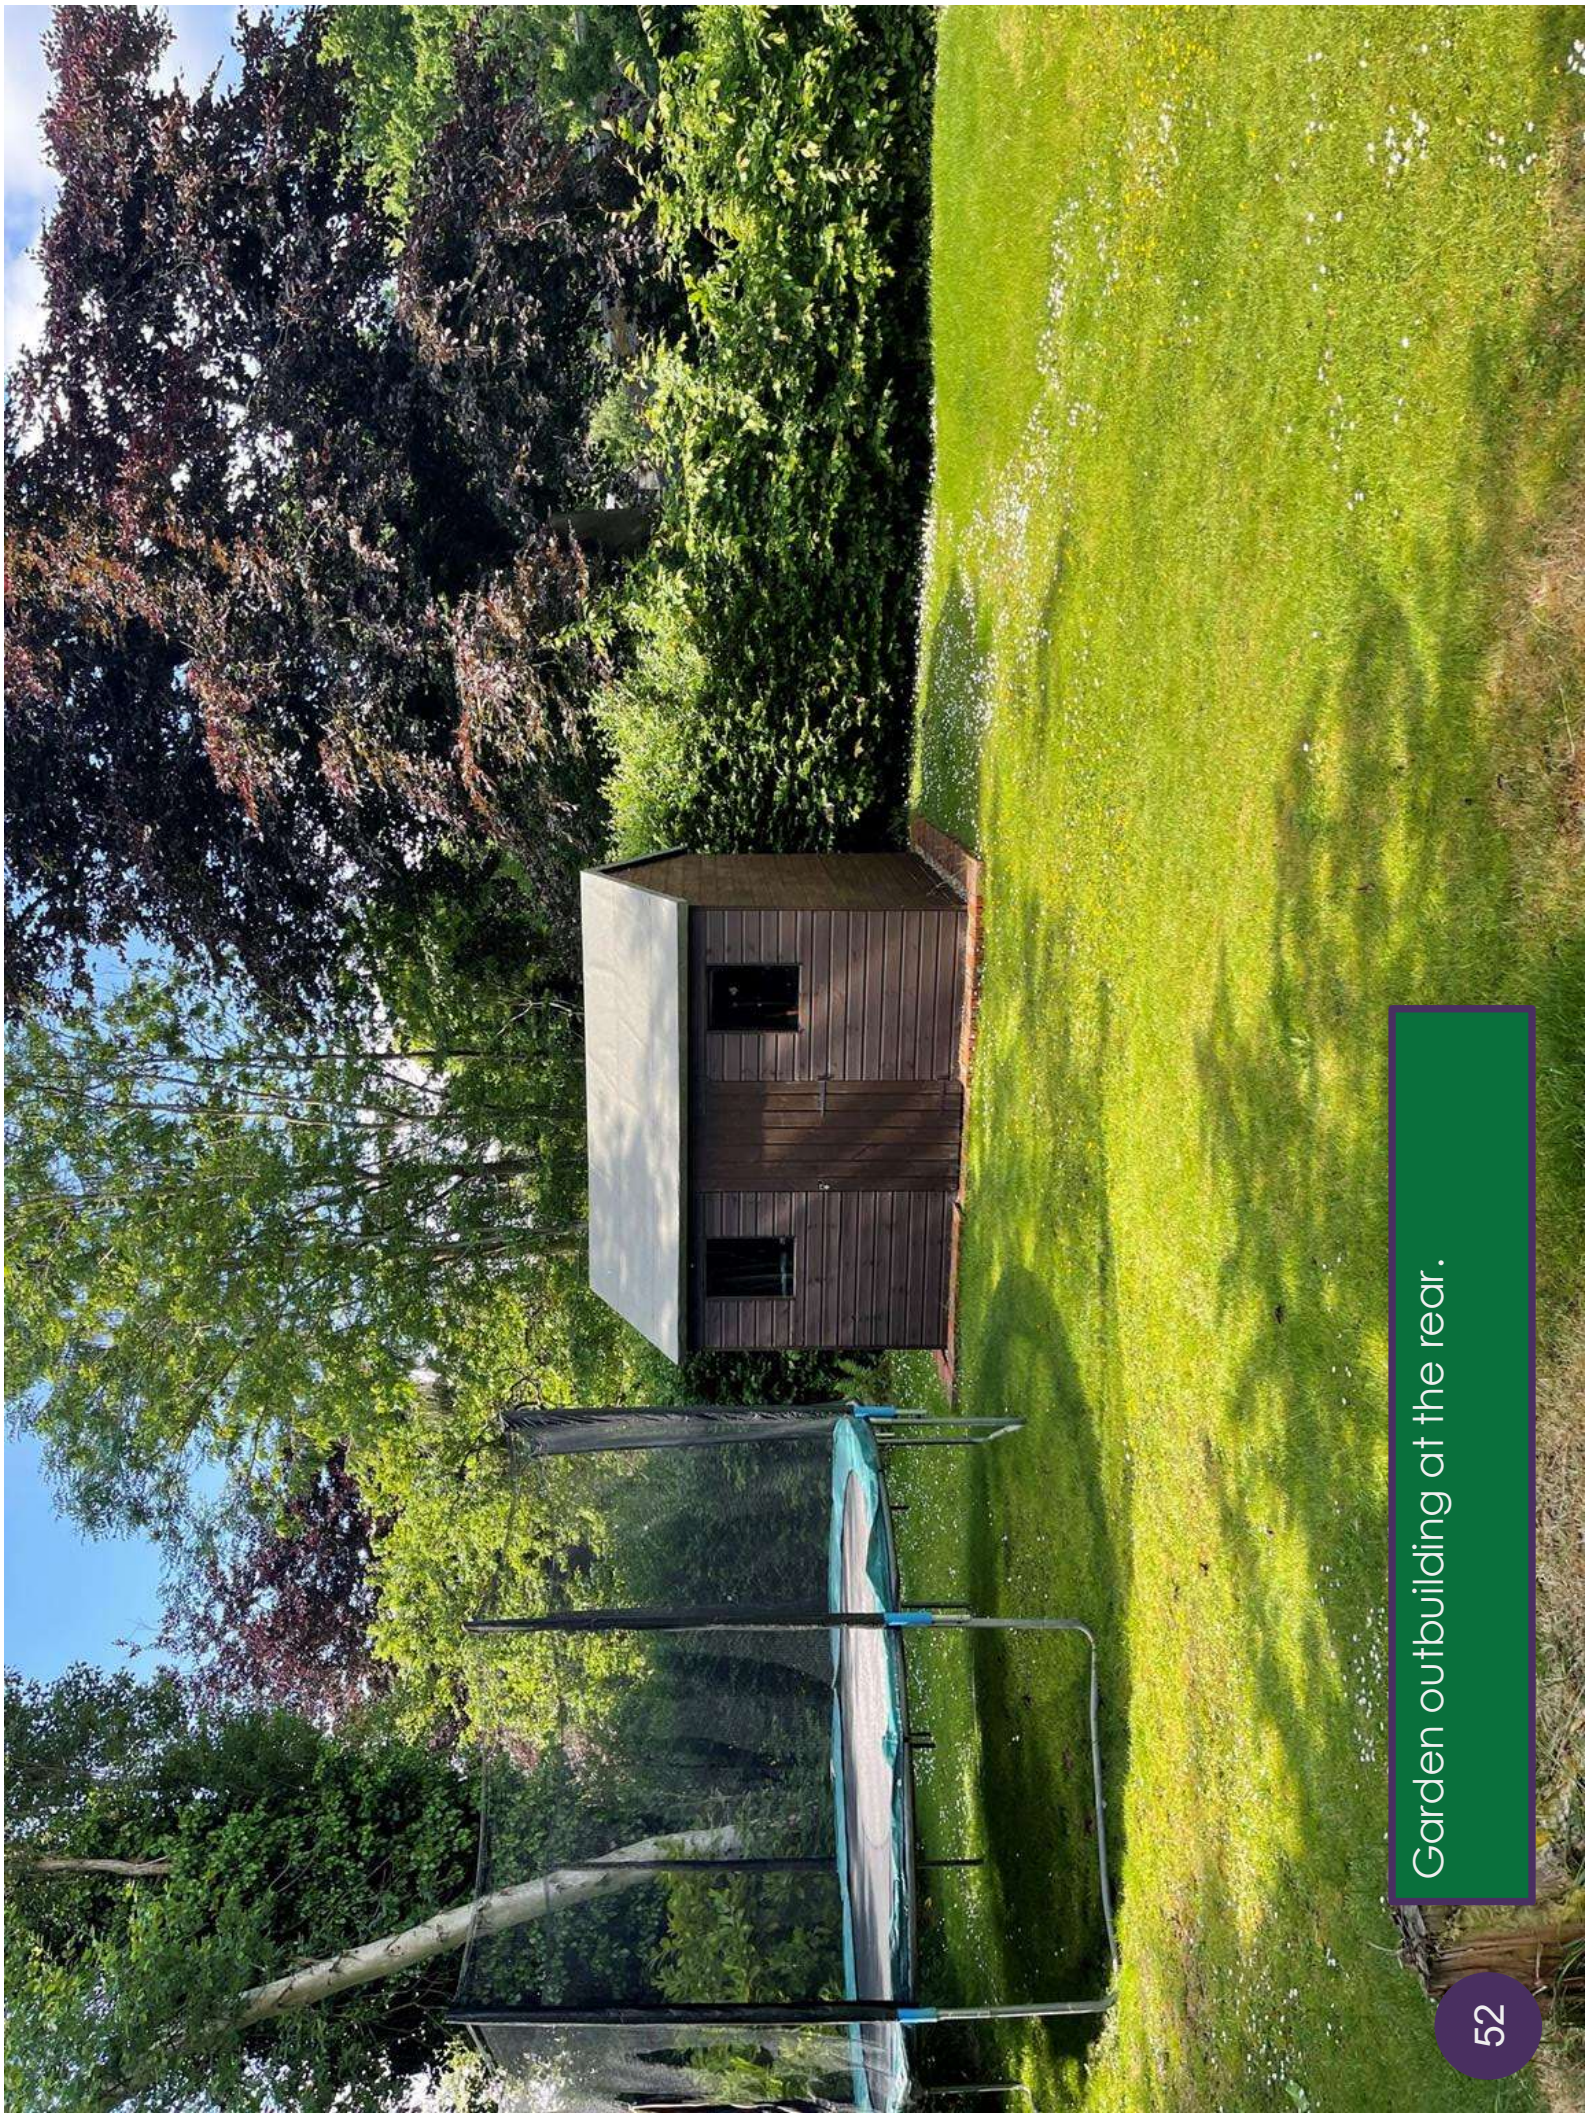
Overlooking neighbours from garden

Garden is slightly overlooked and the left-hand side in front of the patio by the neighbour. Also similar on the right-hand with the first-floor bedroom windows. I don't see that this will be much of an issue as these are only bedroom windows.

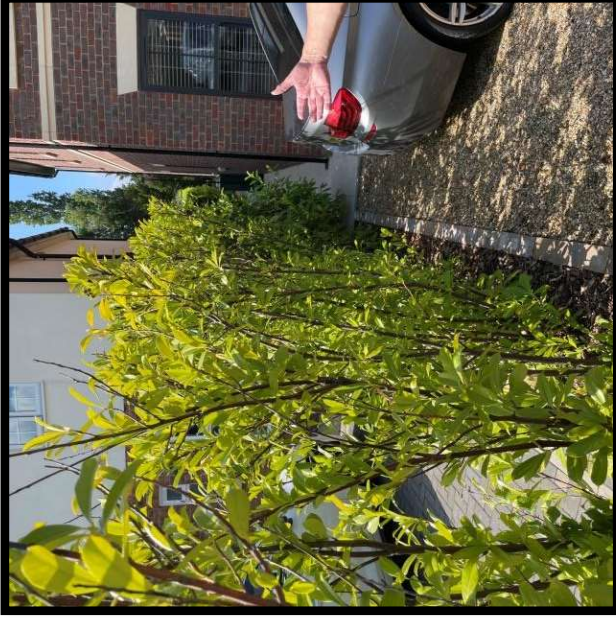
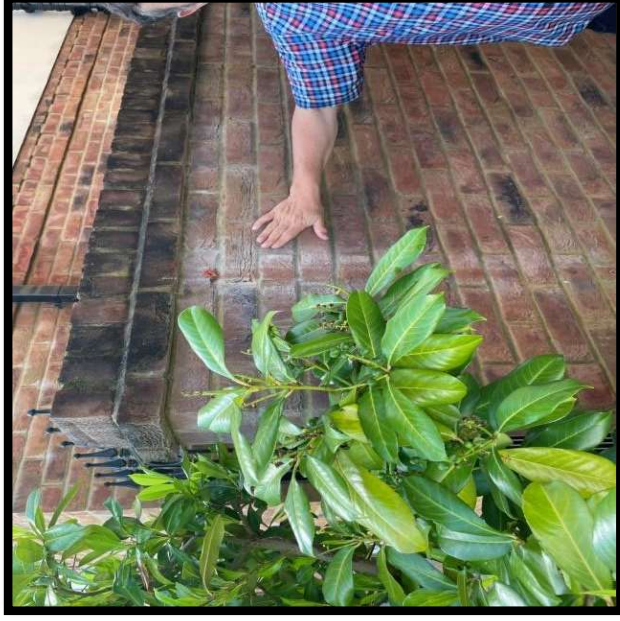
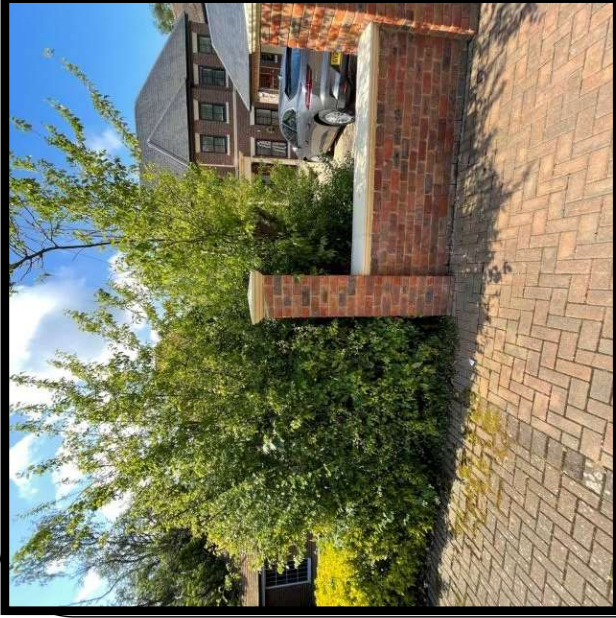
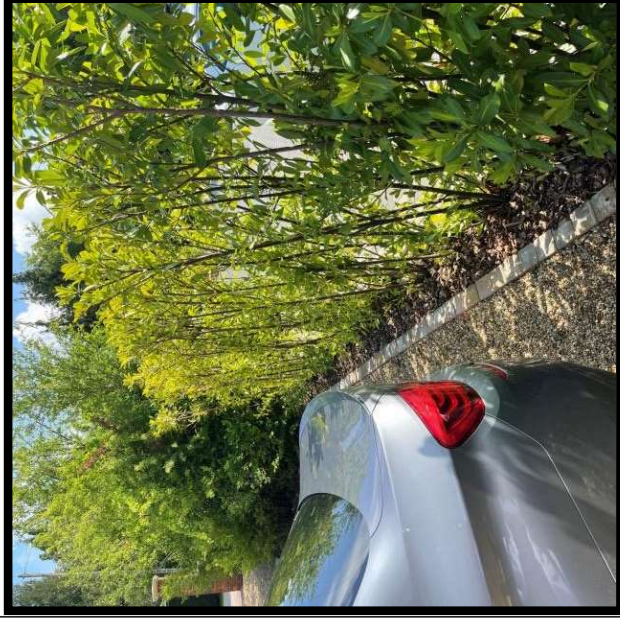
Left – hand side boundary front of property

Boundary on the left-hand side appears to be physically marked with the brick pier and I would say the boundary starts on the face of the pier facing the neighbour. The boundary continues down as a very thick shrubby area which then goes to a smaller shrubby area. This laurel hedge is owned by the seller.

Boundaries more clearly defined by the brick wall with the gate and I would say the boundary here is the face of the brickwork facing the neighbour's property. According to the owner/seller, they used to own this property and when selling it to the current neighbours, they made sure the wall belonged to them. This should.

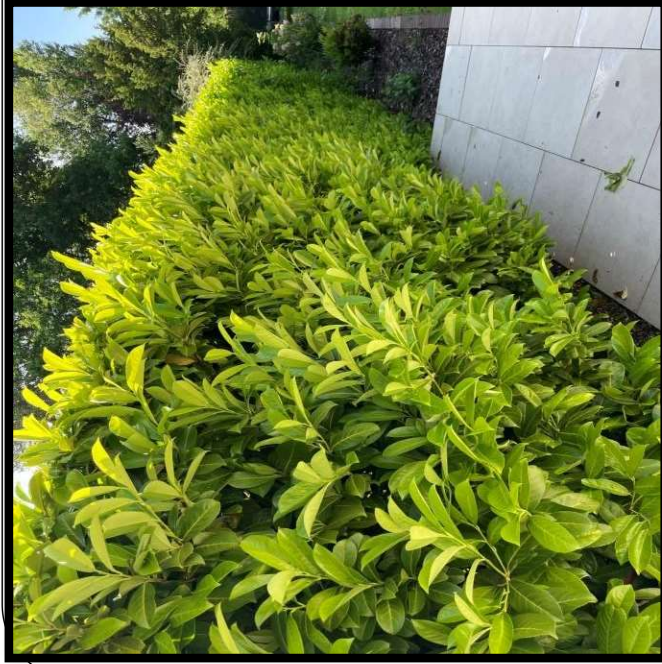
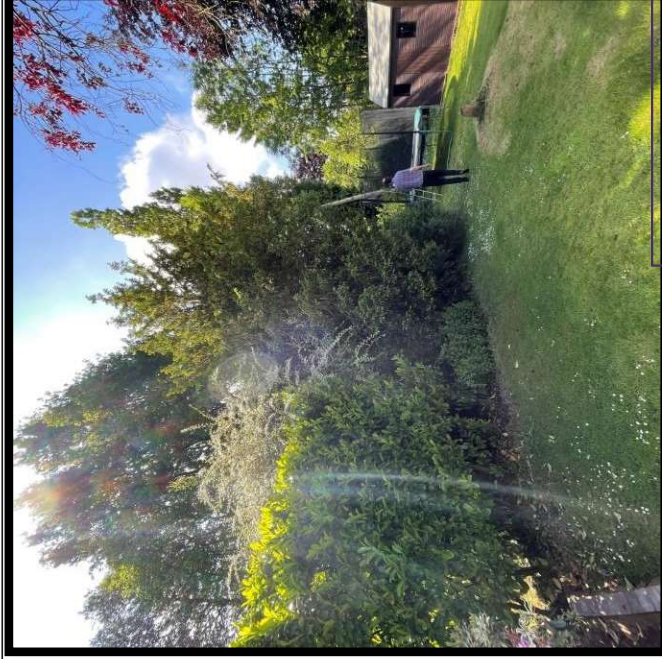
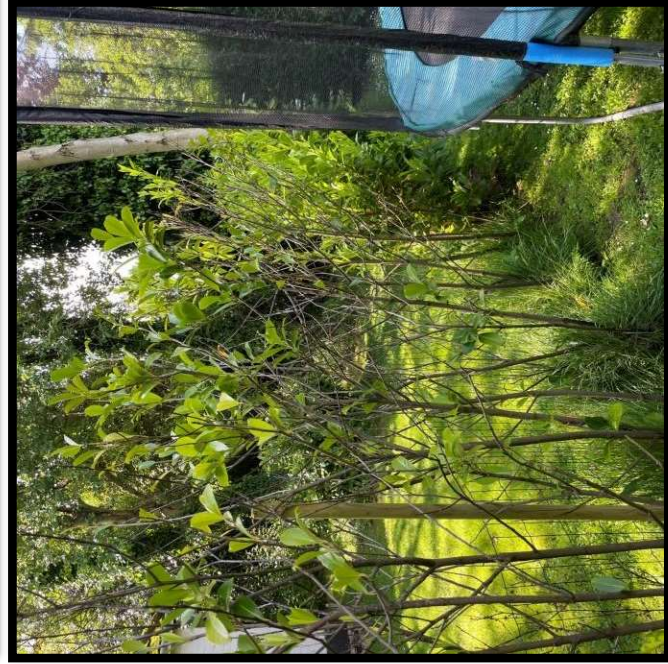
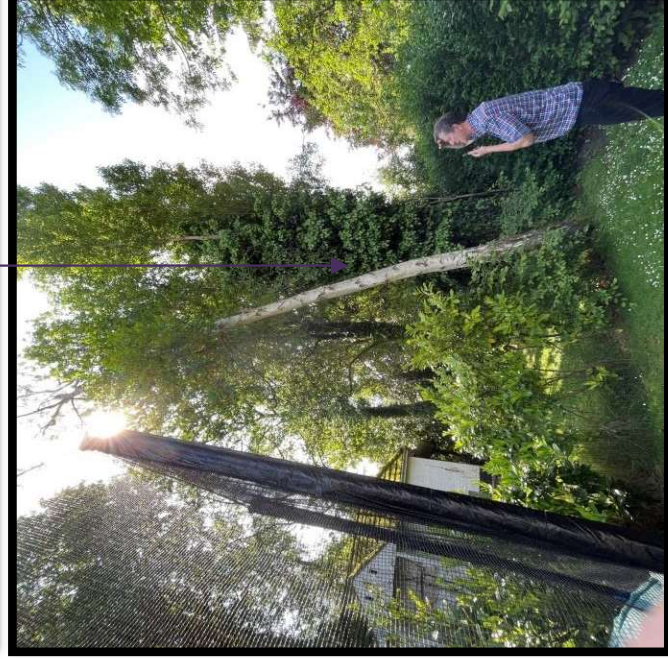
Continuing done the left-hand side of the property there is a thick laurel hedge, this belongs to the Seller (according to him) on the left-hand side – hedge is approximately 2 m high. Appears reasonably well maintained. Then there are two large fir trees and again, the boundary appears to be defined by a light weight chain-link lightweight fencing with the laurel hedge on the sellers' side of the property. At the bottom of the garden where there is a birch tree in the sellers' garden, this appears to be leaning excessively into the neighbour's garden, the angle is approximately 60°. Would recommend this tree is removed to reduce risk of it falling over and causing damage or injury to the neighbour. There is a further large deciduous tree approximately 18 m tall at the rear and this is on the neighbour's side.

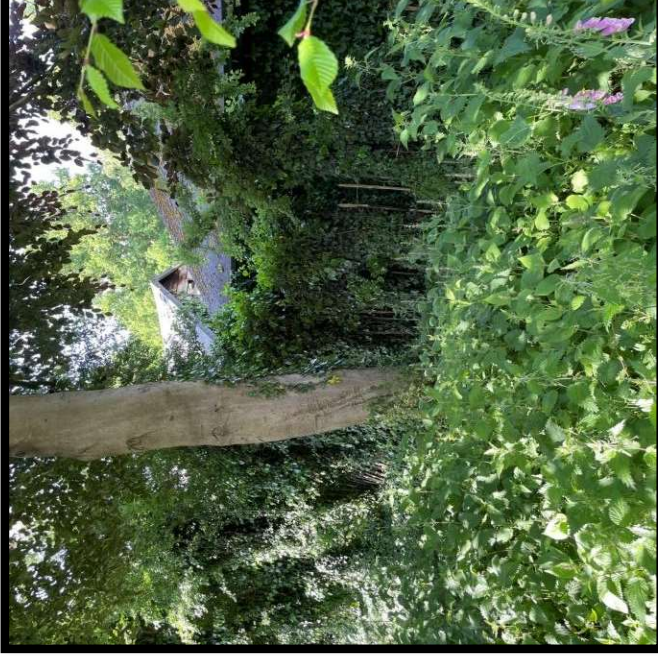
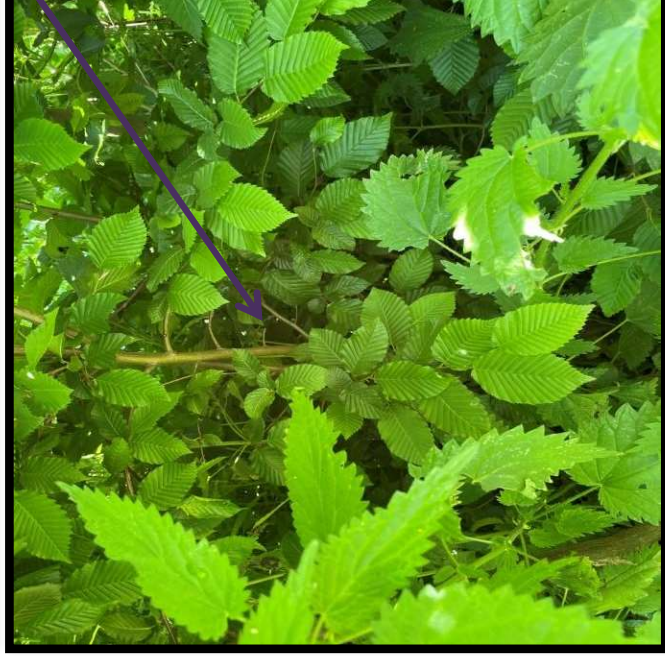
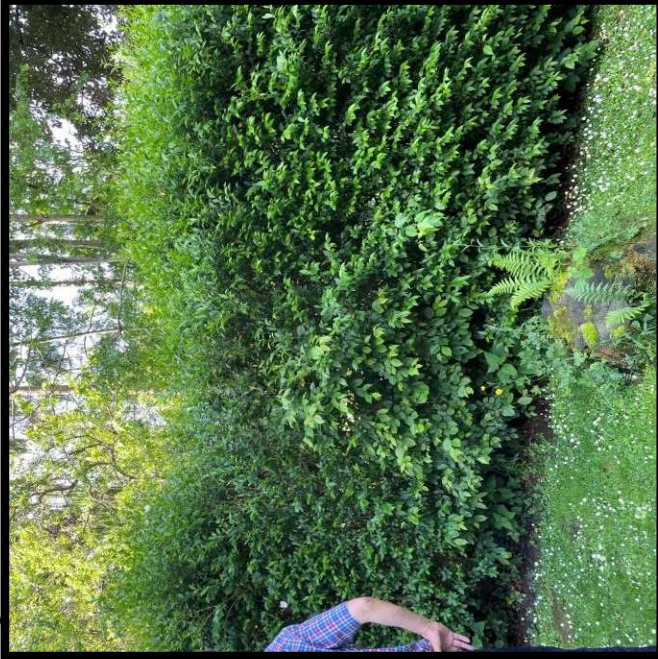
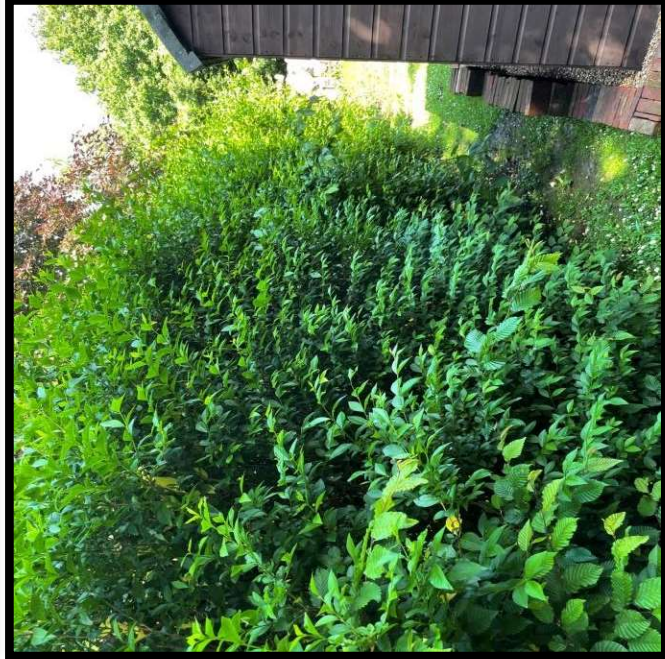
Left-hand side boundary at the rear of property

Across the back boundary there is a thick hedge there is a thick hedge combination of beech and other shrubbery, this extends across the back, I did not see any clear physical markers on exactly where the boundary there is a large copper beech tree at the rear which is approximately 16 m high. In the middle of the thick shrubbery/hedge there are fence posts marking the physical boundary.

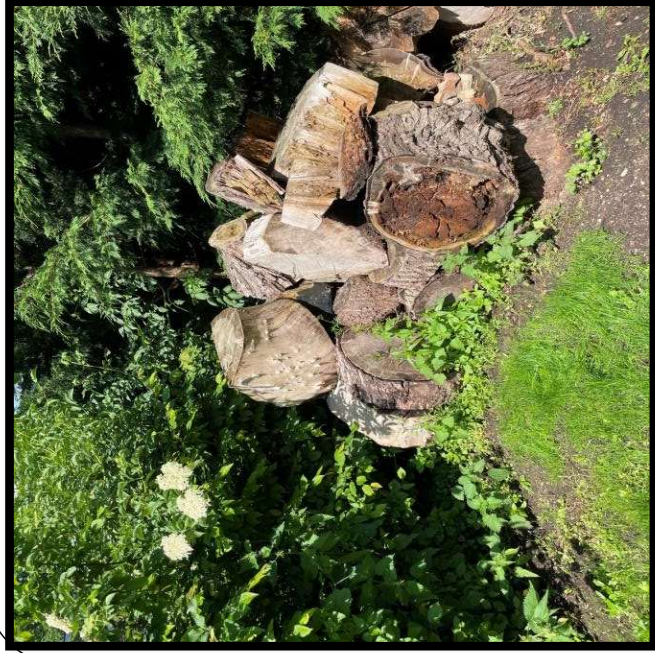
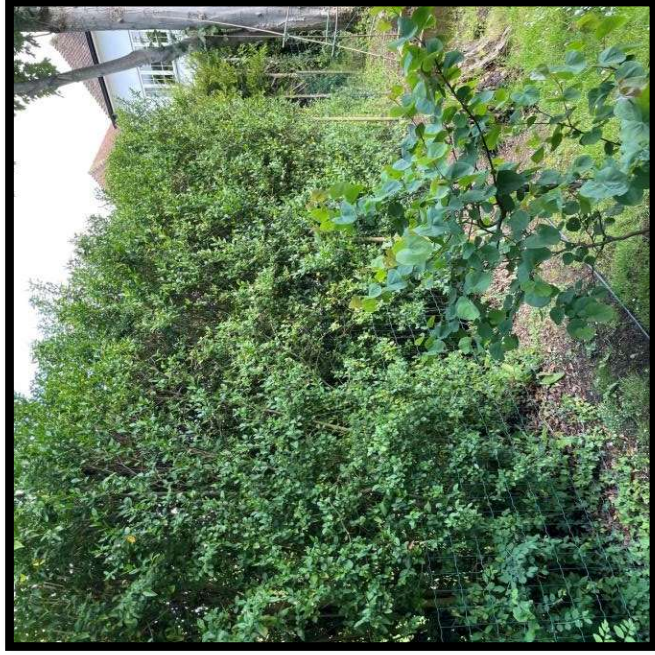
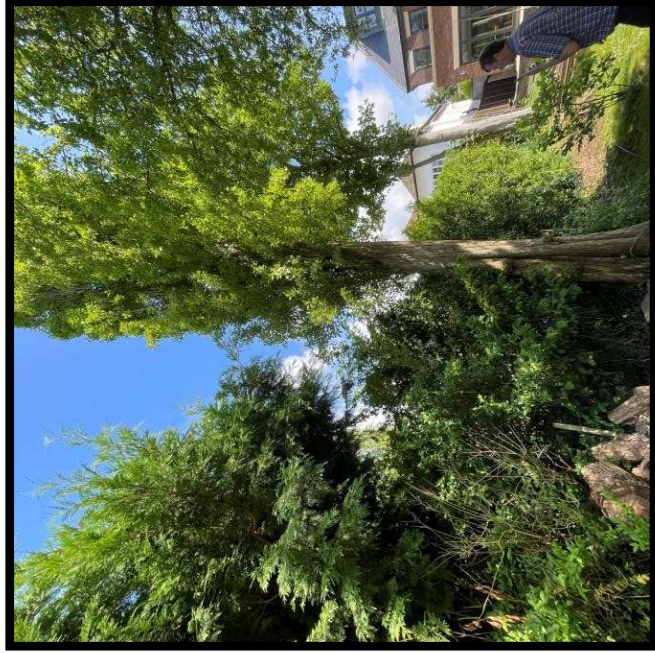
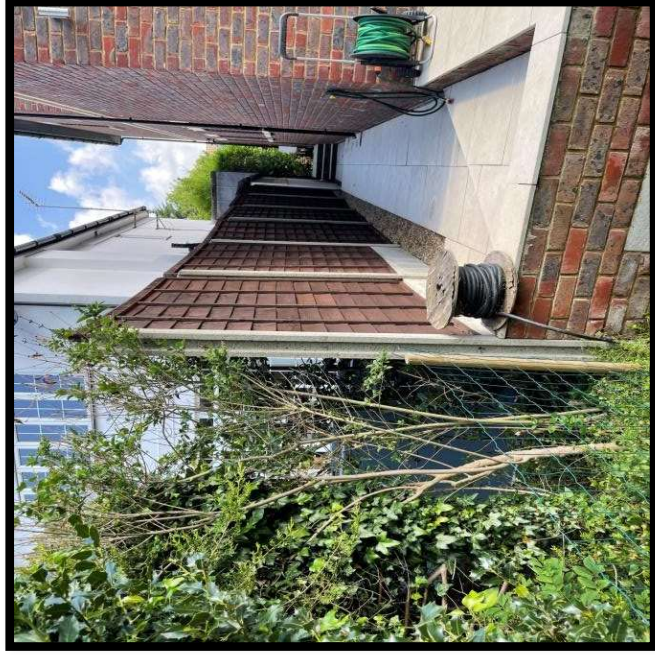
End of garden boundary and neighbours land/outbuildings behind

Facing up the boundary on the left-hand side facing the property from the rear of the garden, there are several Leylandii trees which have been cut down at various stages approximately 3 m high, this is where you have all the logs stored up against the boundary - marked with a chain-link fence where you have the large deciduous tree with the rough bark. This is a lime tree.

Moving up this boundary towards the property, there is a clear chain-link low-level fence visible.

There is a further large sycamore tree, again this appears to be at least 20 m high very close to the rear of the property less than 9 m. Depending on the depth of the foundations this could have an influence on the soil dynamics. You will need confirmation that building control approval is available for the inspection of the foundations. RFI.

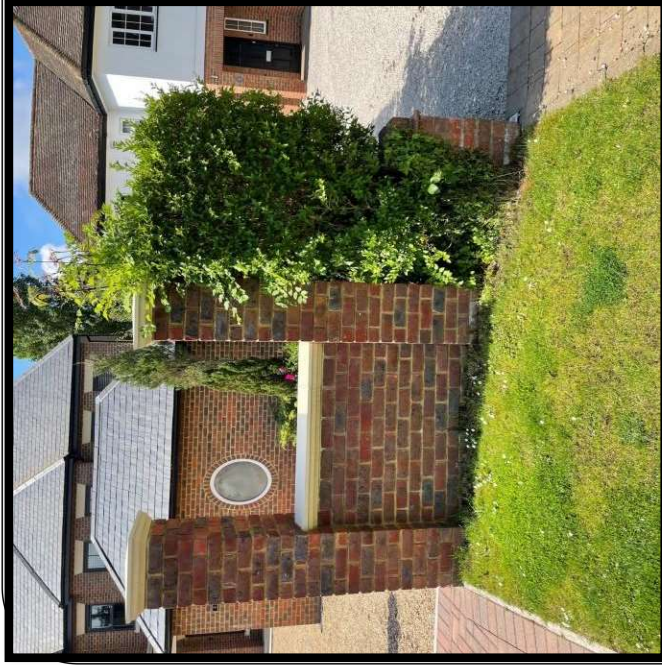
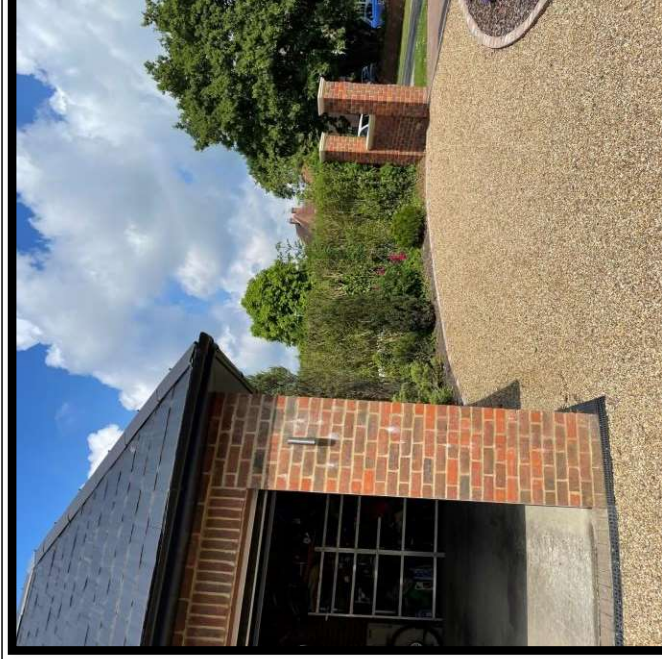
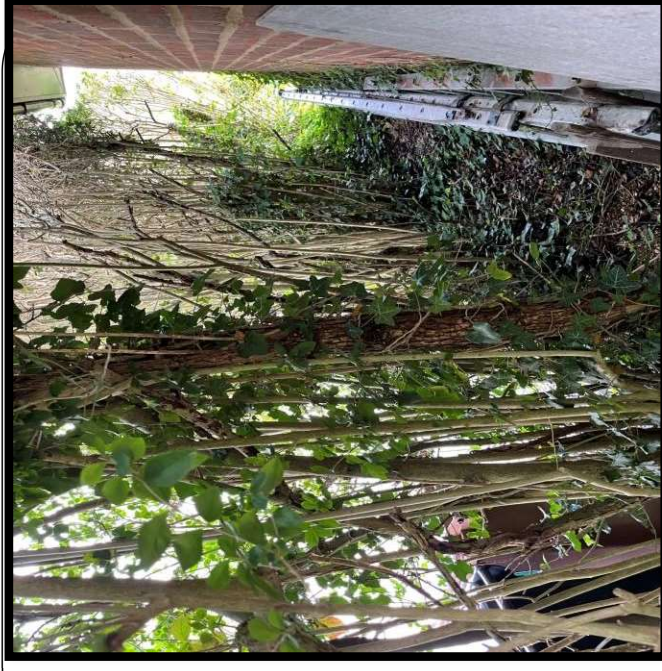
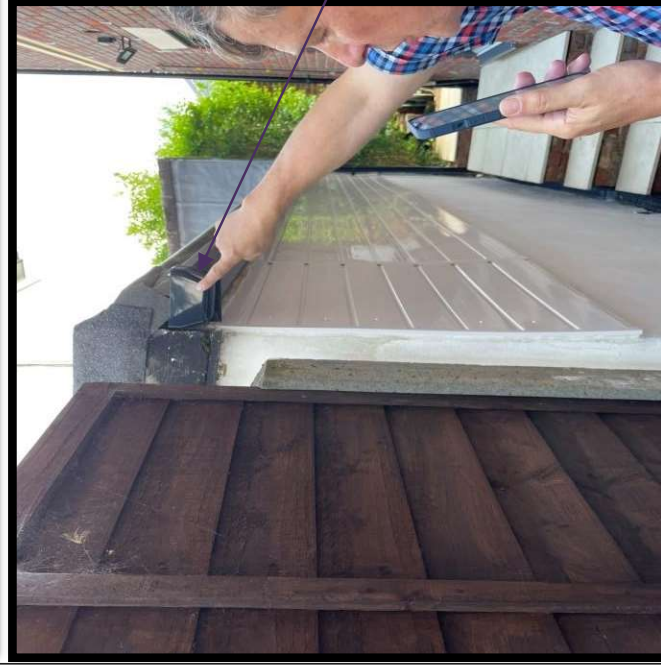
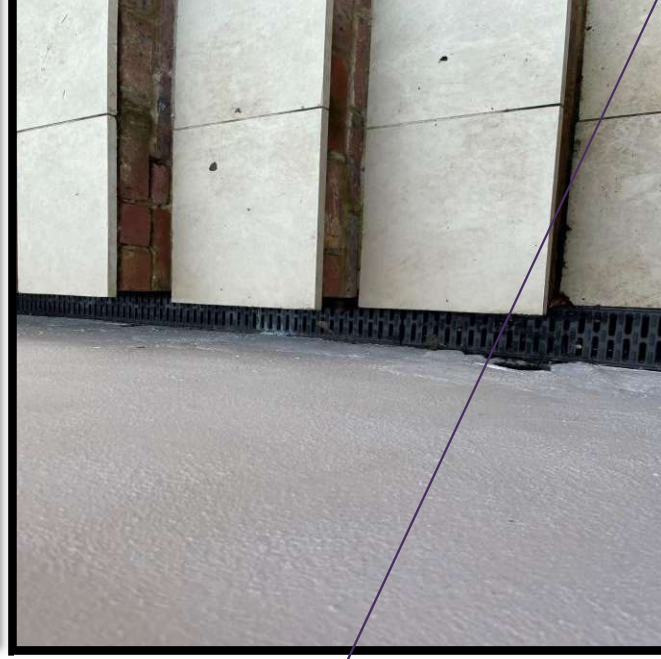
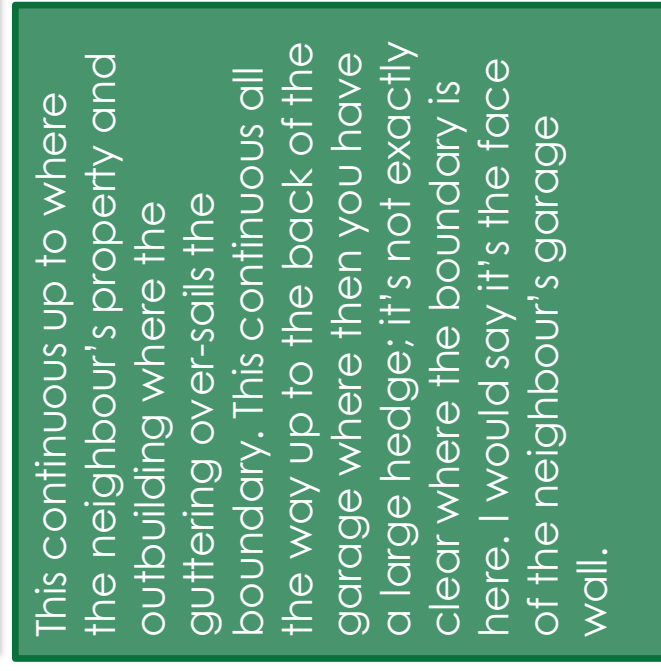
Right-hand side boundary at the rear of property

This continuous up to where the neighbour's property and outbuilding where the guttering over-sails the boundary. This continuous all the way up to the back of the garage where then you have a large hedge; it's not exactly clear where the boundary is here. I would say it's the face of the neighbour's garage wall.

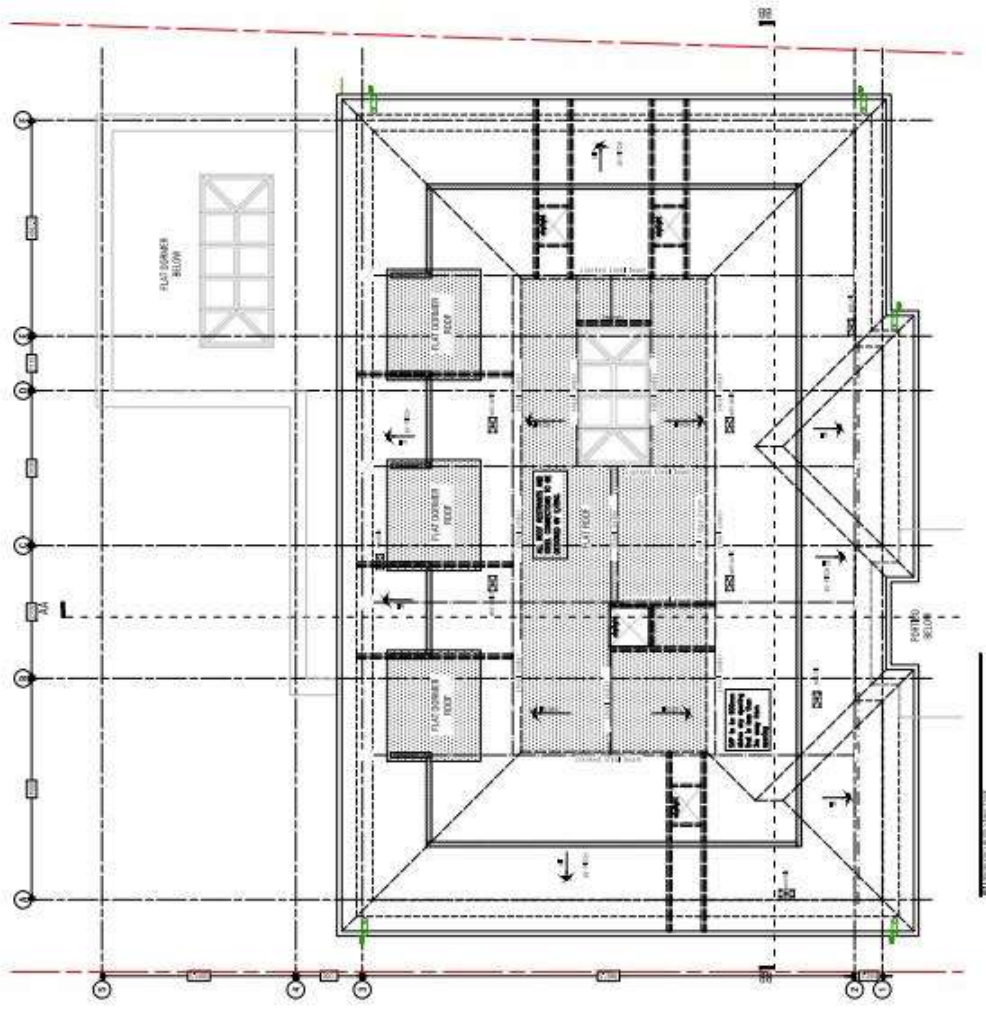
Roof plan

1st floor and attic level. This skylight never added.

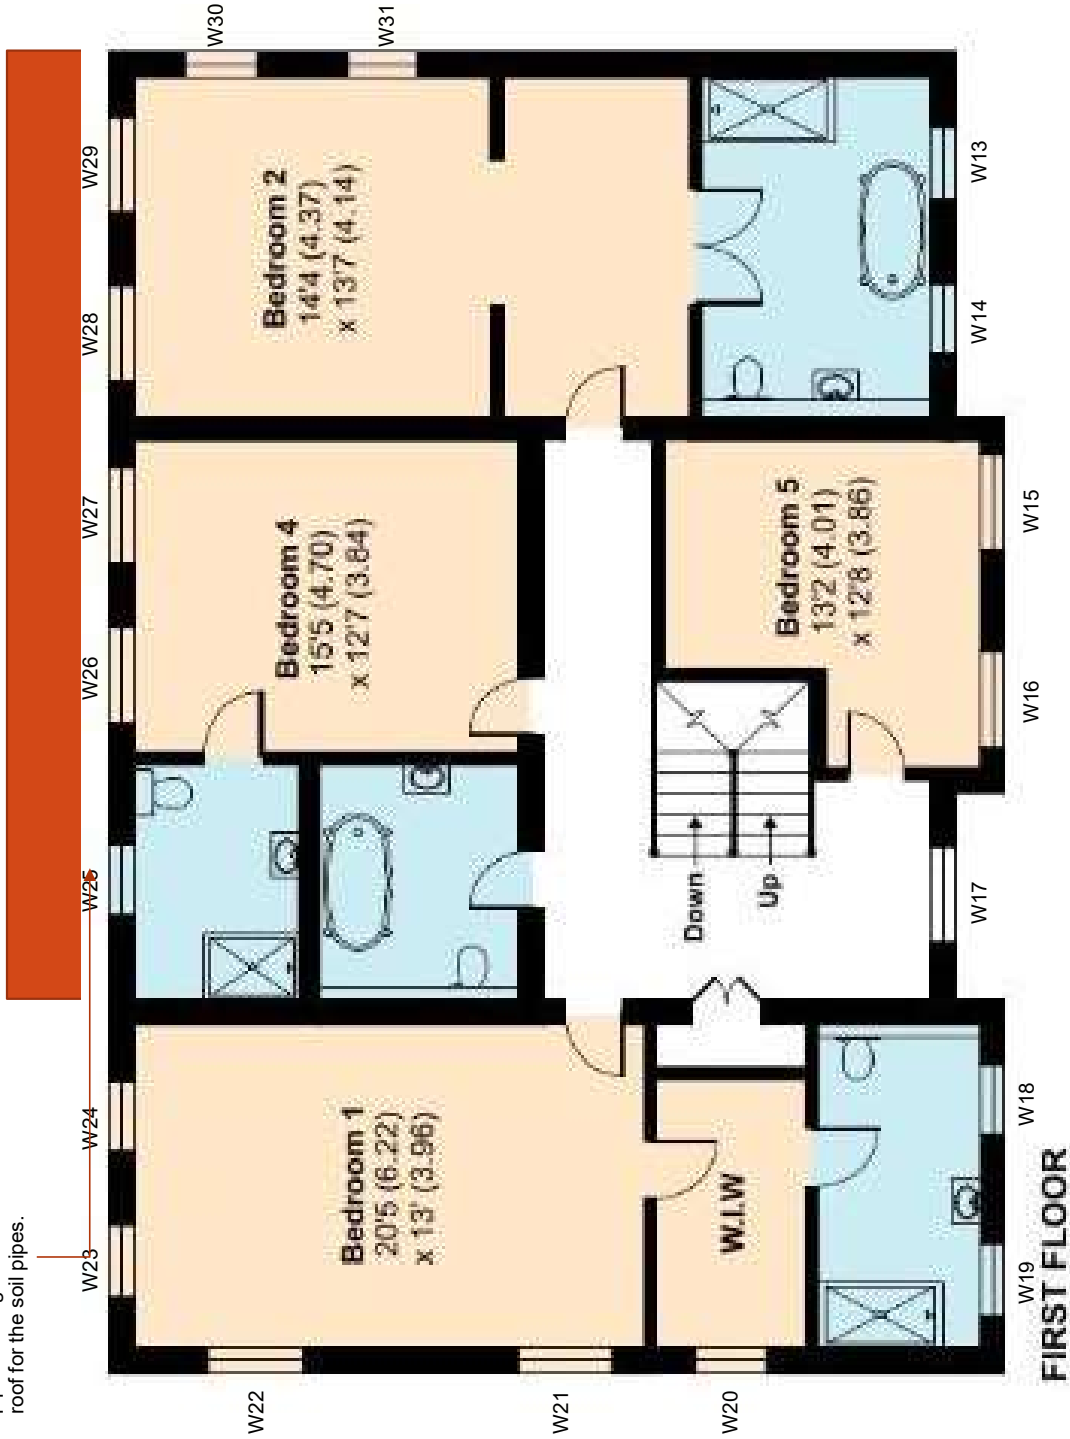
FIRST FLOOR PLAN:
SAMPLE SURVEY

Weathering details are poor to the pipes coming out of the wall and roof for the soil pipes.

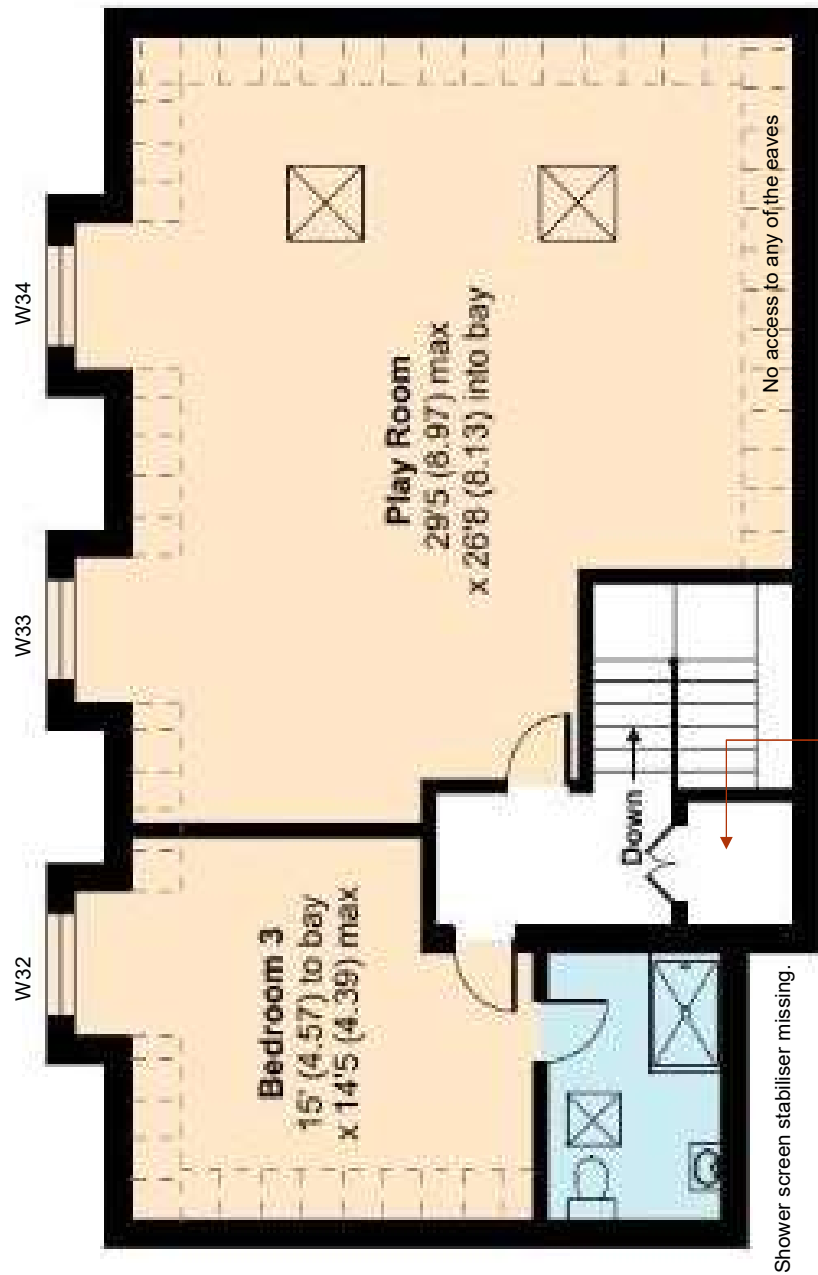
SECOND FLOOR PLAN:
SAMPLE SURVEY

Underfloor manifold located here for the top floor only.
