DETAILED BUILDING SURVEY

INCORPORATING A VISUAL / STRUCTURAL ASSESSMENT OF THE PROPERTY

BUILDING SURVEY REPORT – SAMPLE REPORT

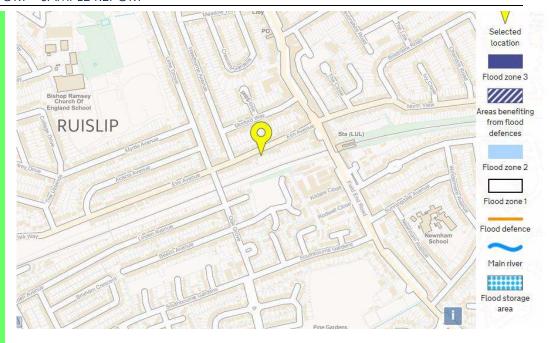
The property does not appear to fall within a flood zone (see map above).

<u>Dark blue</u> shows the area that could be affected by flooding, either from rivers or the sea, if there were no flood defences. This area could be flooded:

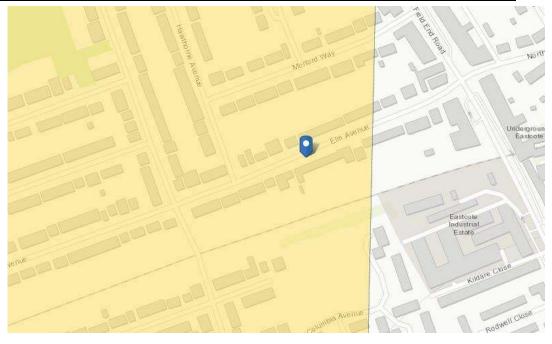
Radon Gas Check

Some parts of this 1km grid square are in bands of elevated radon potential. Maximum radon potential is 1-3 %.
